# **A survey of parts of the drainage system within the south-east sector of Hilton Parish.**

## **Sections covered:**

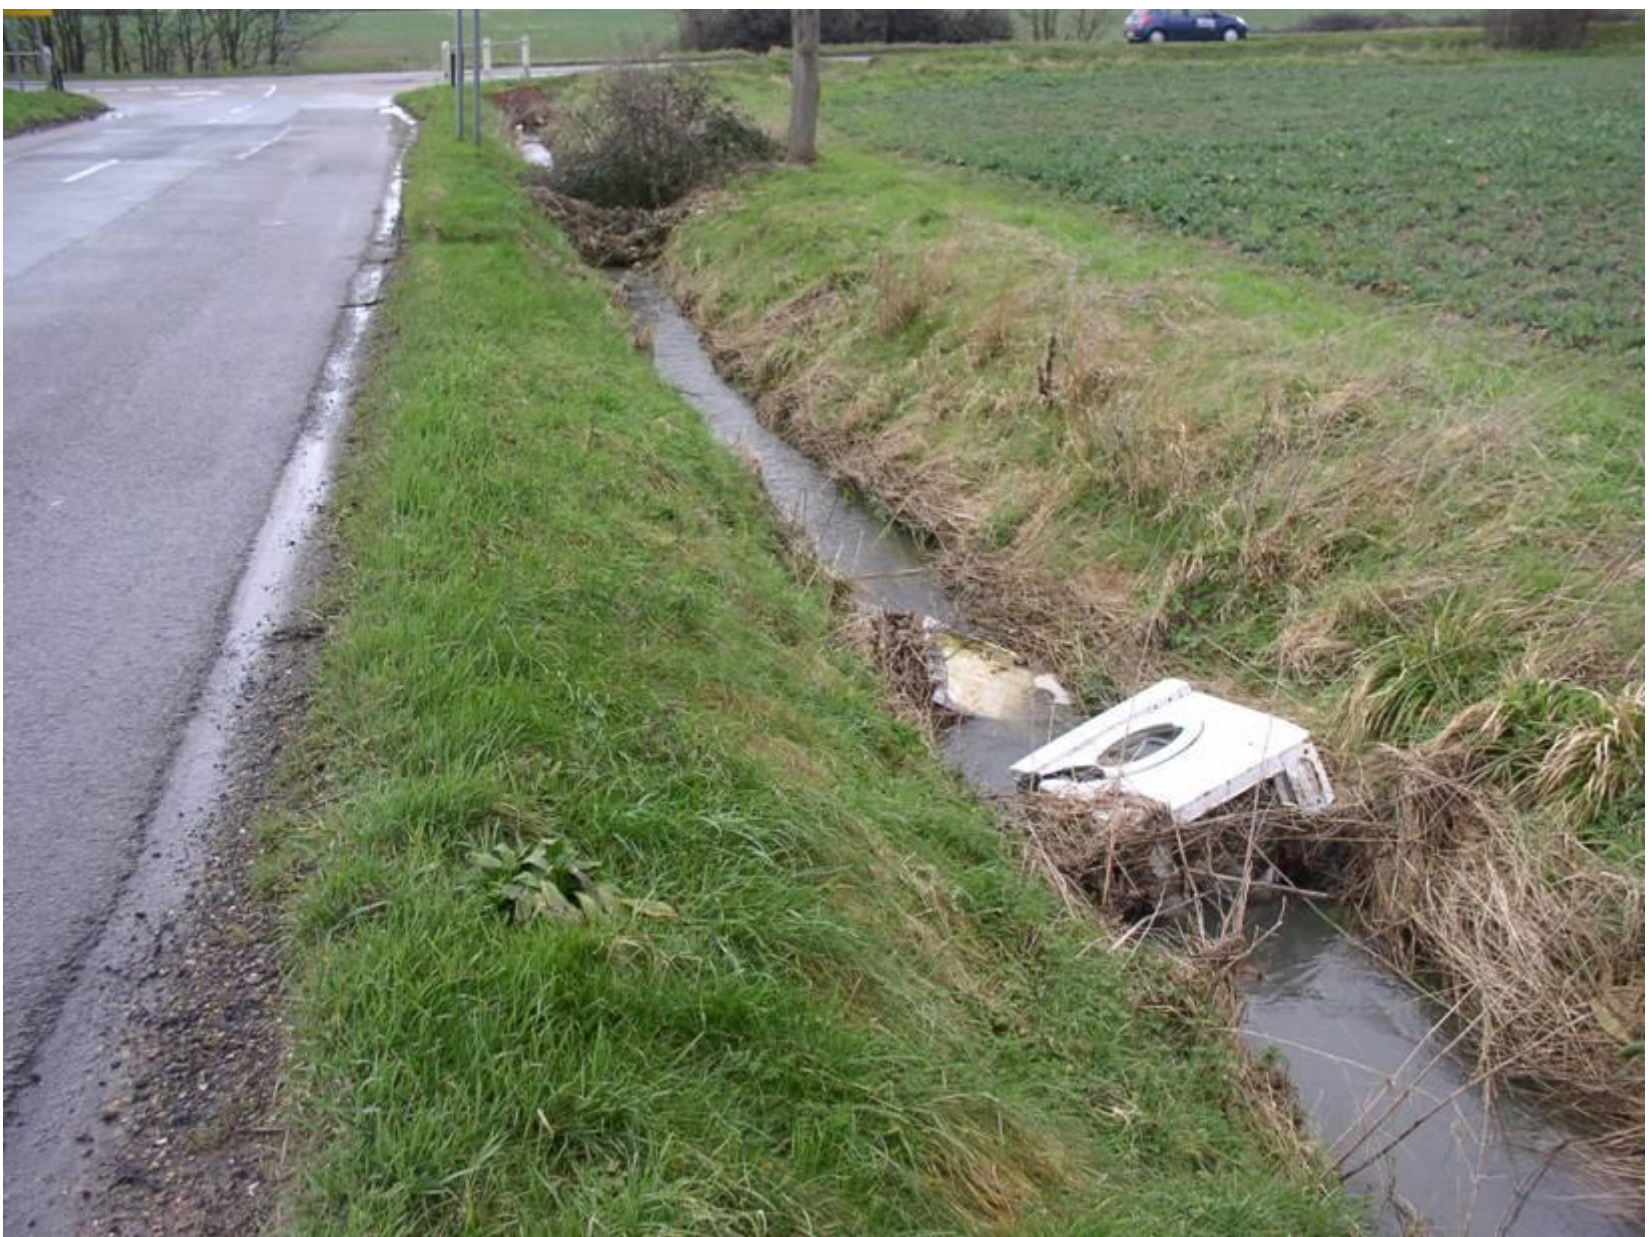
Potential blockage from discarded washing machine just east of B1040/Rogue's Lane junction.

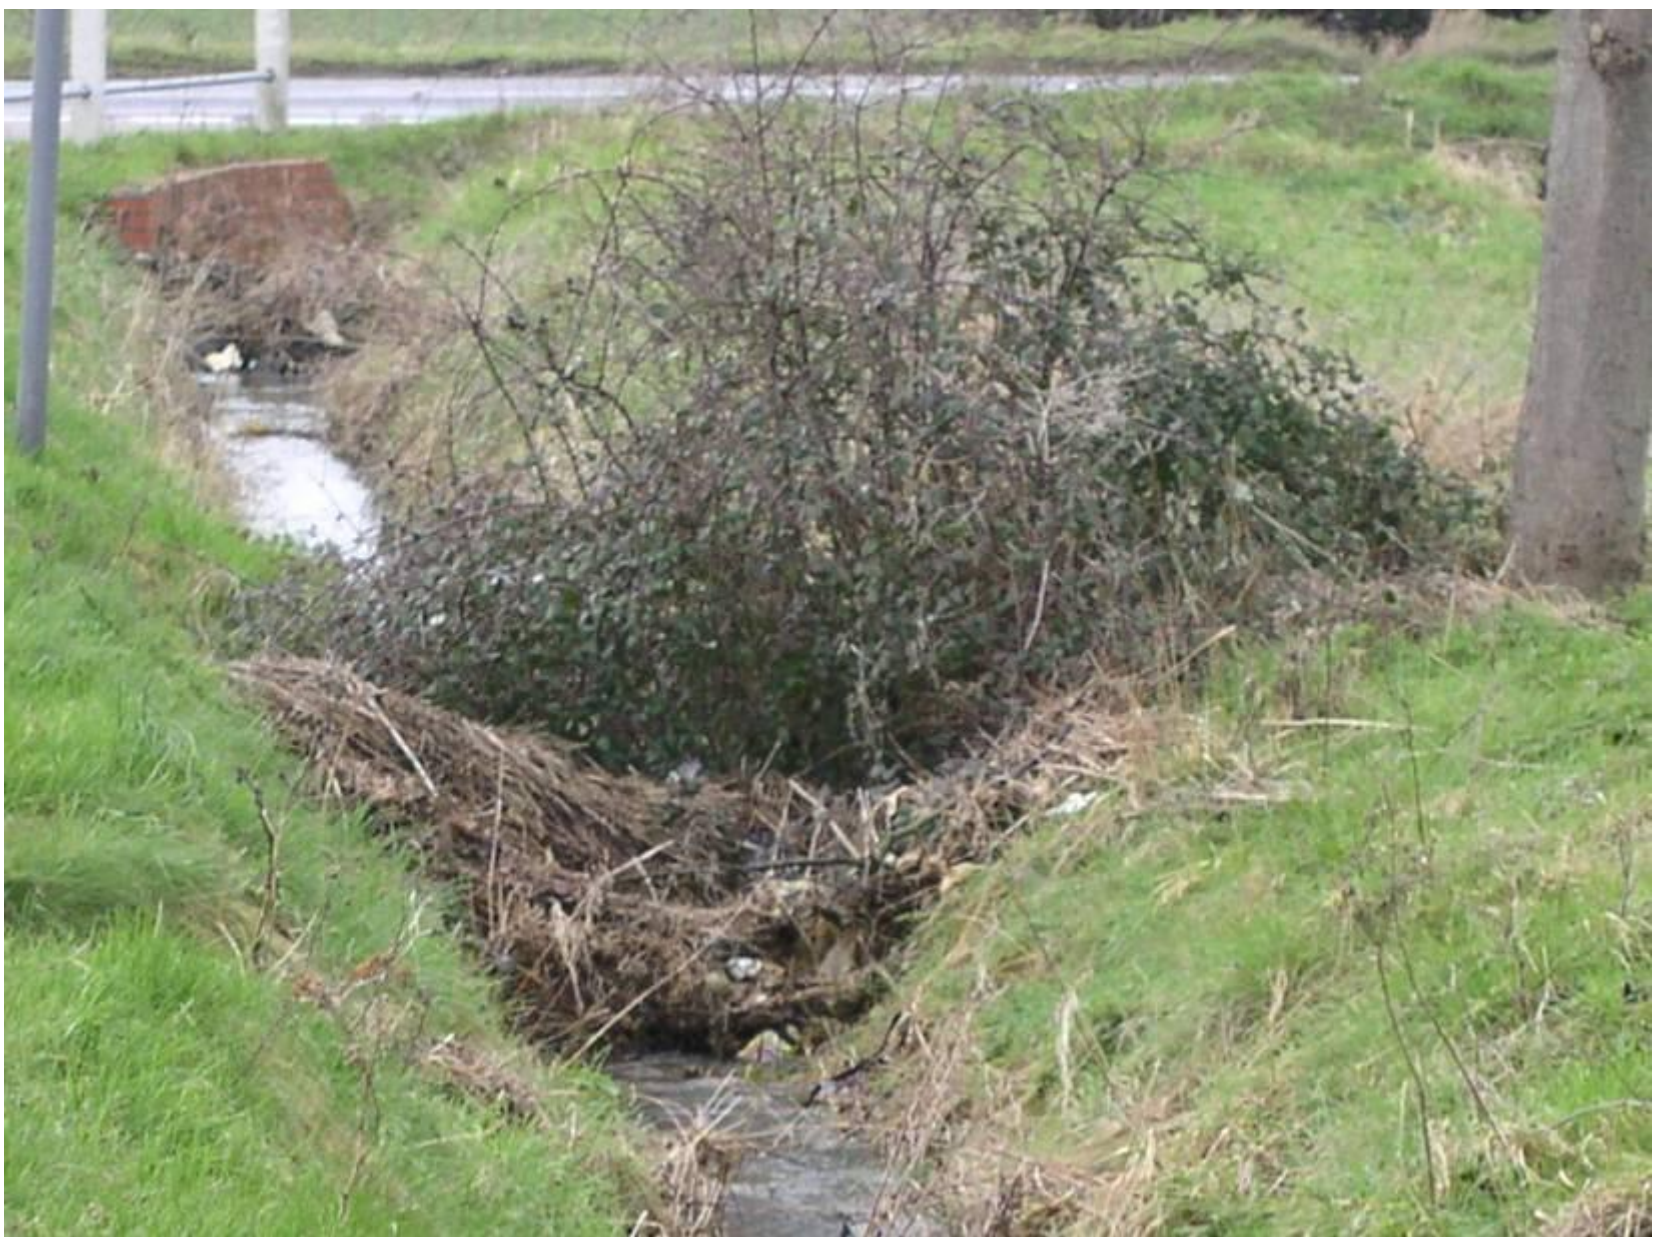
Area of natural debris build-up just east of B1040/Rogue's Lane junction. Although relatively severe, this was not causing any significant blockage.

Urgency 1

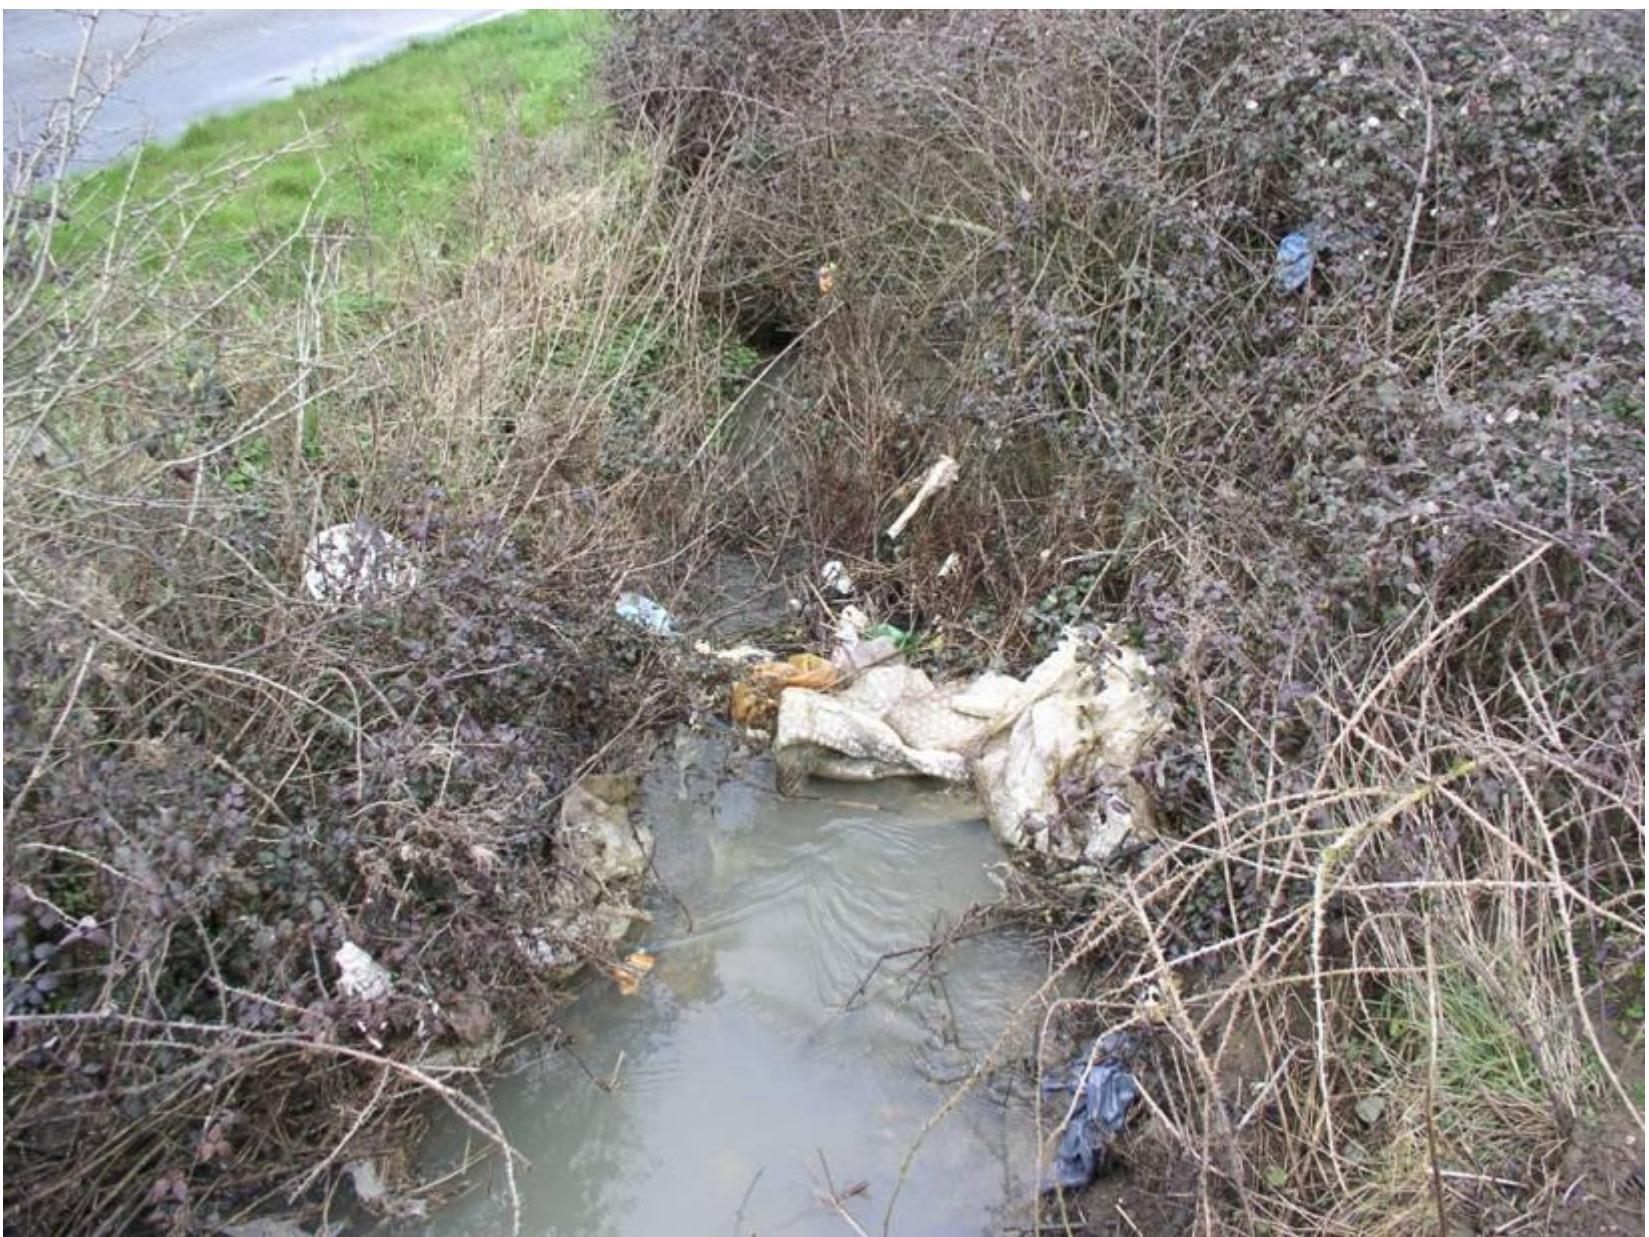
Potential blockage from discarded man-made items (plastic bottles and sheeting), at the electricity sub-station on the B1040.

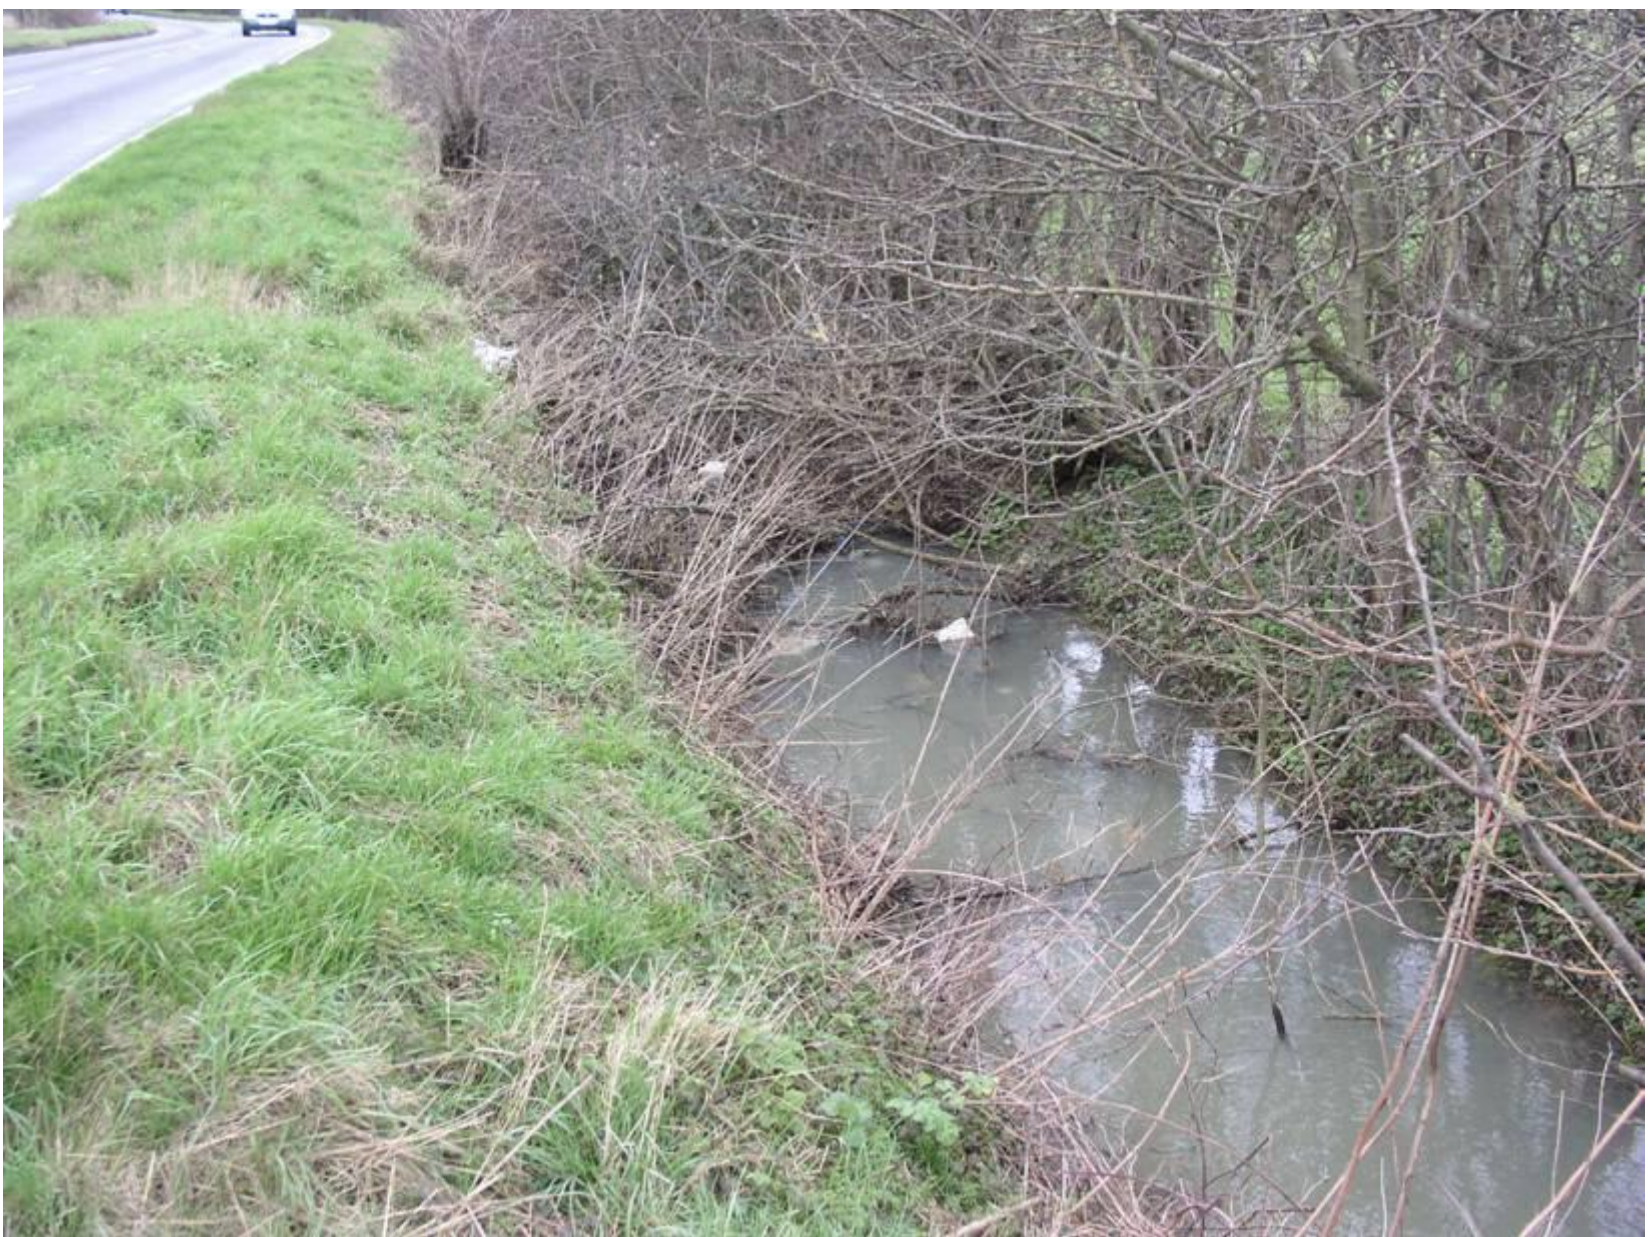
Build-up of natural debris + man-made items 200 metres north west of electricity sub-station entrance.

Urgency 0

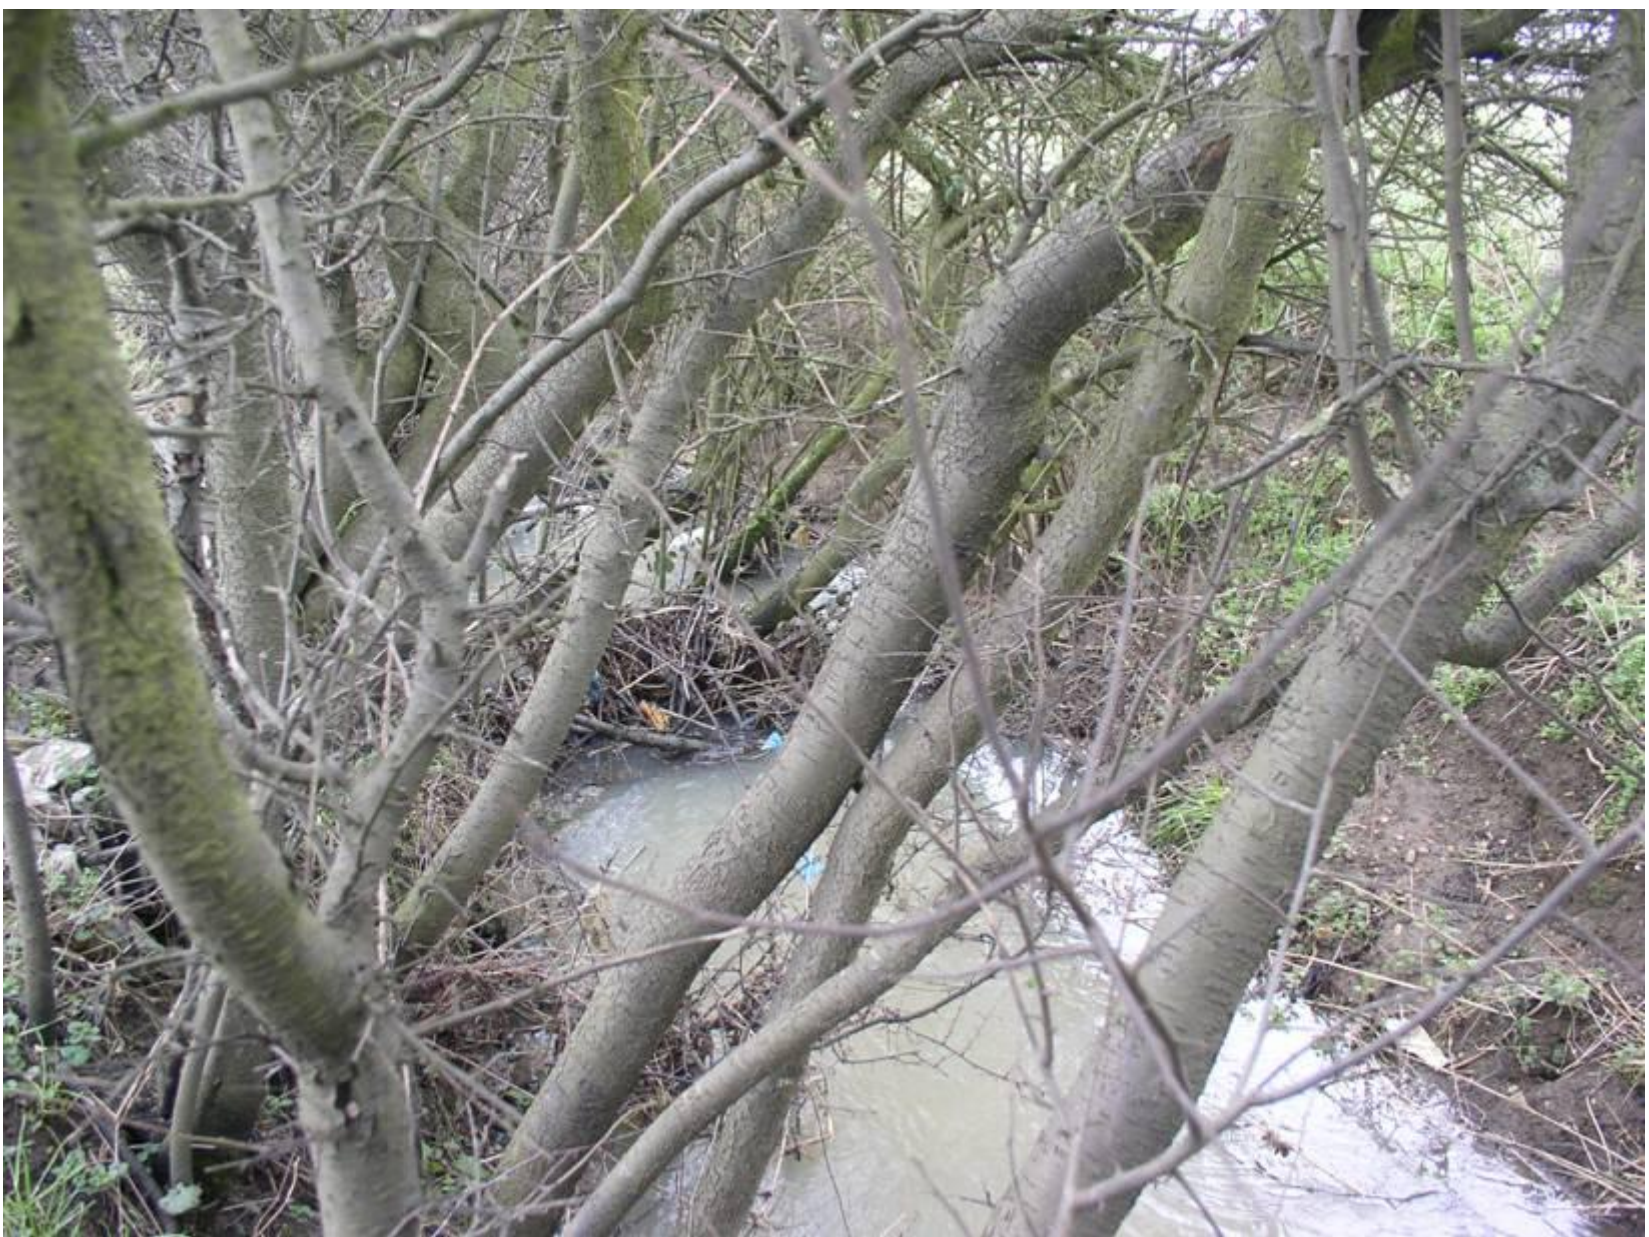
Build-up of natural debris + man-made items 250 metres north west of electricity sub-station entrance. This is built up against a tree growing in the middle of the ditch.

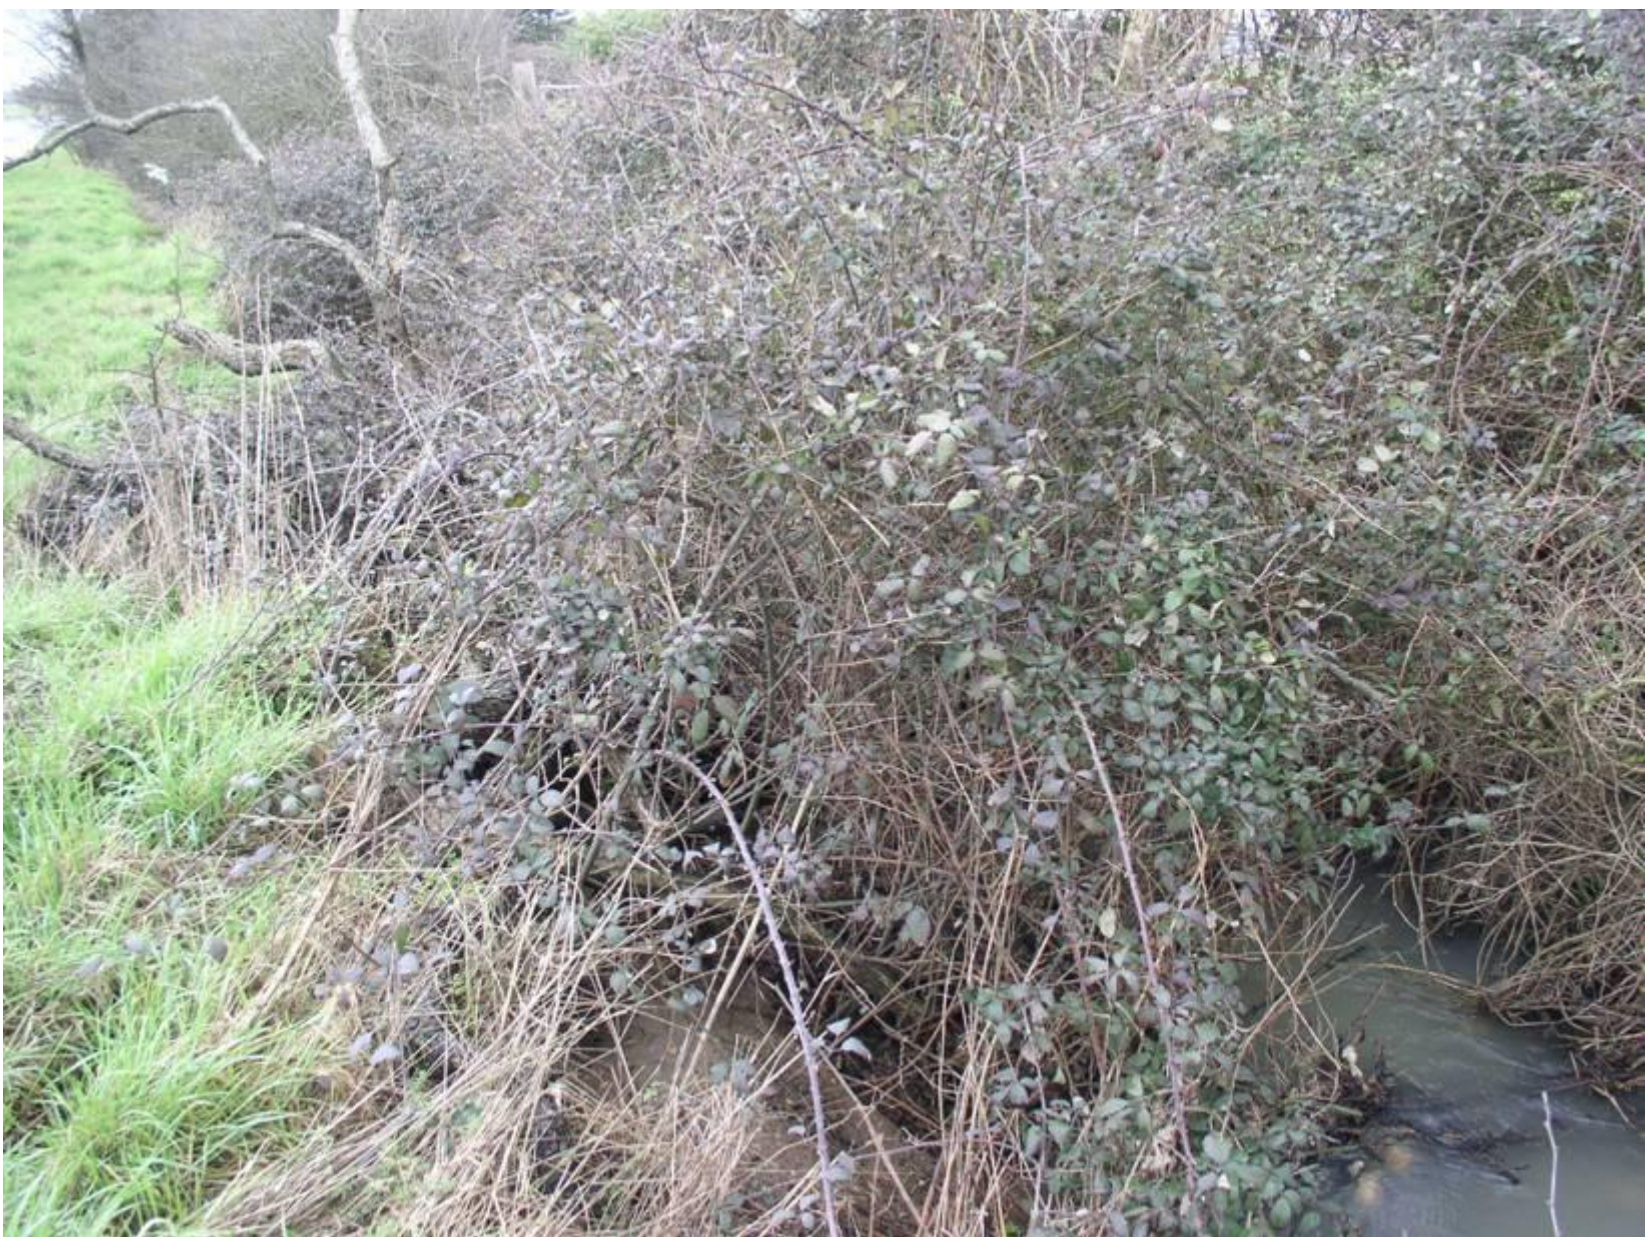
Brambles and other hedge growth plus a fallen tree causing some build-up of debris approx. 200 metres north west of electricity sub-station entrance.

Urgency 1

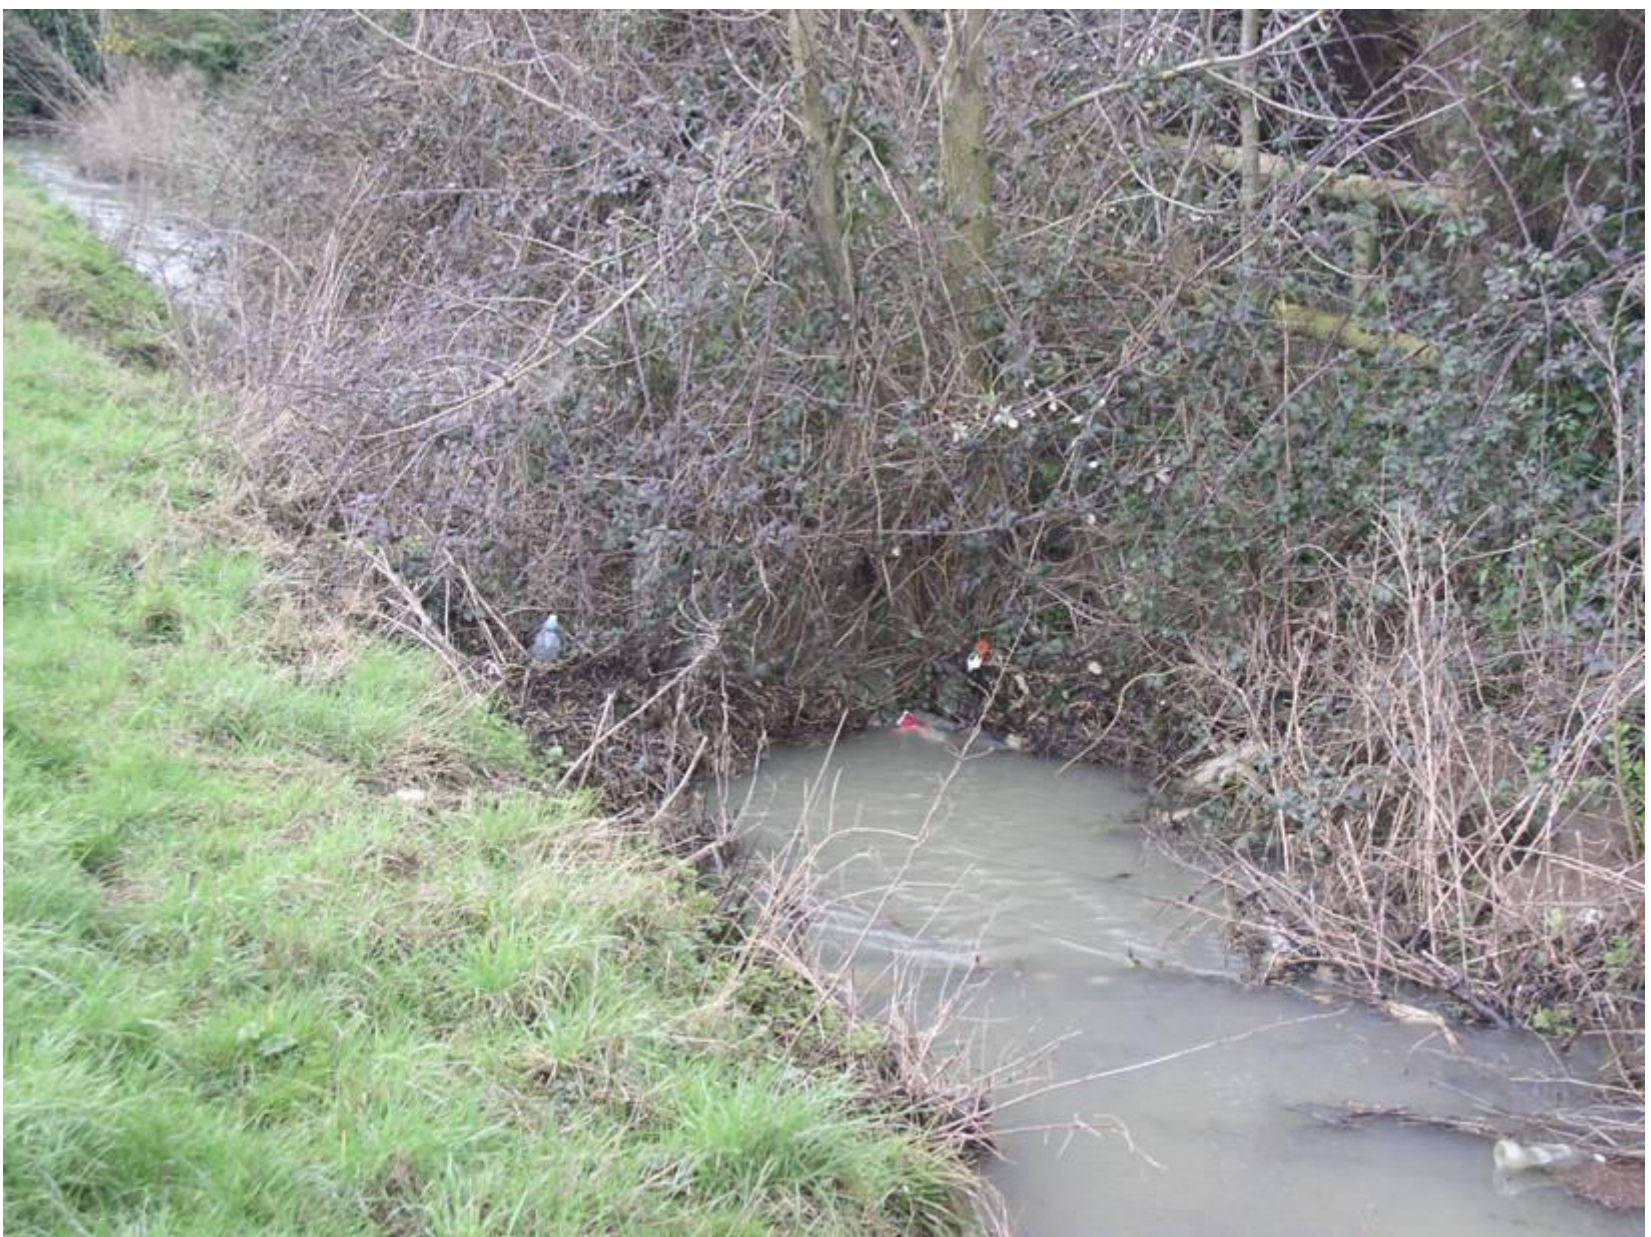
Build-up of natural debris + man-made items at New Farm.

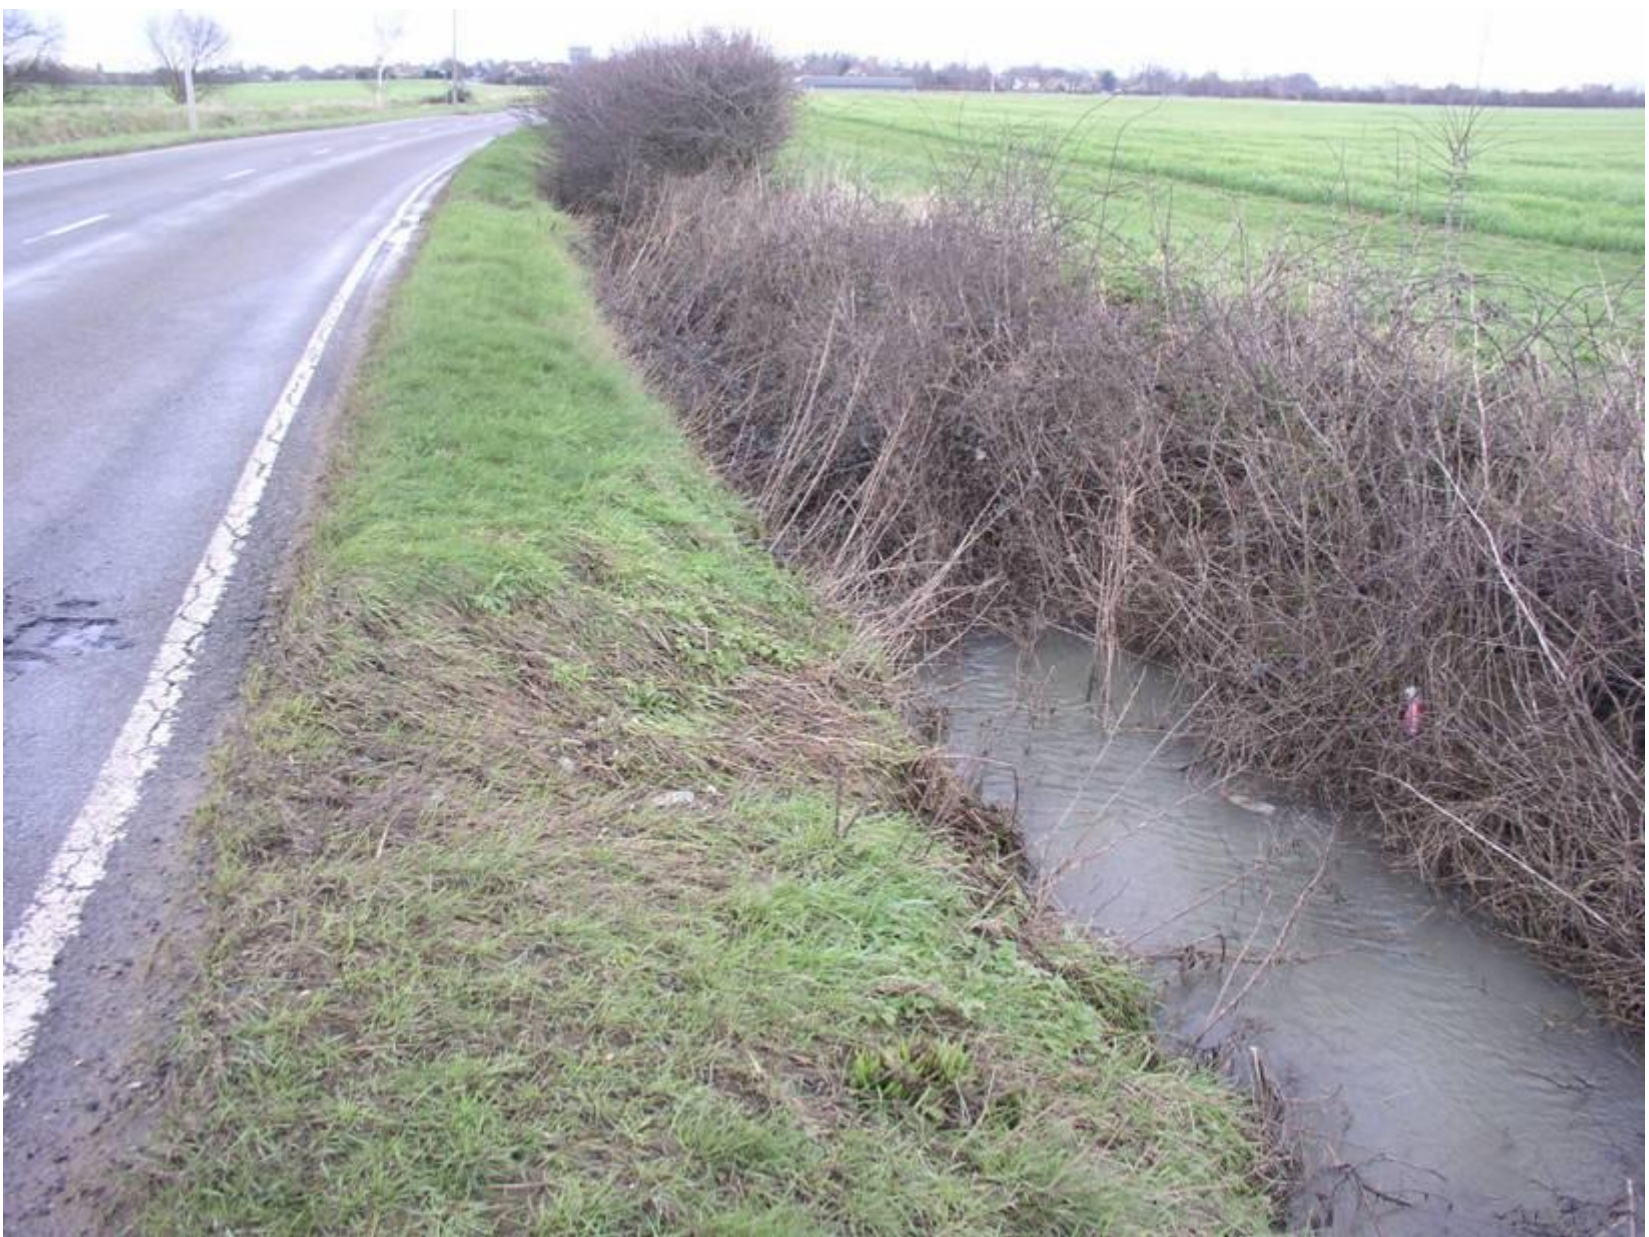
Weed growth over the ditch 75 metres north-west of New Farm.

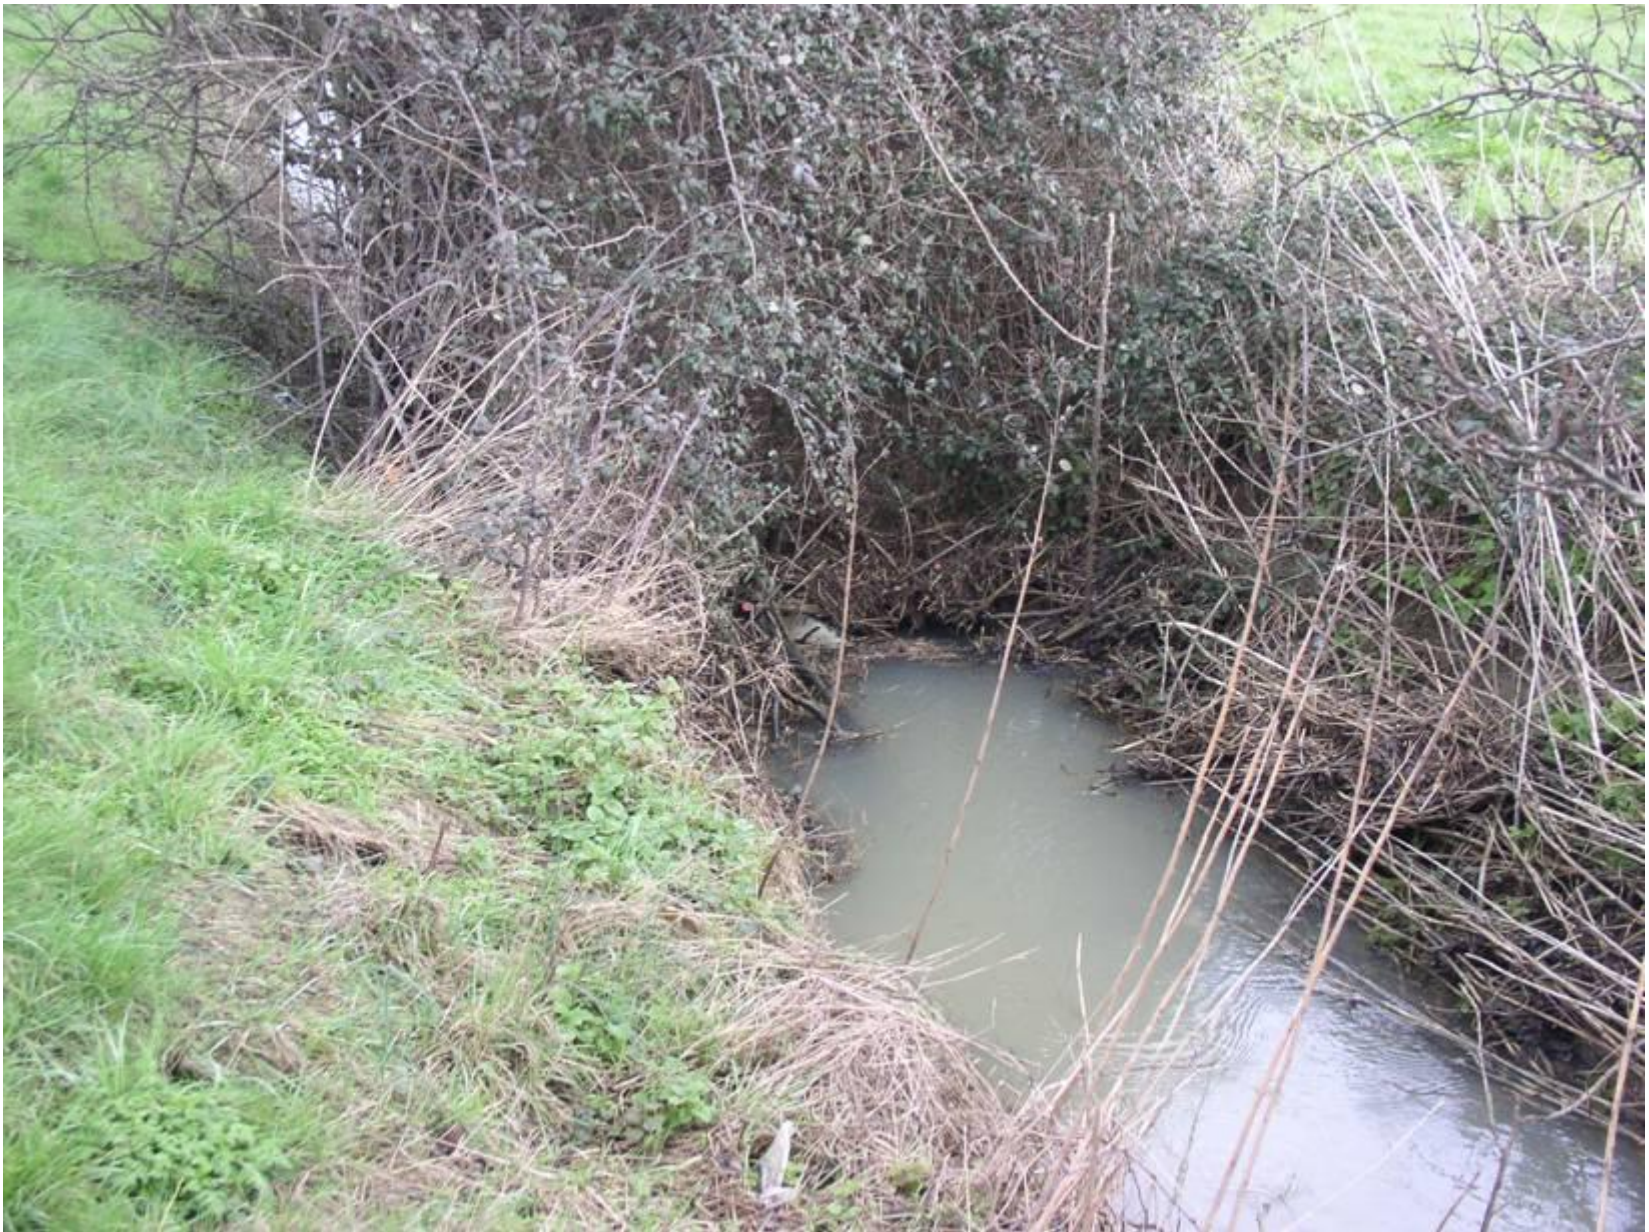
Build-up of natural debris + man-made items 150 metres north west of New Farm.

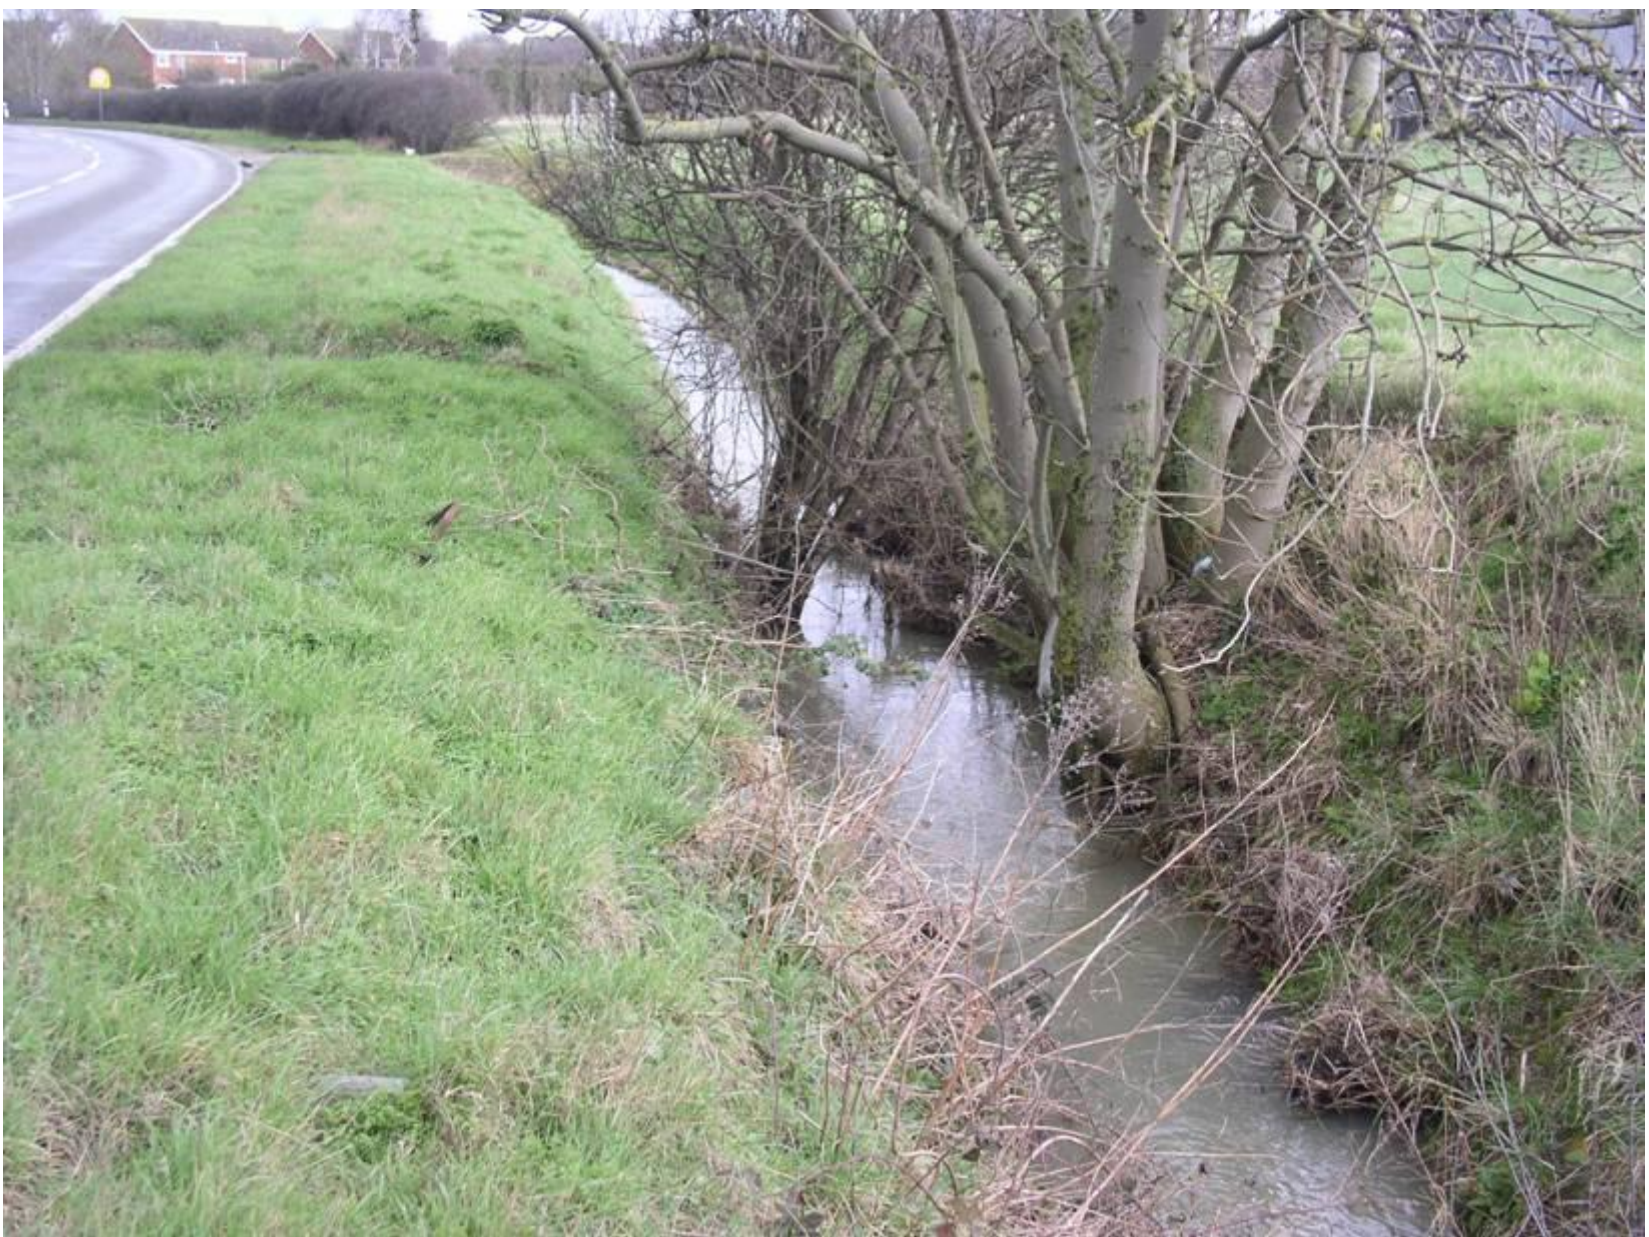
Potential site of debris retention in periods of heavy rain 50 metres before entrance to field with chicken sheds.

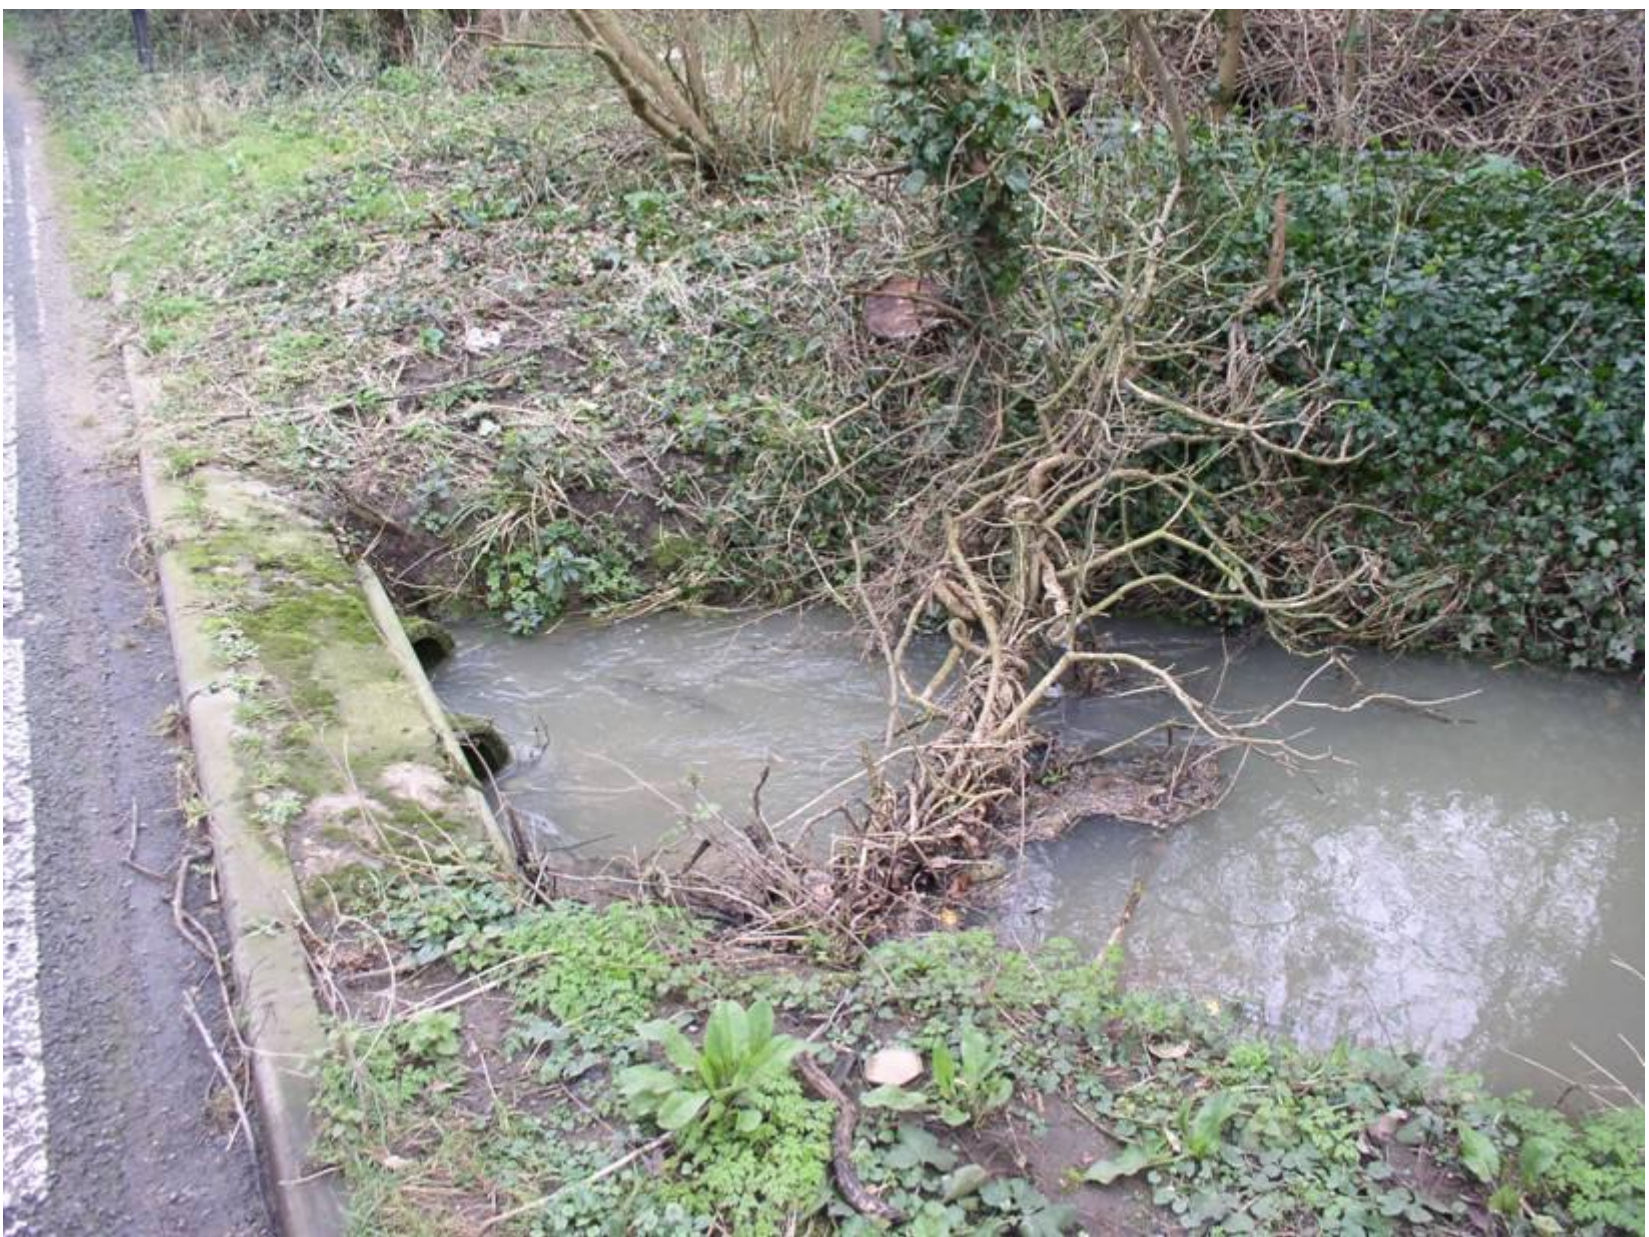
Build-up of natural debris at the 'occasional ford' in Church End.
