# **A survey of parts of the drainage system within the south-east sector of Hilton Parish.**

## **Sections covered:**

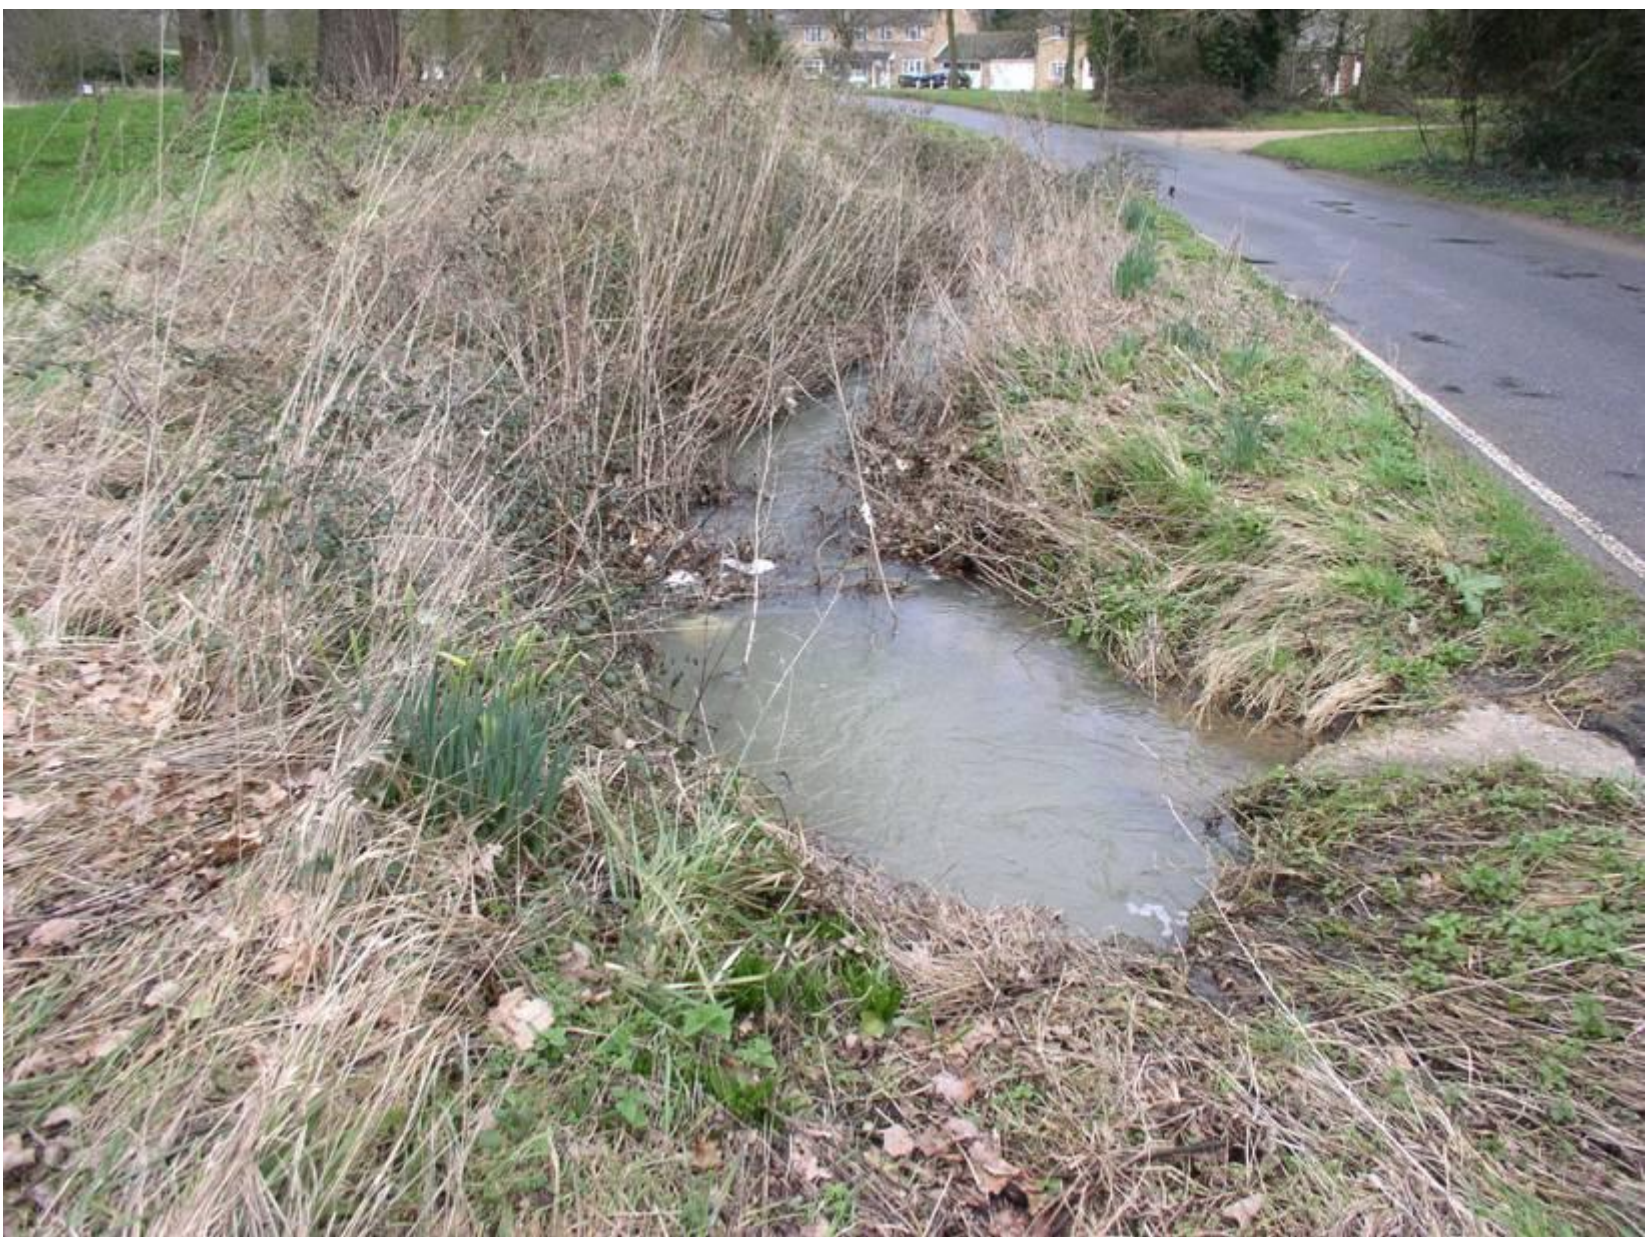
Site of the 'occasional ford' in Church End. There is a small build-up of debris which was not causing any backing up of the water. There is some weed growth just down from this area which, for aesthetic reasons only, warrants cutting back.

Urgency 1

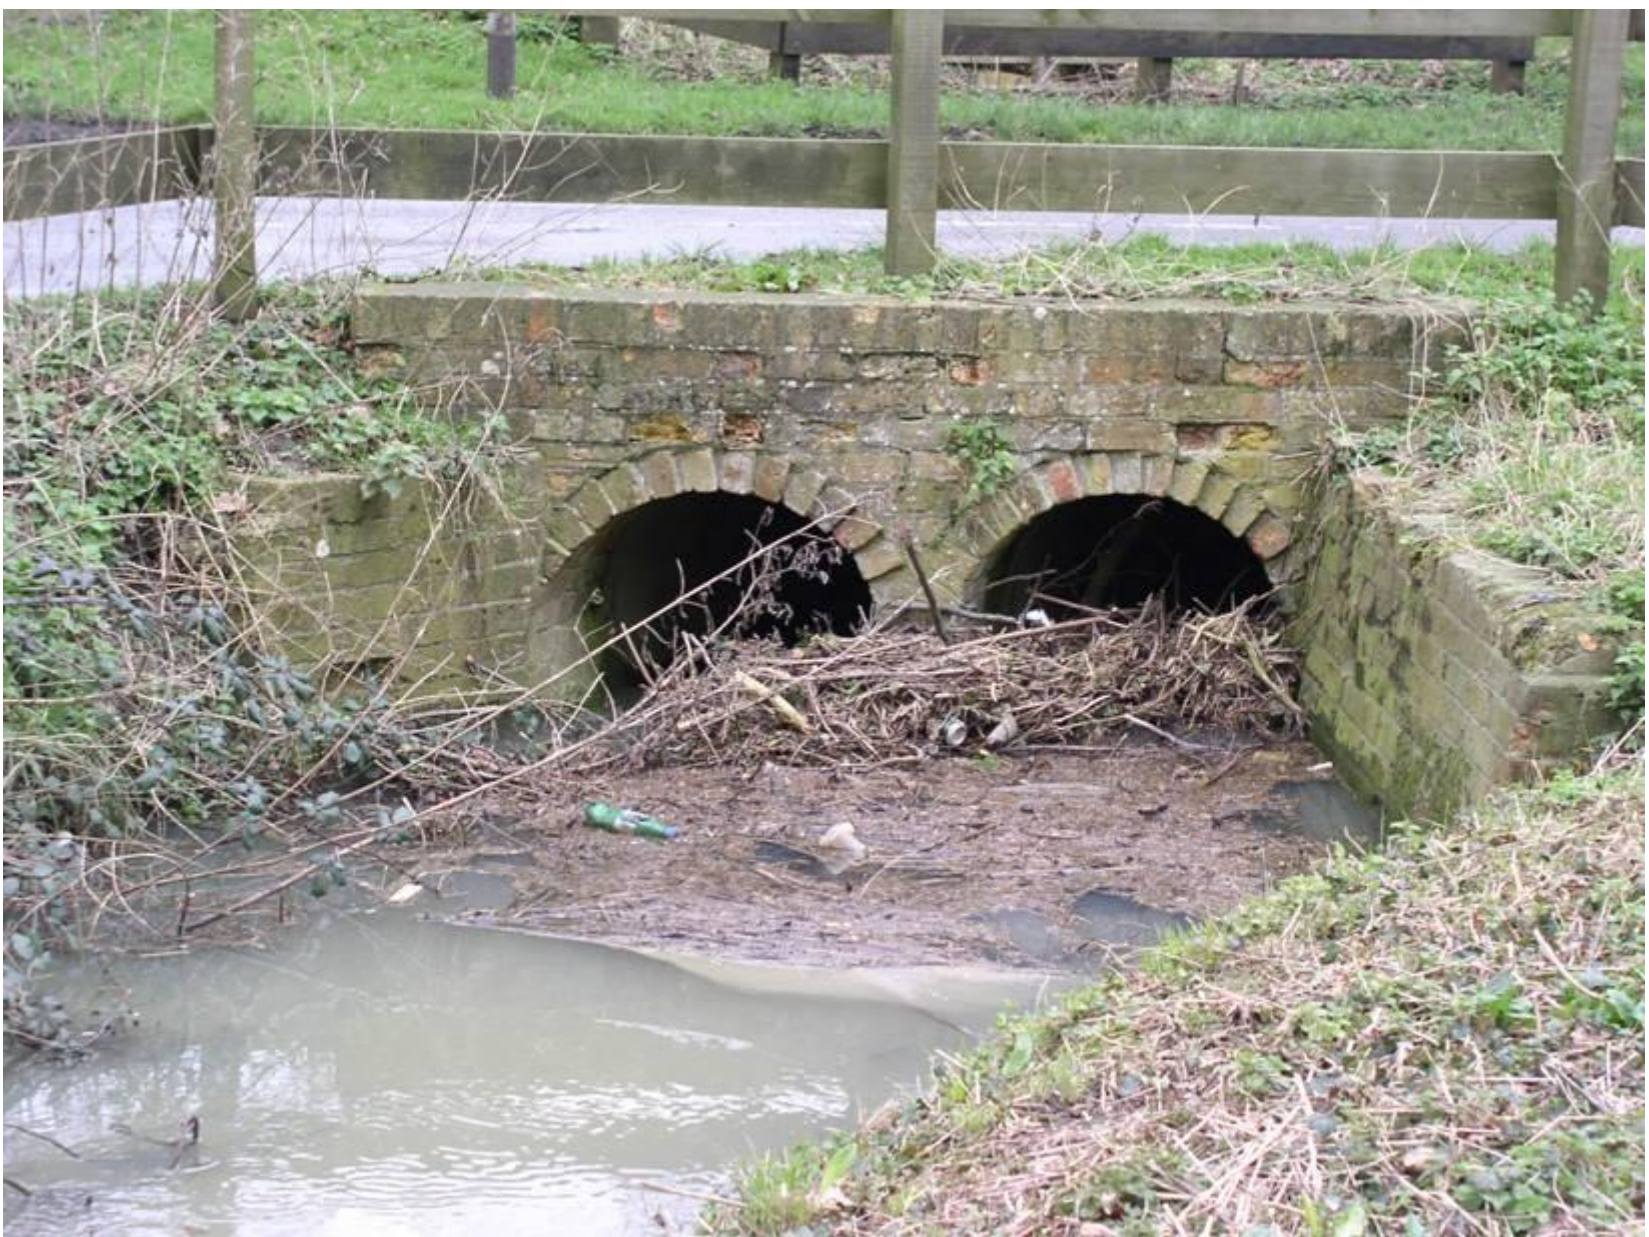
Build-up of natural debris + man-made items at the bridge in Brand's Pit between High Street and Fenstanton Road. This was causing some backing up of water.

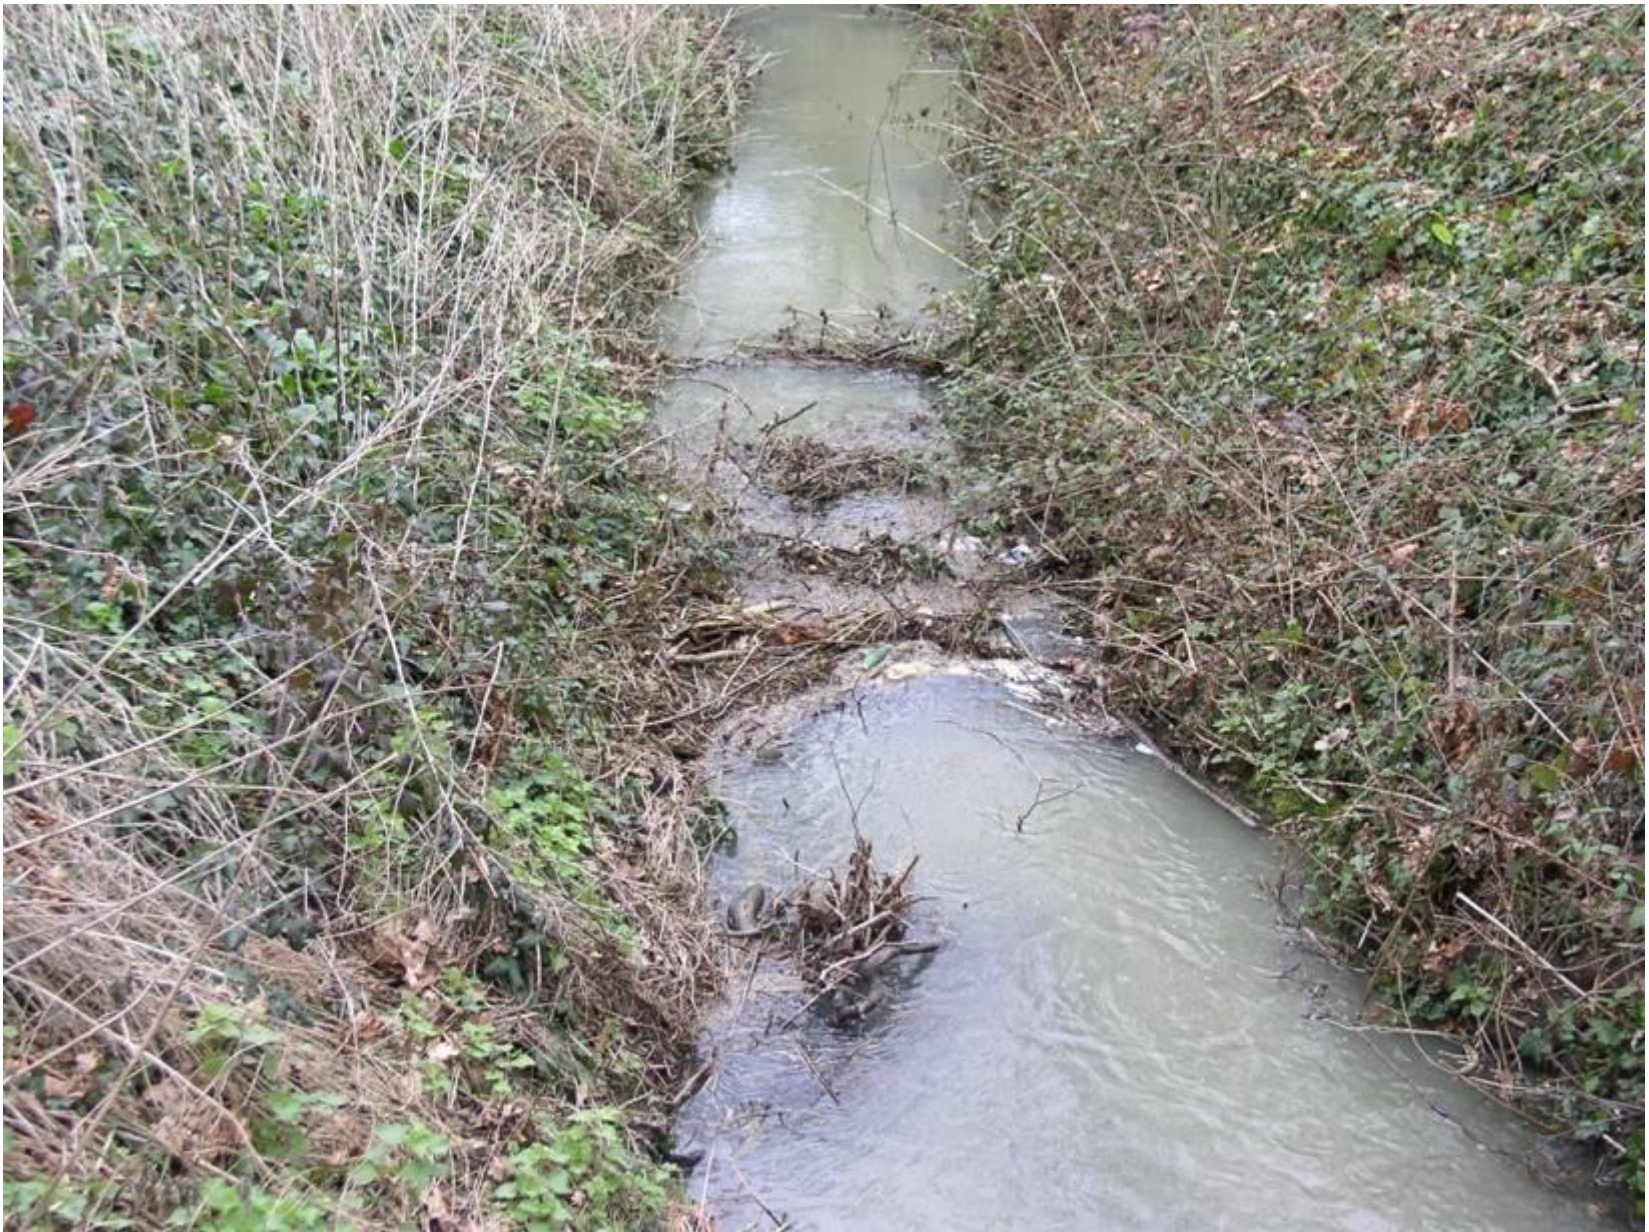
Build-up of natural debris + man-made items just east of the bridge at Brand's Pit.

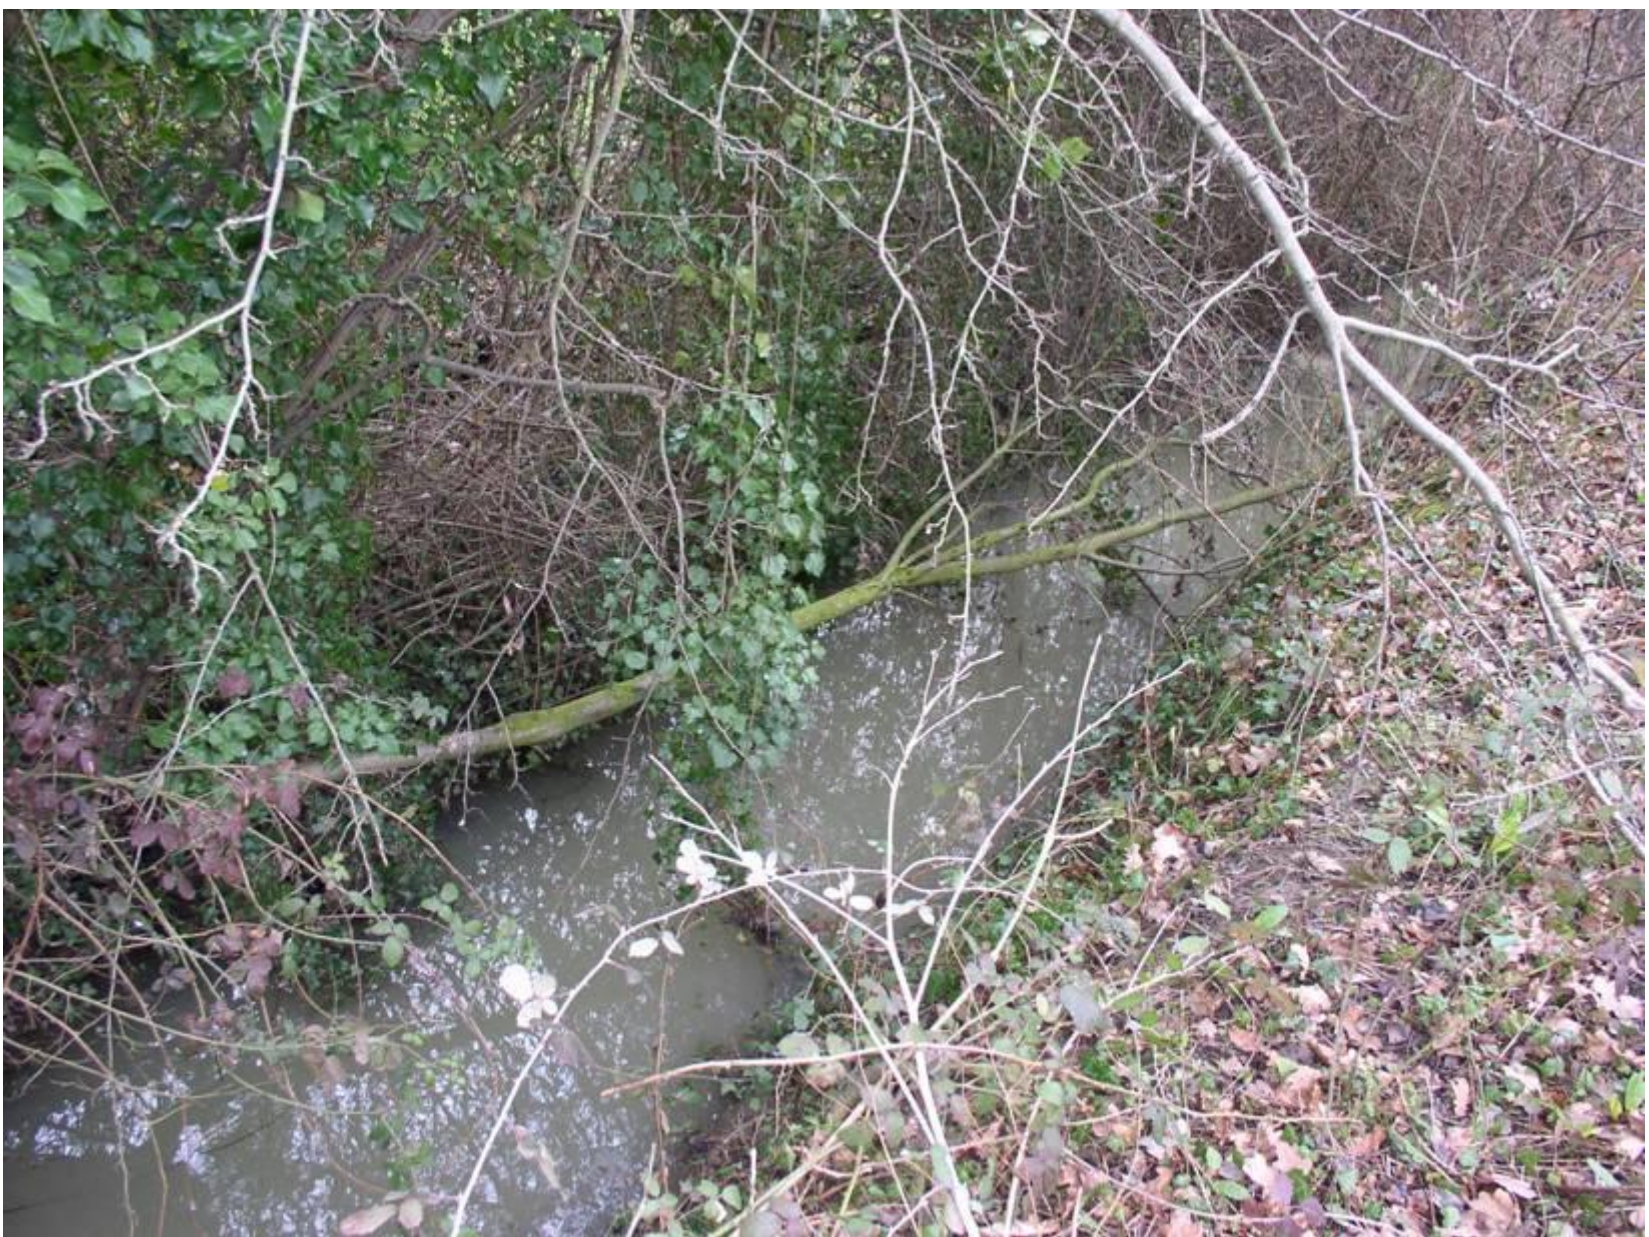
Fallen tree across the ditch just outside Green End House. Although not causing any build-up of debris at the moment, this could do so in the future.

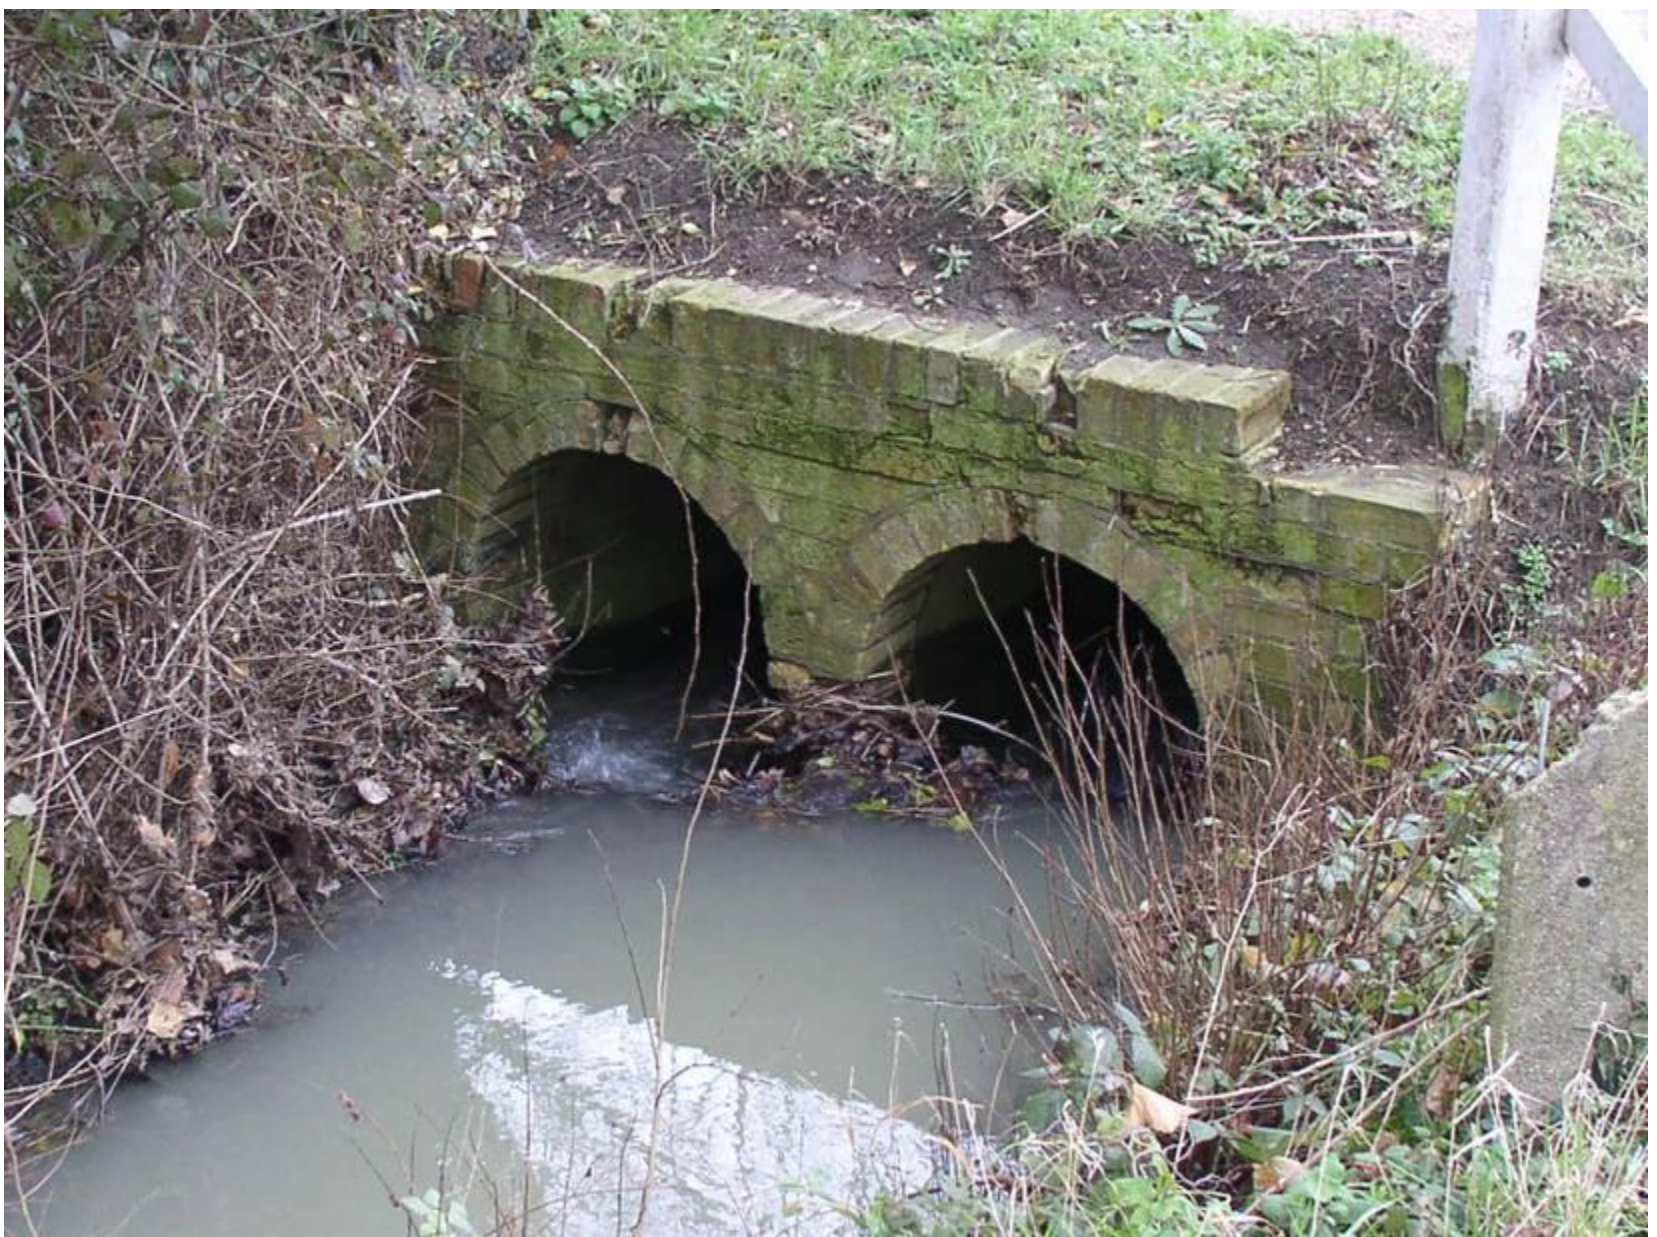
Build-up of natural debris at the culvert at Green End House. This was causing some backing up of the water.

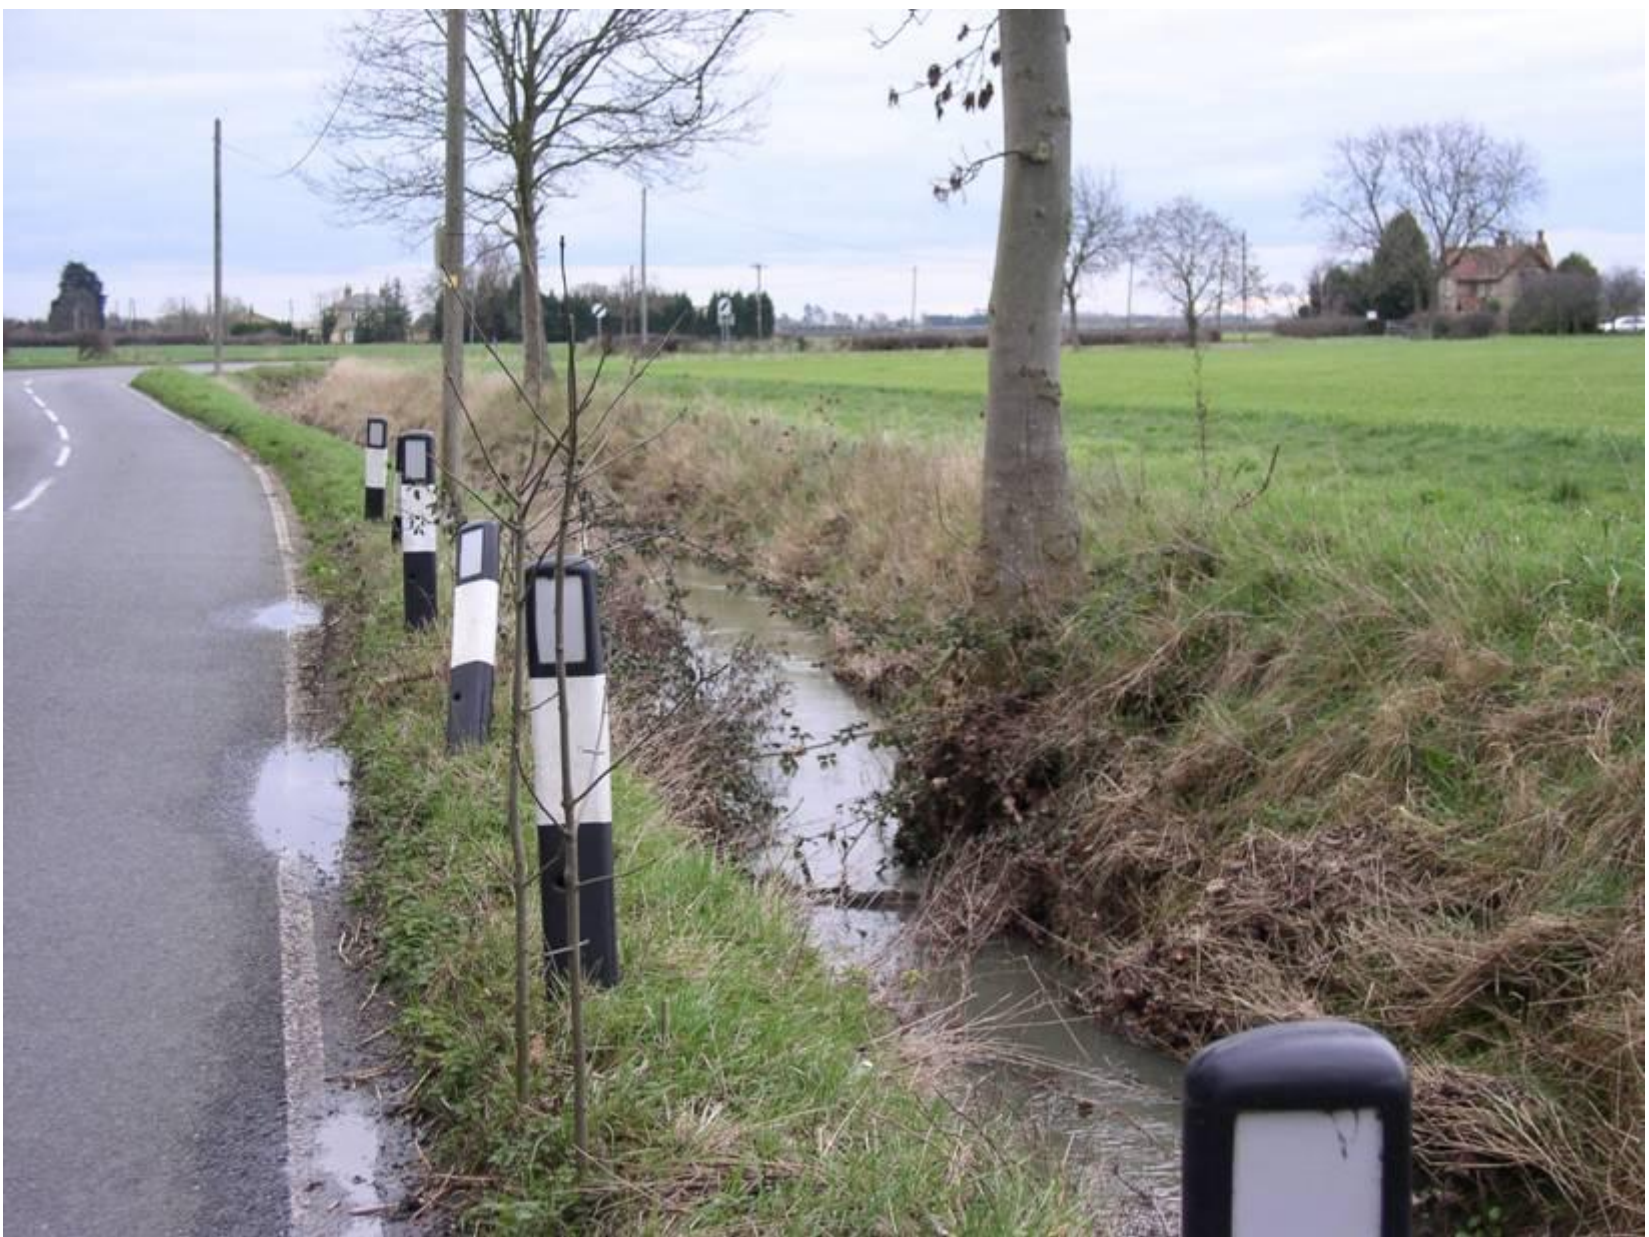
Small build-up of natural debris opposite entrance to Hampden House. Although the debris is not of major concern, the small ash saplings should be removed before coming established.

Urgency 1

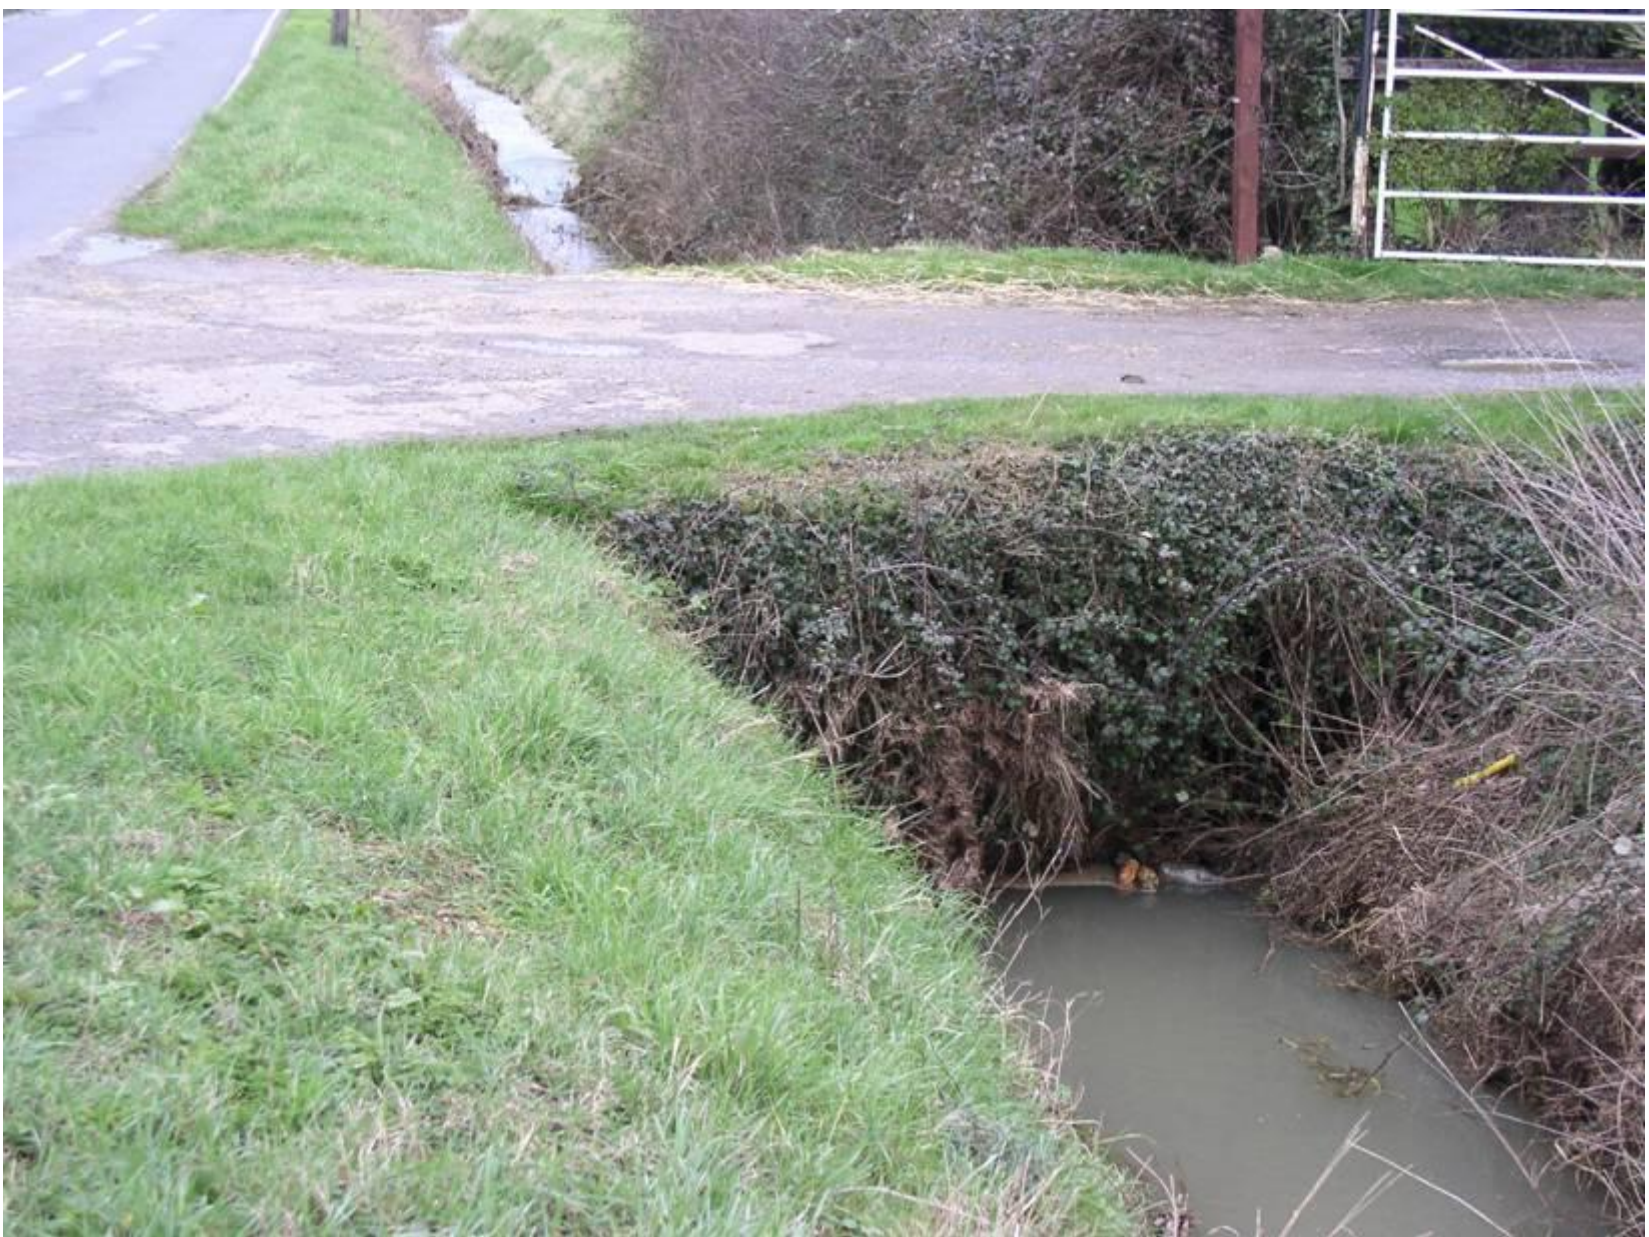
Build-up of natural debris + man-made items at the bridge to Hilton End Farm.

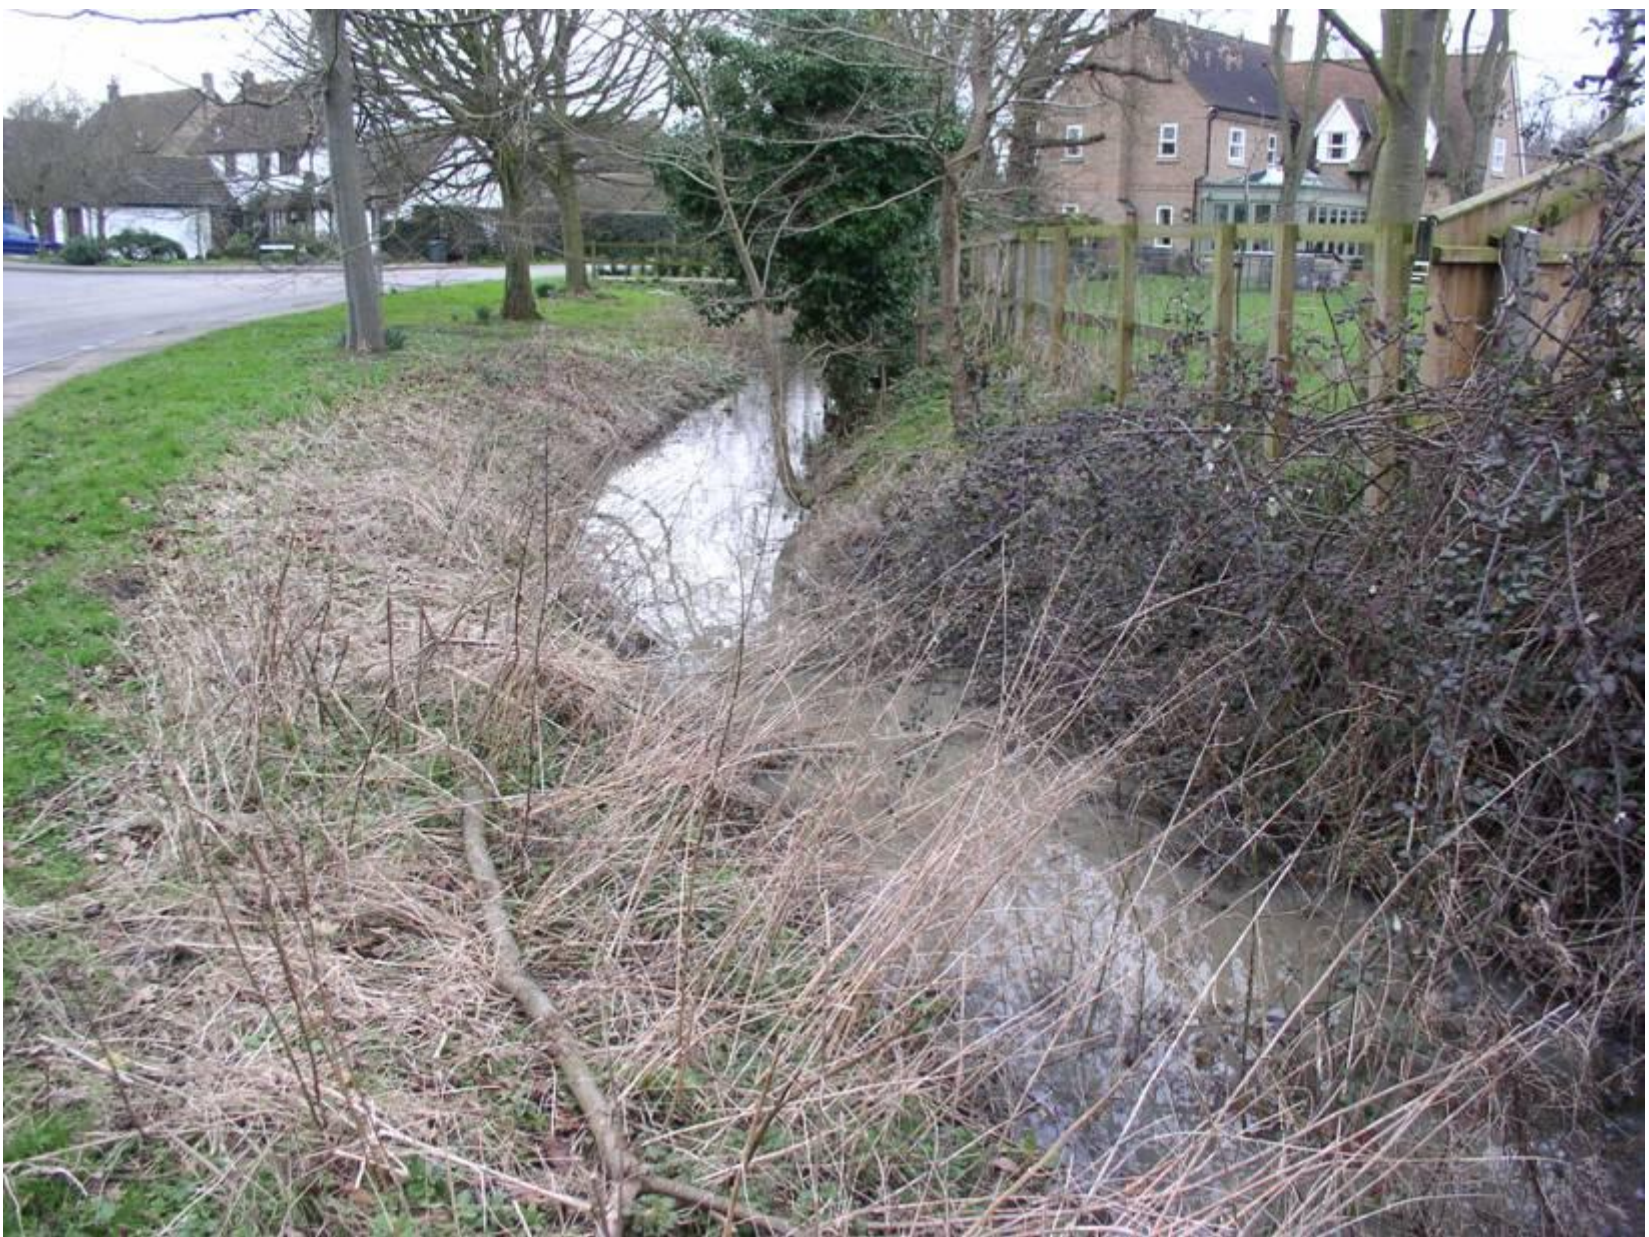
Standing water in the ditch at the North Western end of High Street.

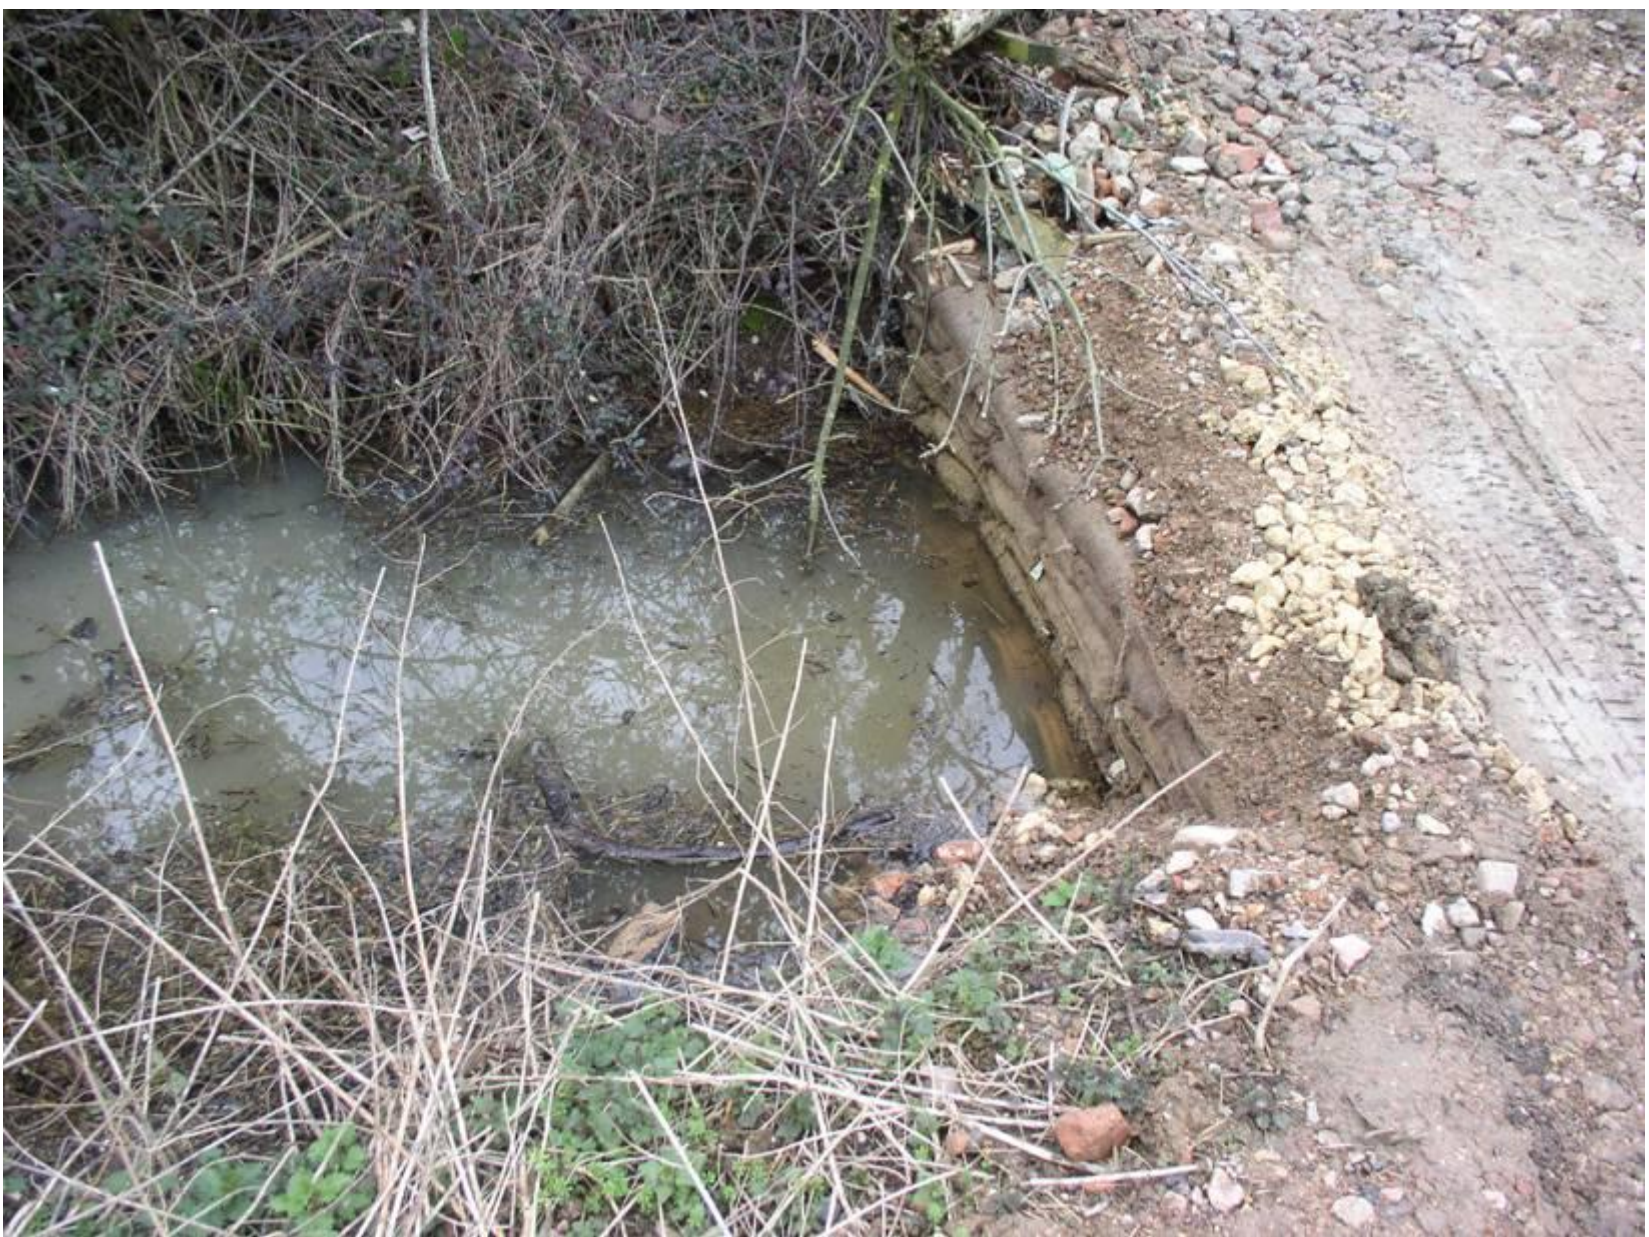
Standing water unable to drain away at the entrance to the building site opposite Hilton Hall. The owner of Hilton Hall finds that when water remains in this ditch for a period of time without draining, then it causes damp in his 'cellar'.

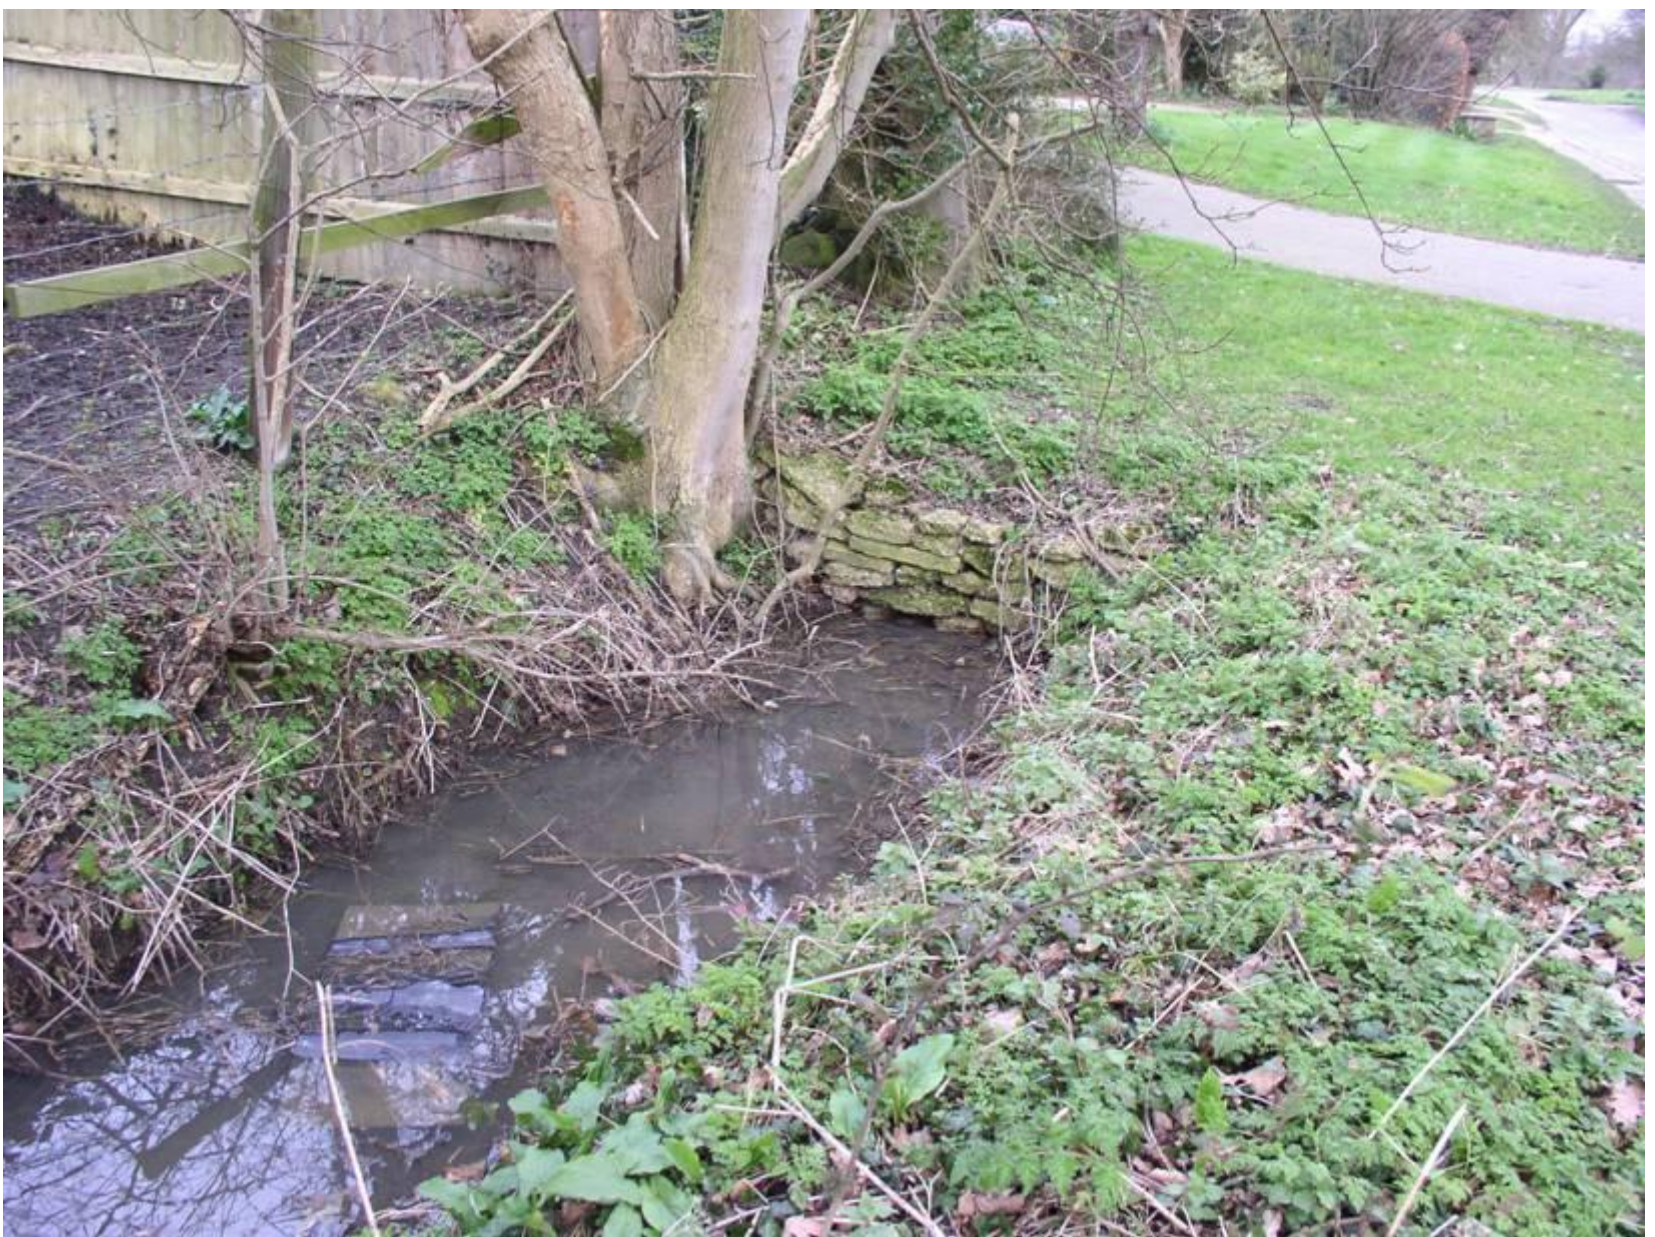
Water build-up at the culvert under the entrance to Sunnybrook.

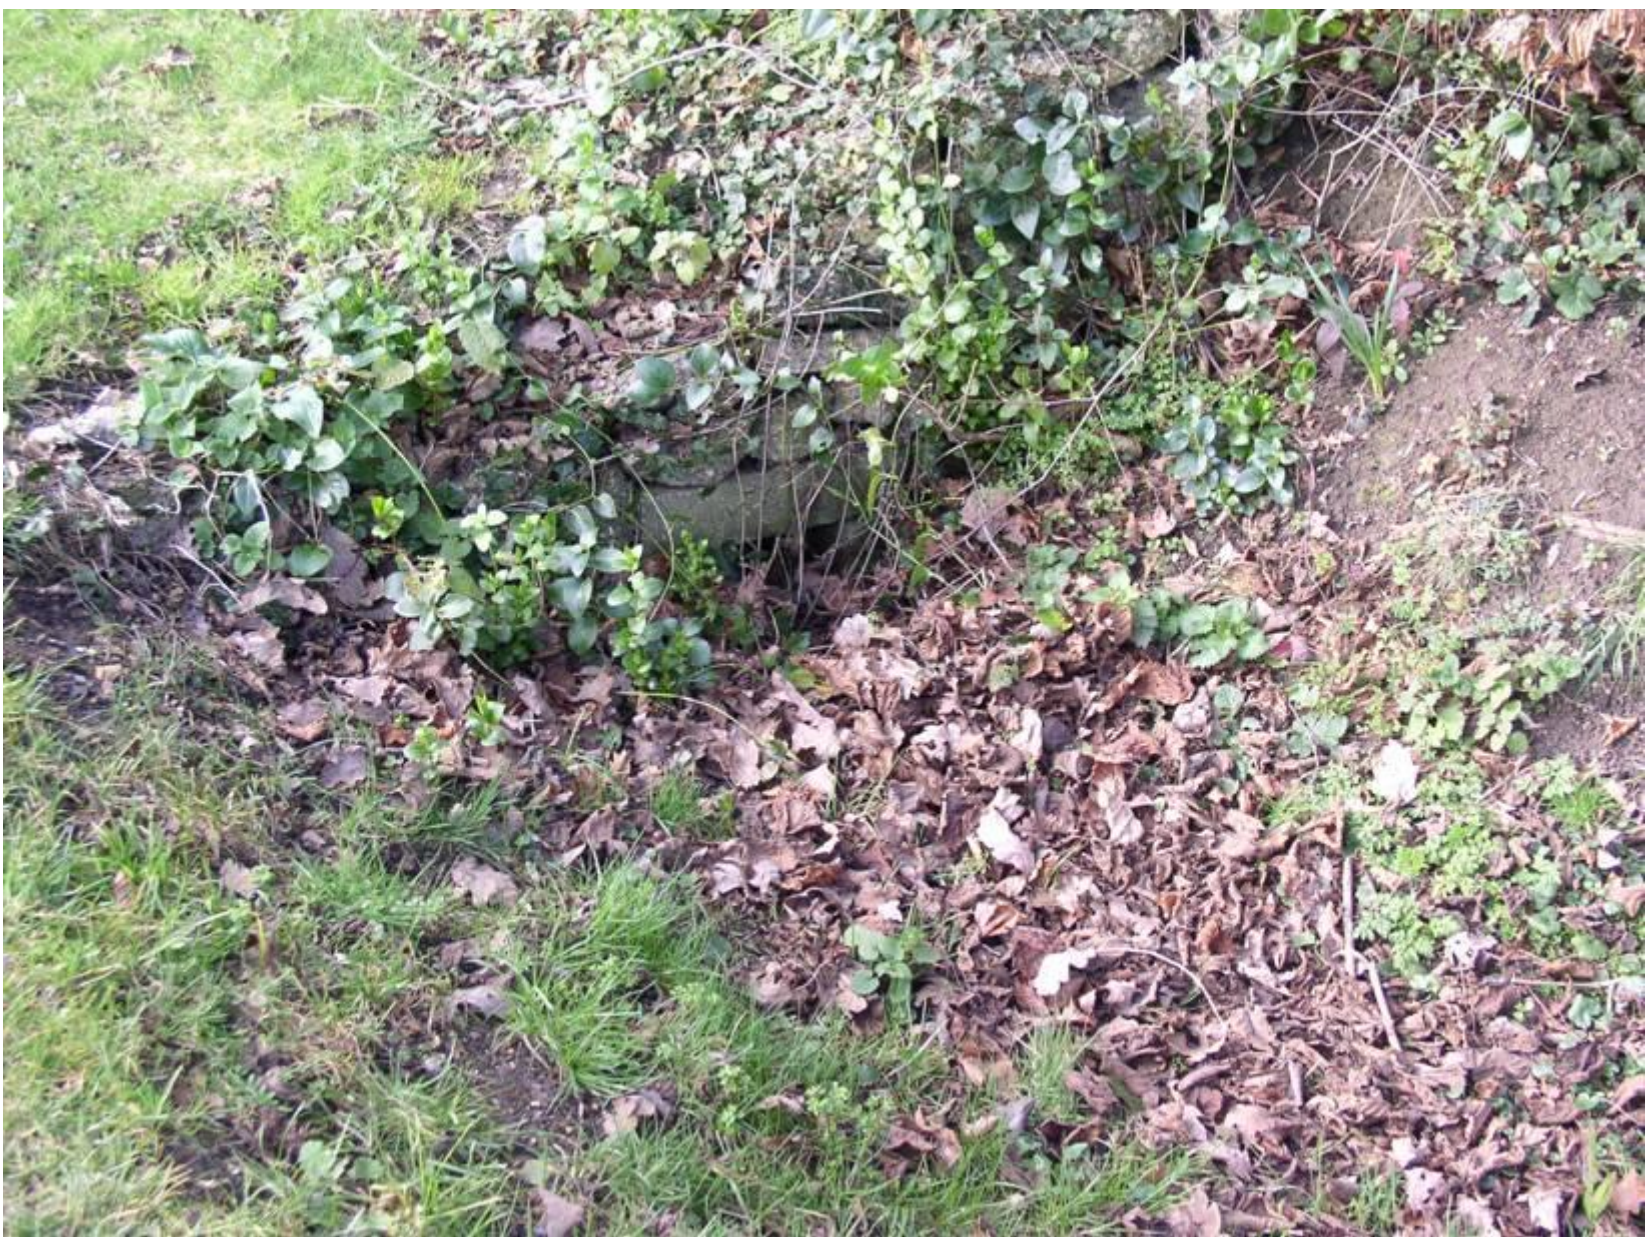
Dry pipes at the south-east end of the culvert in front of Sunnybrook. The ditch shown here needs digging out since it is then able to feed water into Reeve Ditch. This would need to be carried out in conjunction with the clearing of the culvert.

Urgency 2
