# **A survey of parts of the drainage system within the south-east sector of Hilton Parish.**

## **Sections covered:**

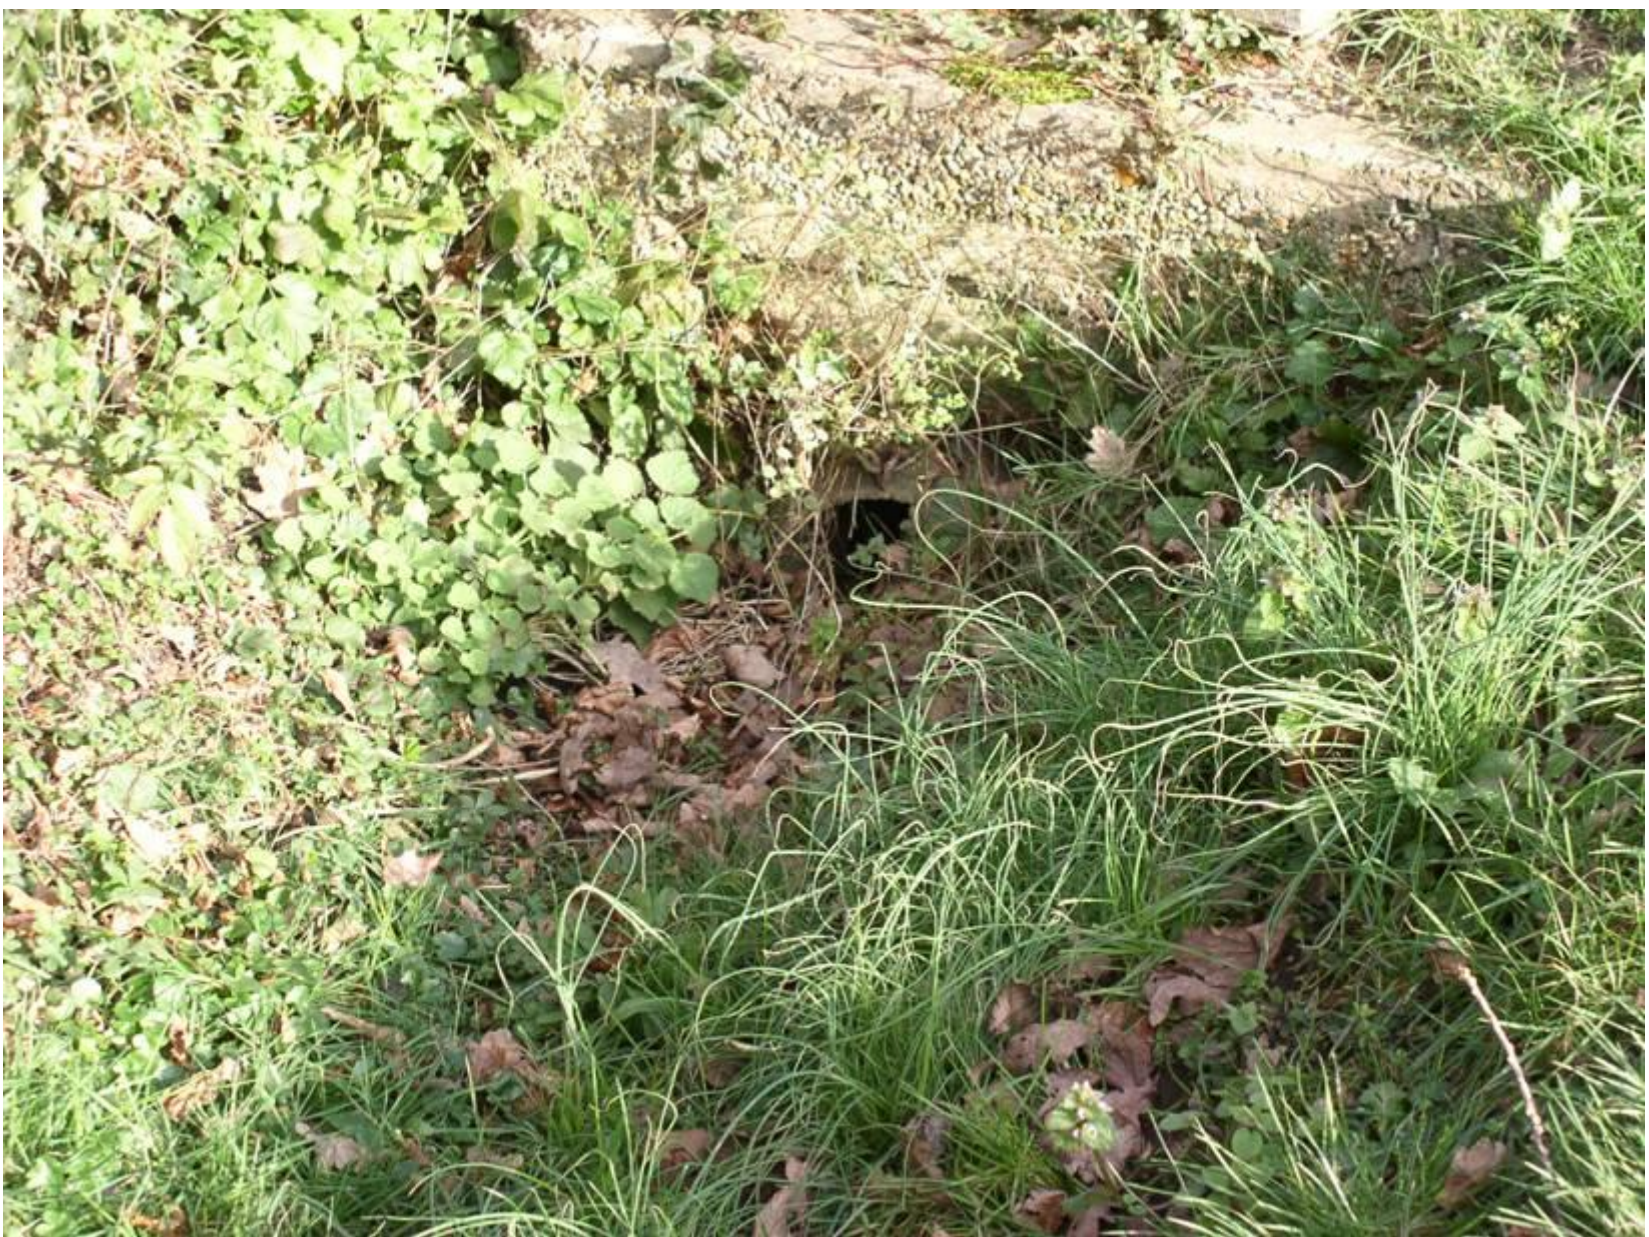
North-west end of the culvert for the entrance to Trin's Close. This shows that the ditch needs digging out.

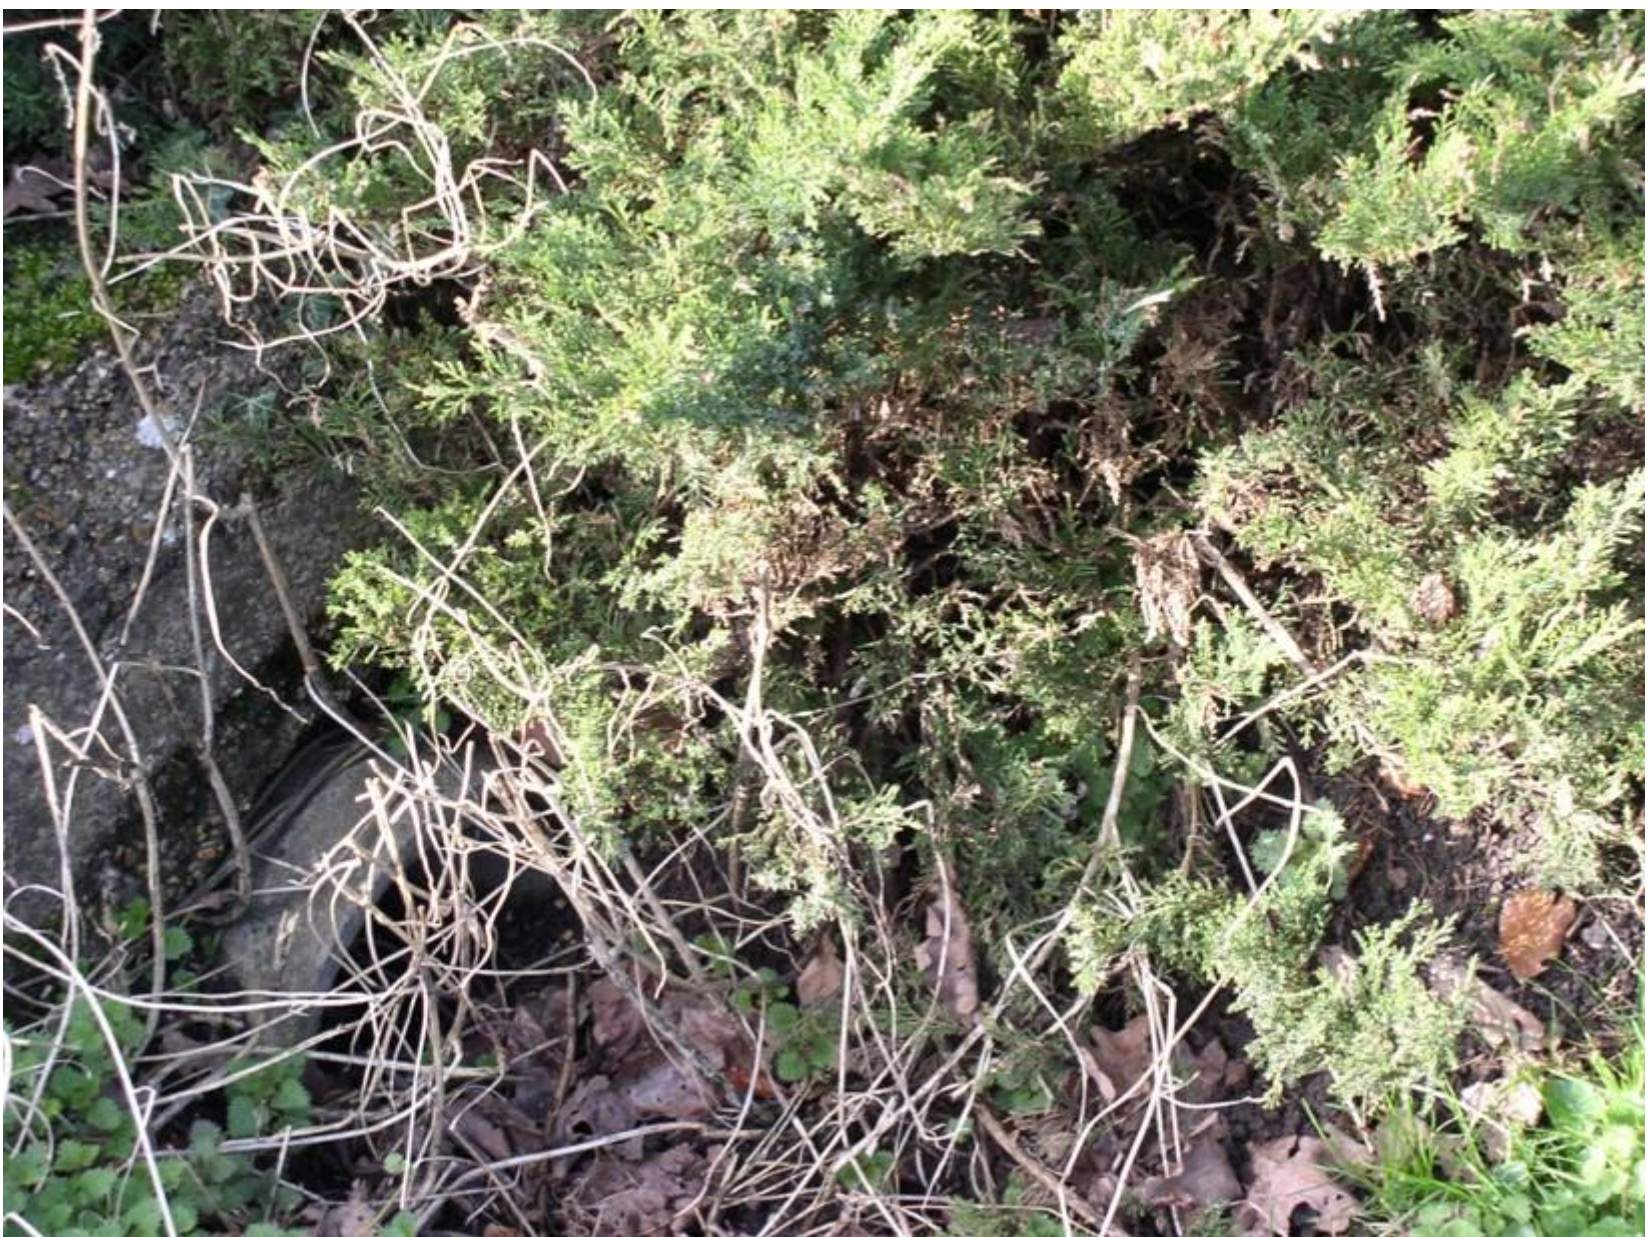
South east end of the culvert for the entrance to Trin's Close. This again shows that the ditch needs digging out.

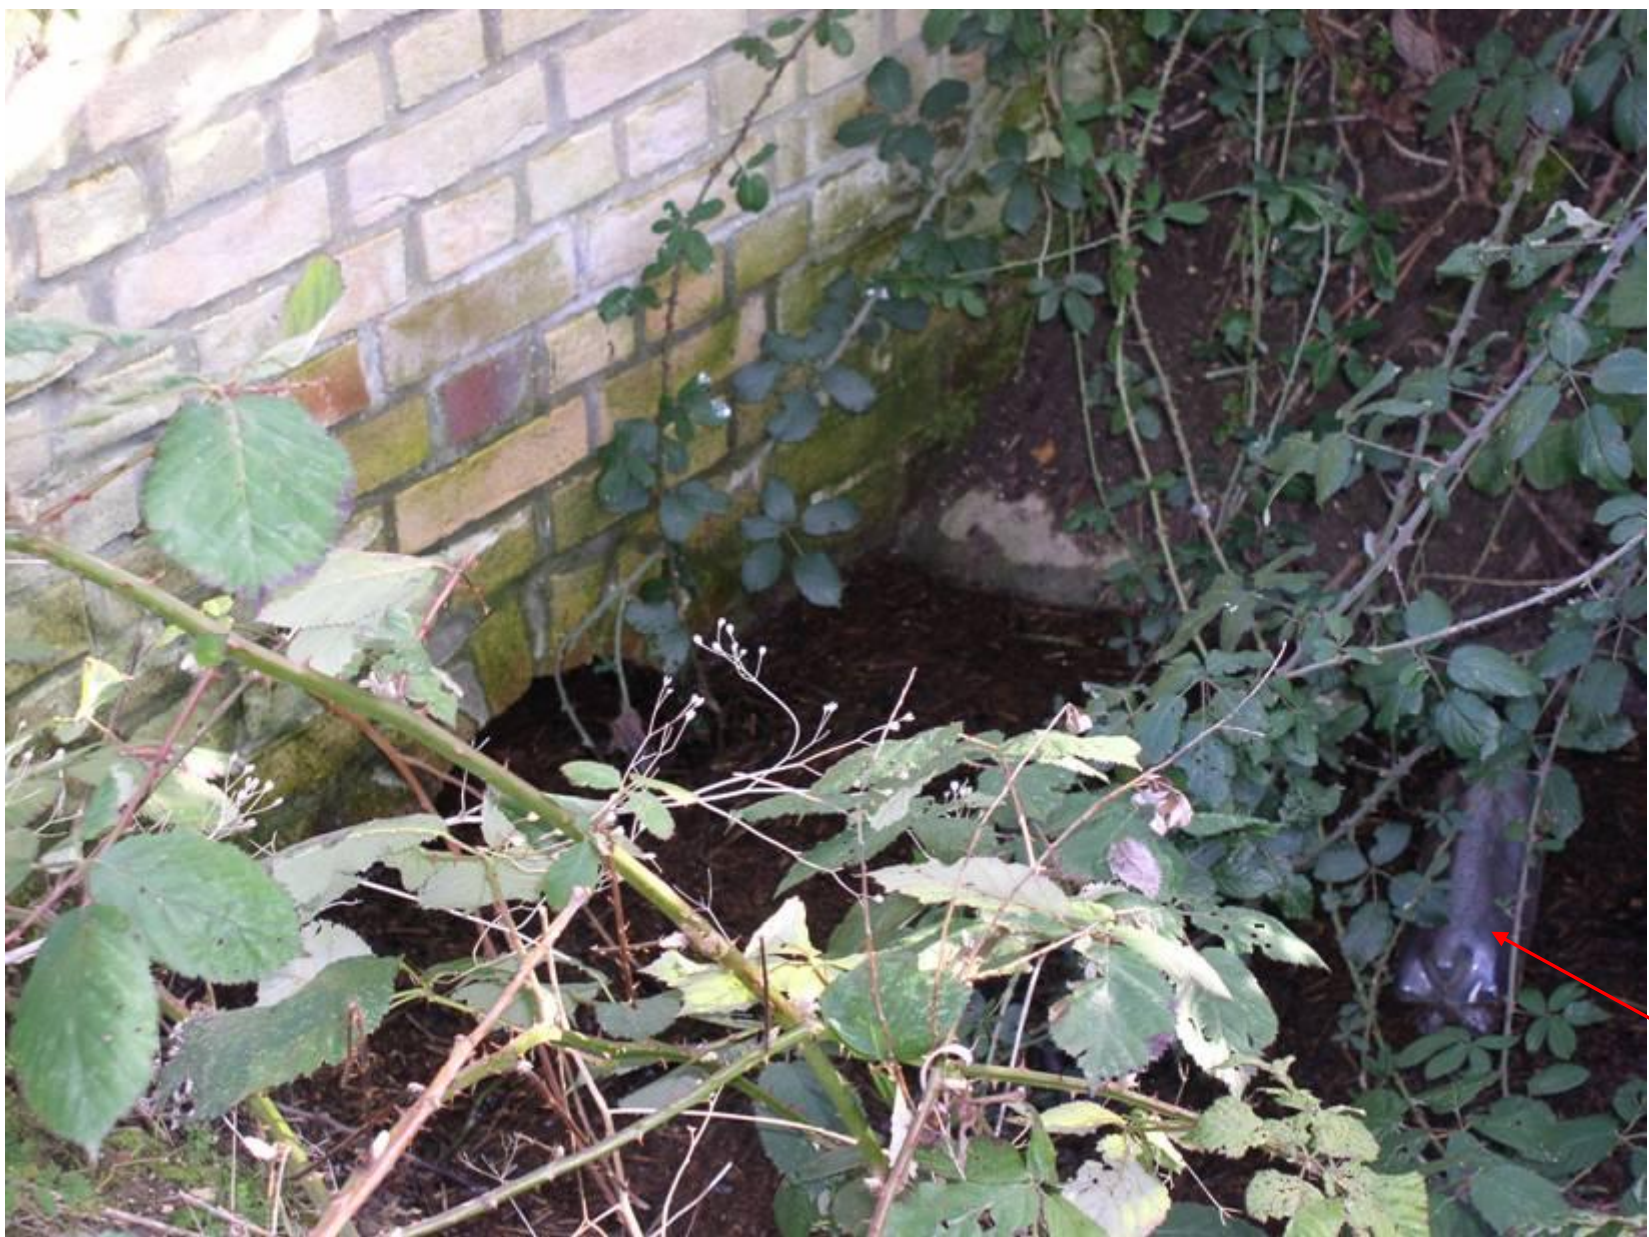
North-west end of the culvert for the entrance to Tarrant. This shows the depth of the water which is static. It should flow to the Main Drain from Reeve Ditch. This ditch needs to be dug out to allow water flow.

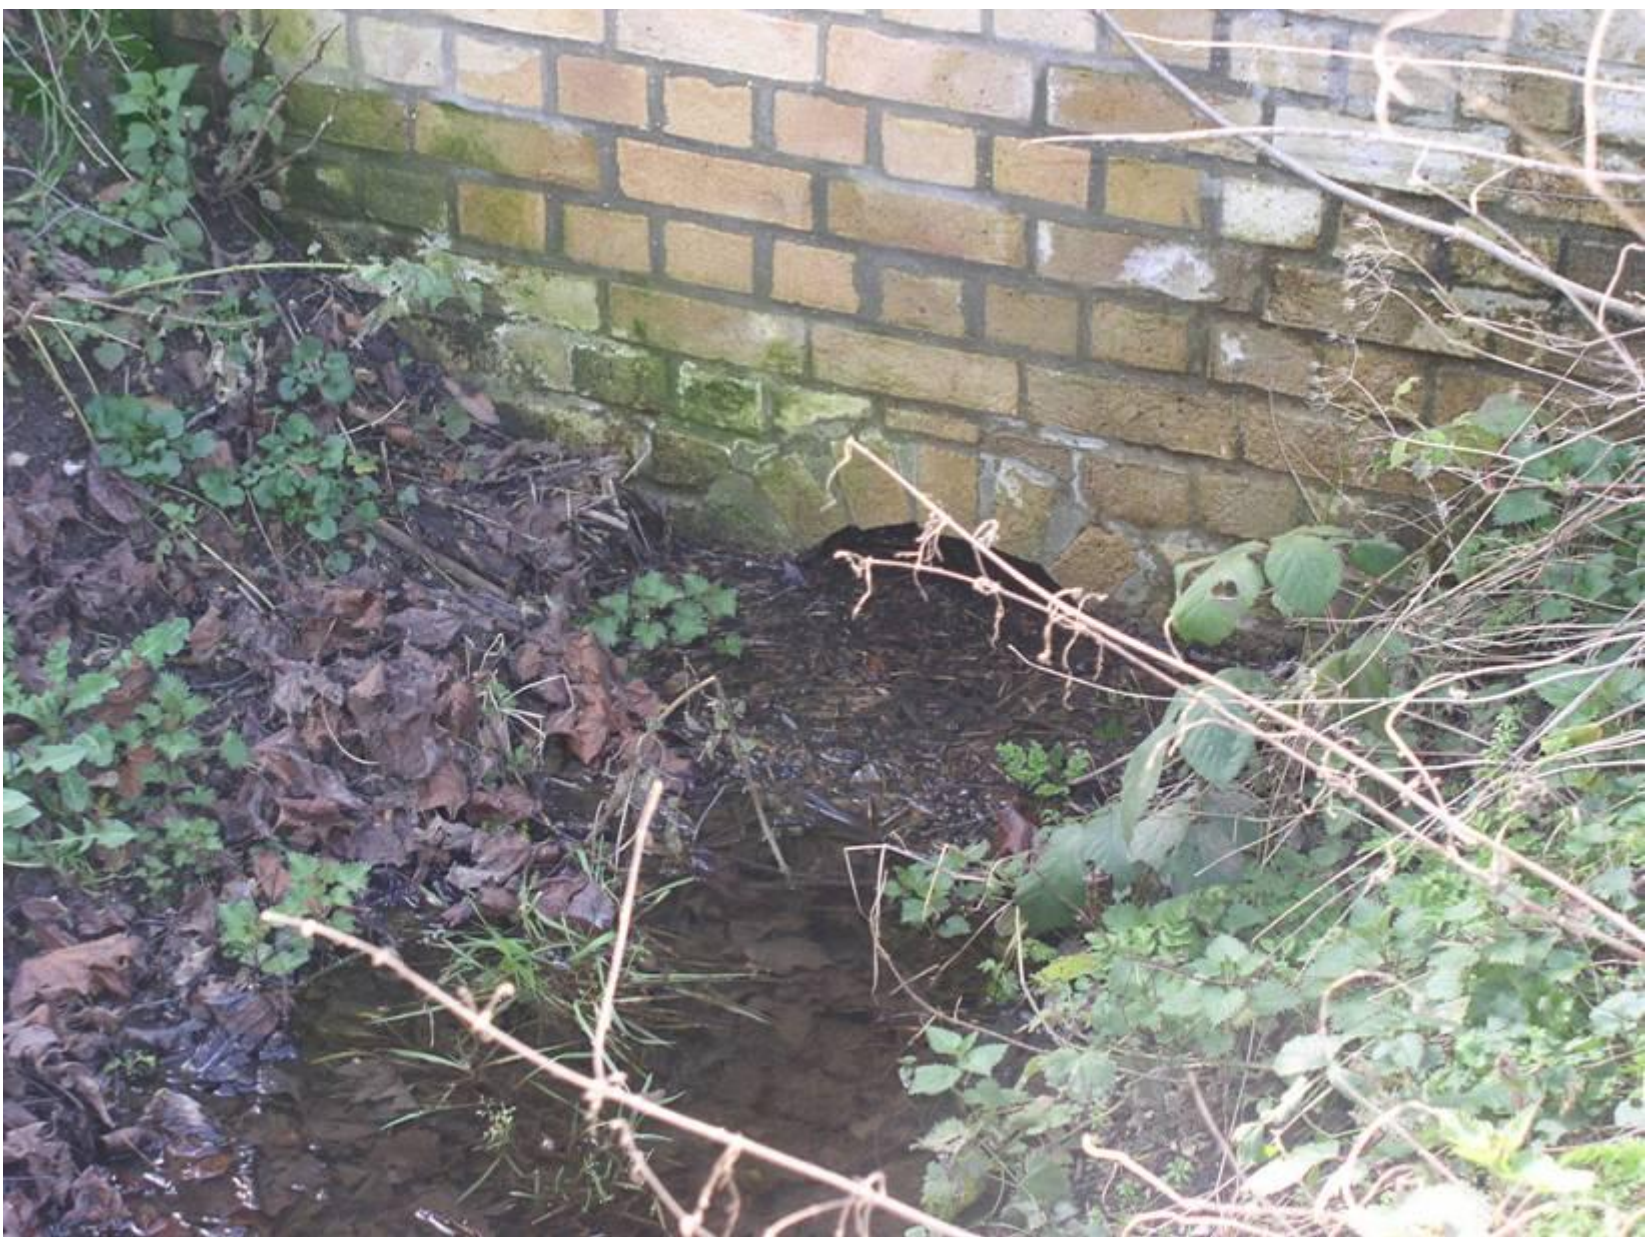
South-east end of the culvert for the entrance to Tarrant. Again this shows static water and again shows the need for the ditch to be dug out to allow water flow.

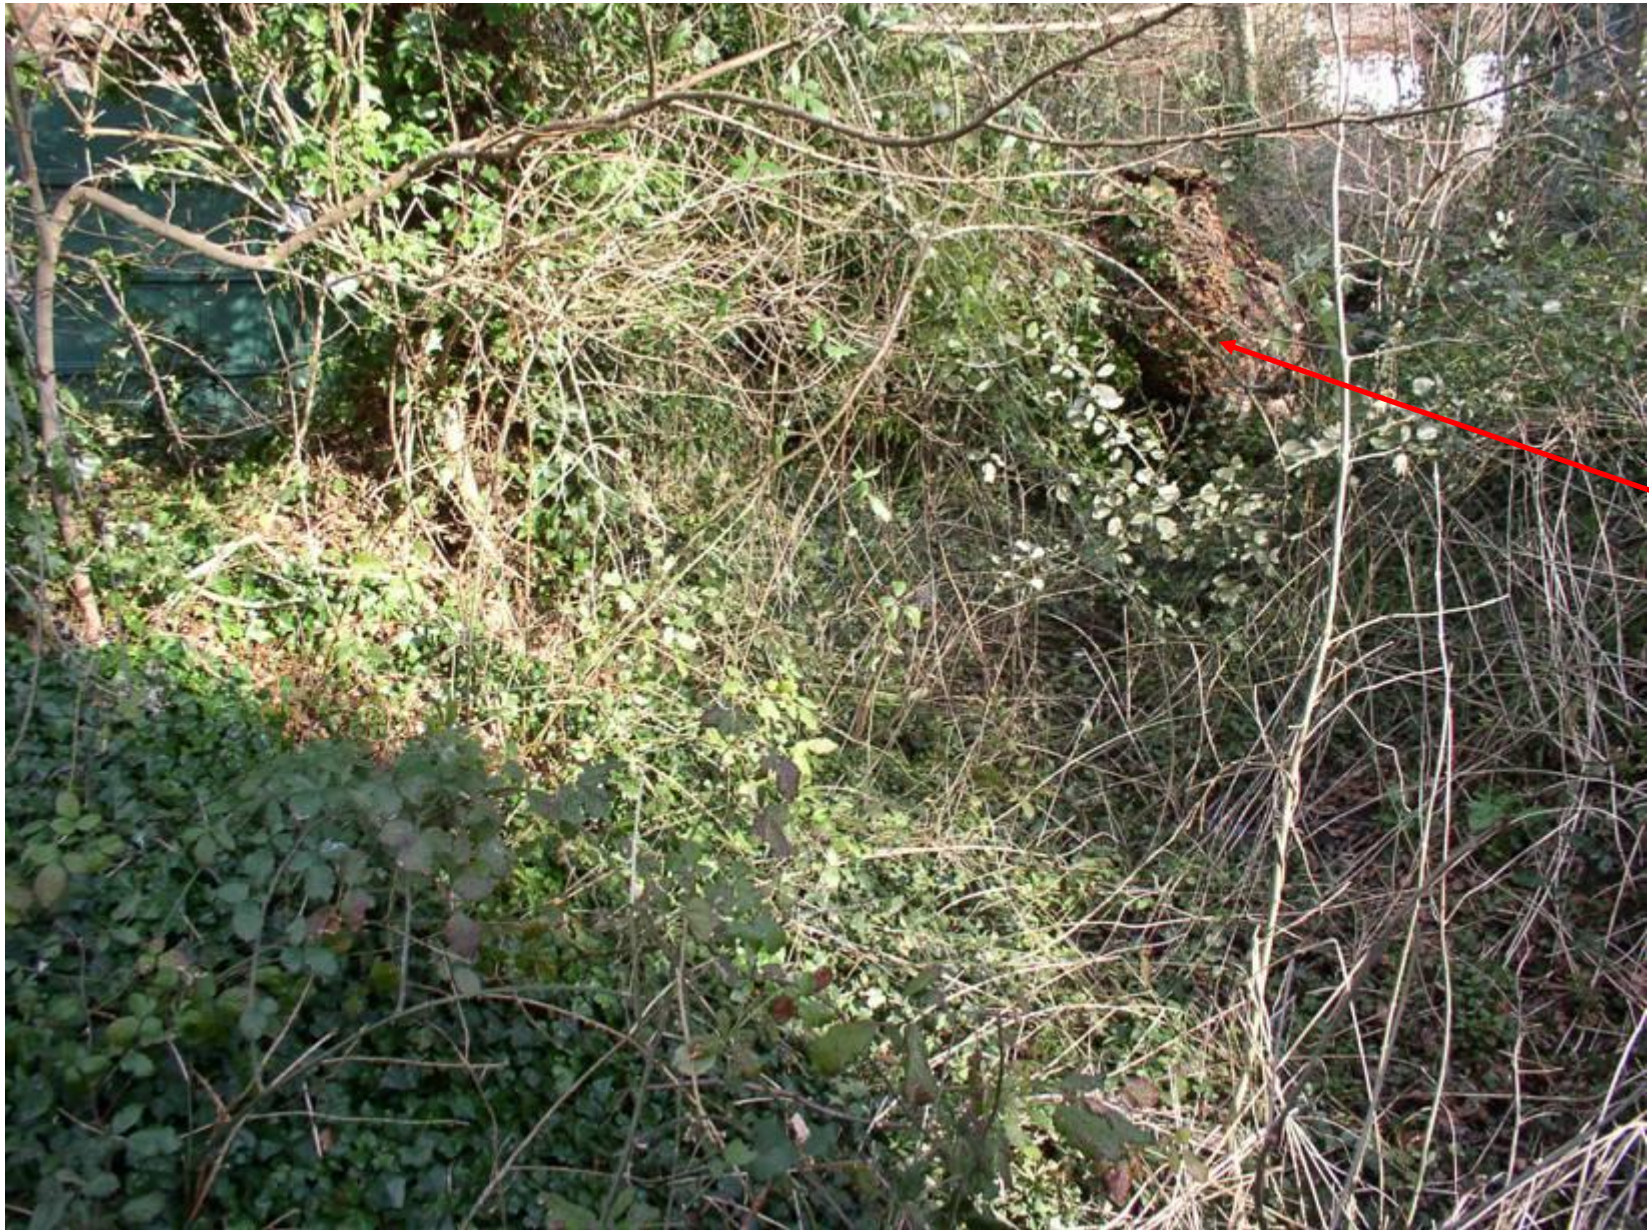
Ditch next to Anglian Water pumping station showing ditch feeding Reeve Ditch from The Grove. This ditch warrants digging out to allow water flow after heavy rain events. A further complication is that the recent high winds have blown over a very large tree stump (highlighted). If this is allowed to remain it will rot and fill the ditch.

Urgency 2

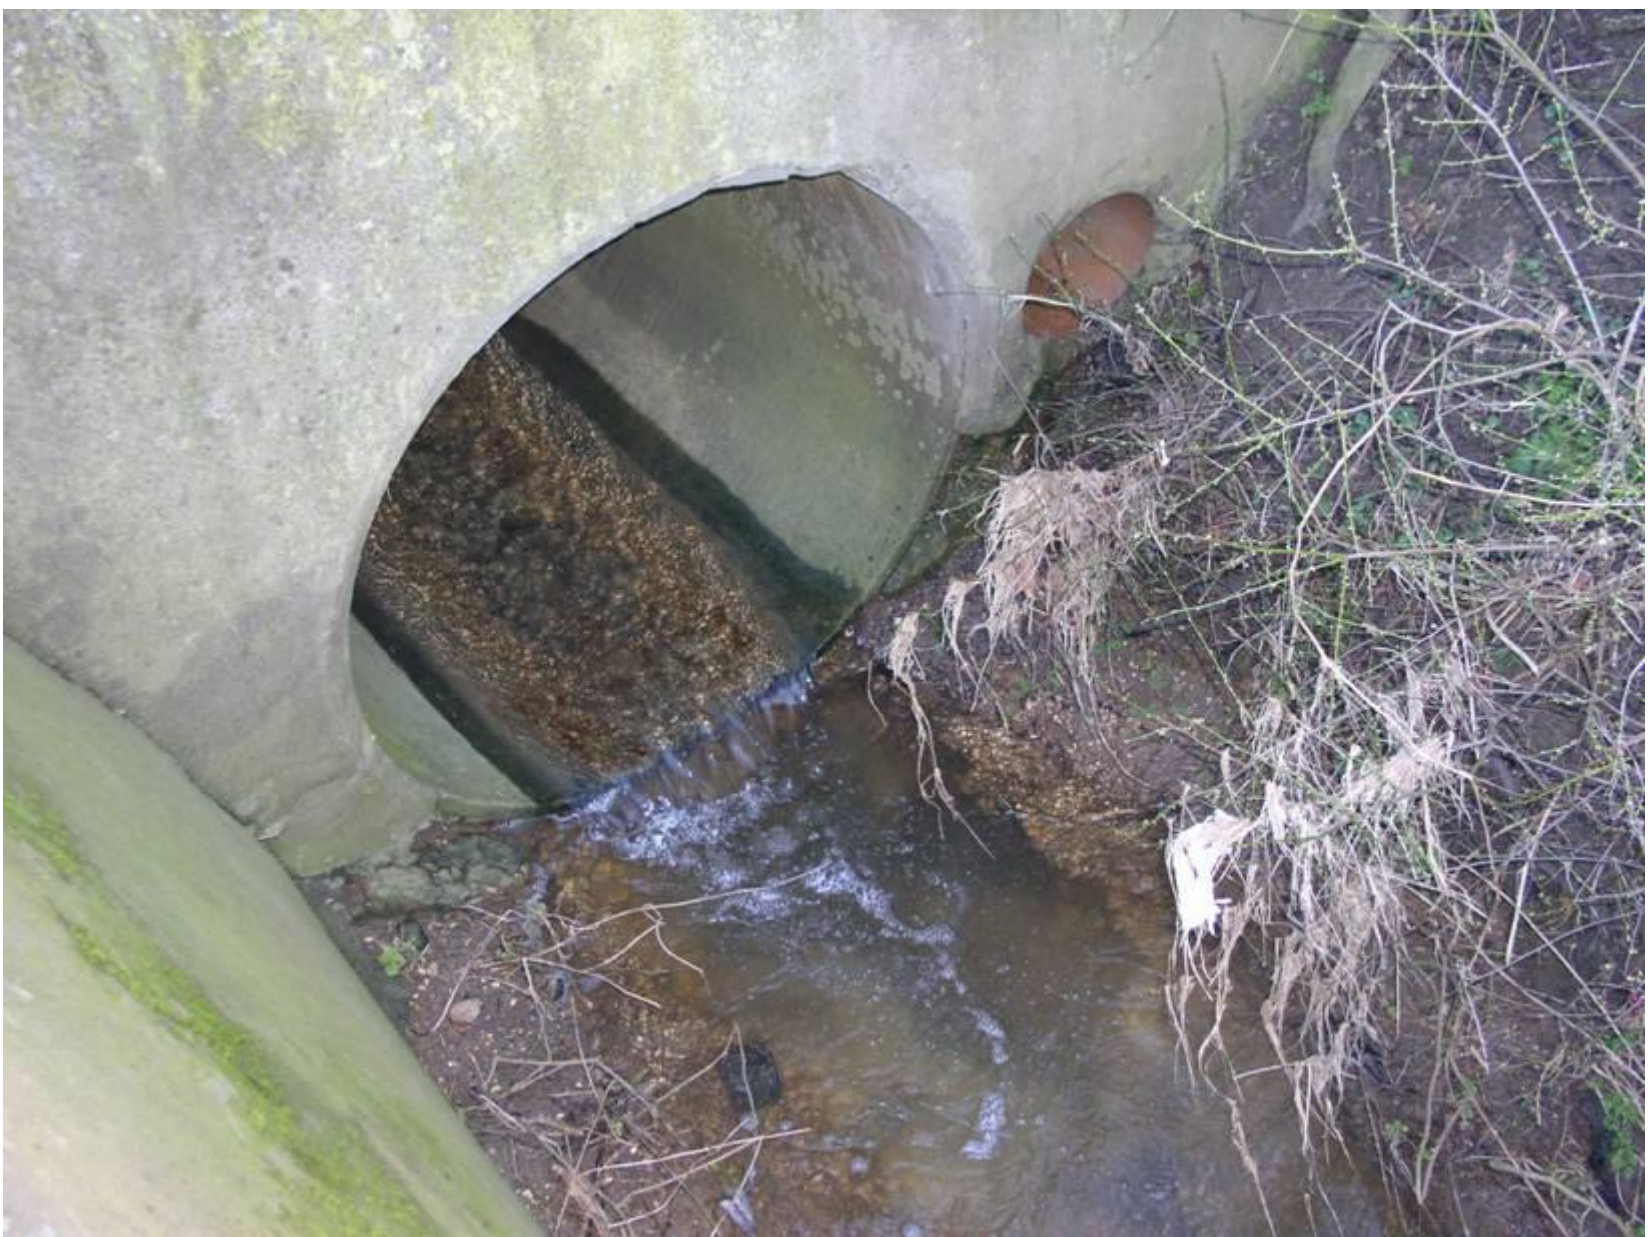
The first shows that over the years when HDC have cleared it on their regular contractual basis, they have dug too much from the base of the ditch. In doing so they have created a small 'waterfall' at the eastern end of the culvert under Fenstanton Road outside the chicken farm. As the water has come through the culvert it has eroded a 'sink'. This has occurred at several locations along its length.

South-eastern end of the culvert where the Fentstanton Road crosses the Main Drain near the chicken farm. This has been dug out to too great a depth by HDC.

Having last dug the ditches in 2002 they HDC will shortly be looking to repeat the task. Currently there is no need for such work. The only work needed in the immediate future will be clearance of some of the shrubbery within and at the sides of the ditch and the debris they have collected.

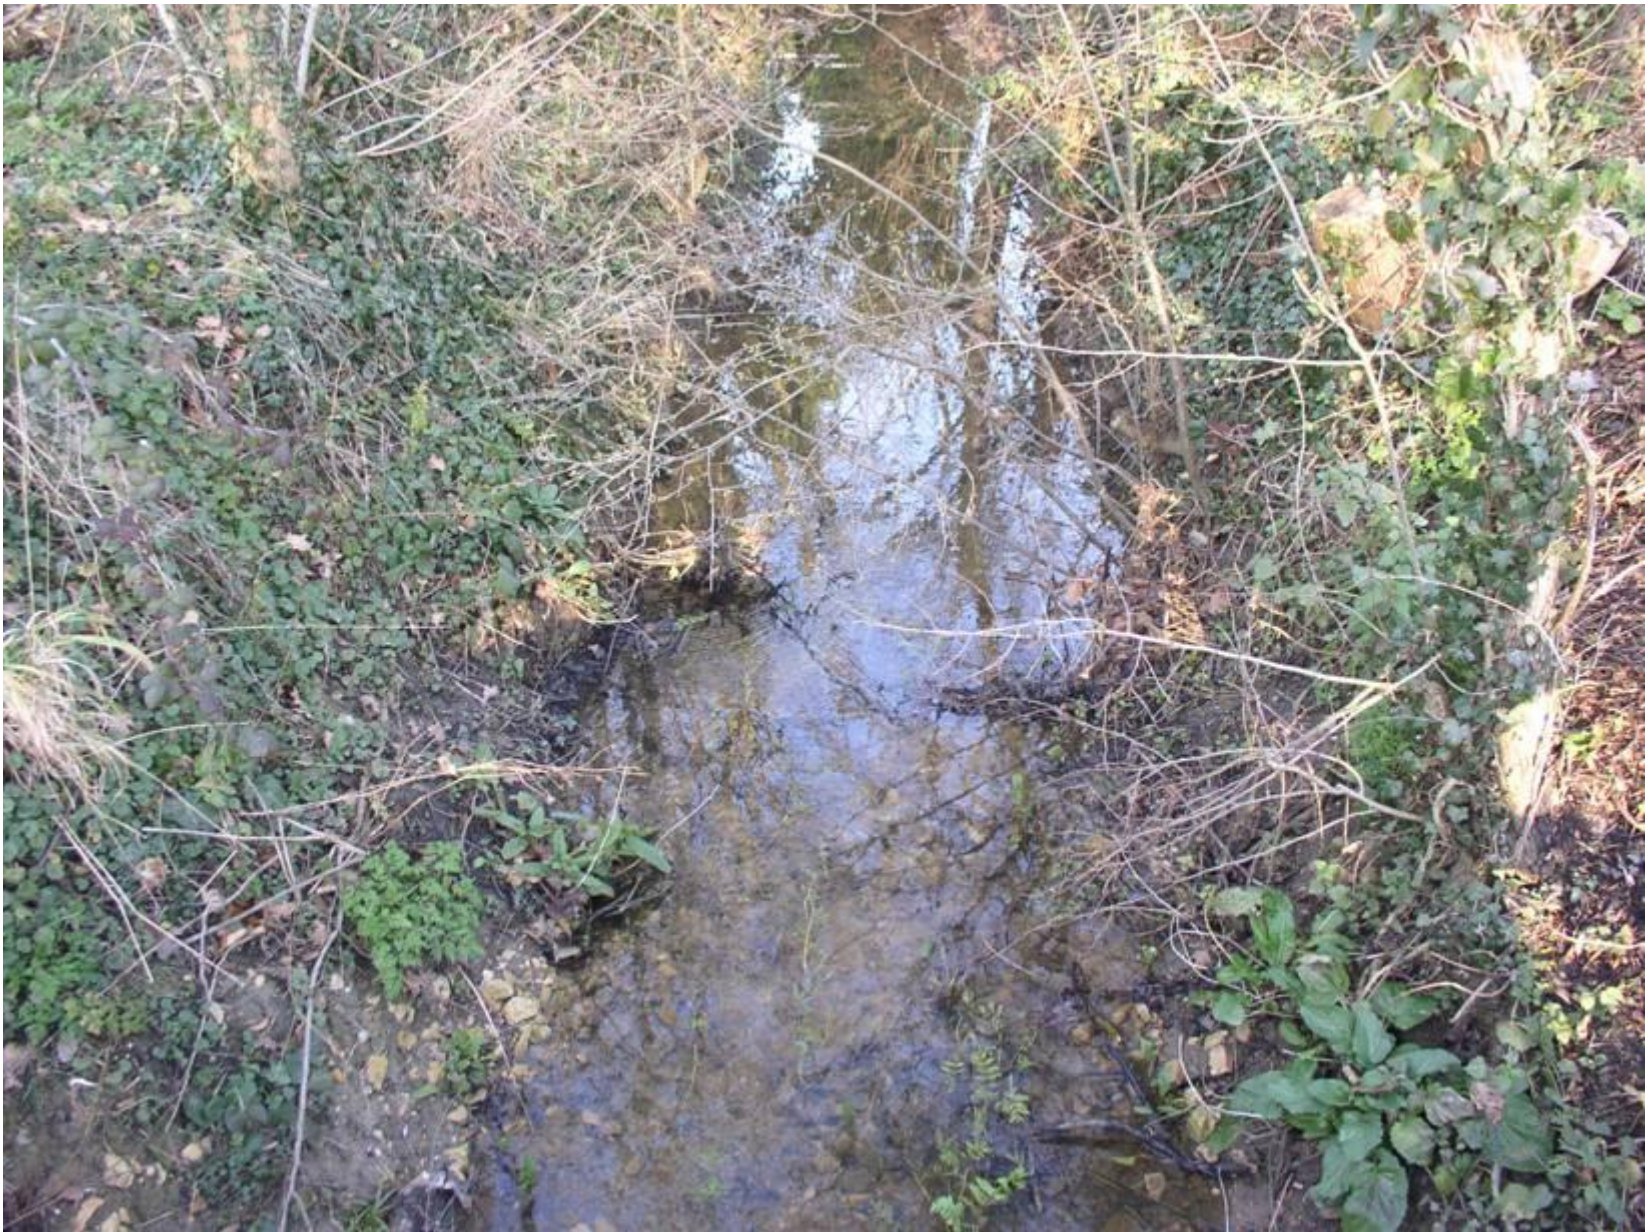
Both the second and third slides show how the ditch has established a 'gravel base'. This is a sign of good health which encourages biodiversity (fish will not lay eggs in silt but will in gravel.)

Ditch outside Elmsbrook. This shows the establishment of a gravel base which will encourage a more healthy environment for an increase in biodiversity.

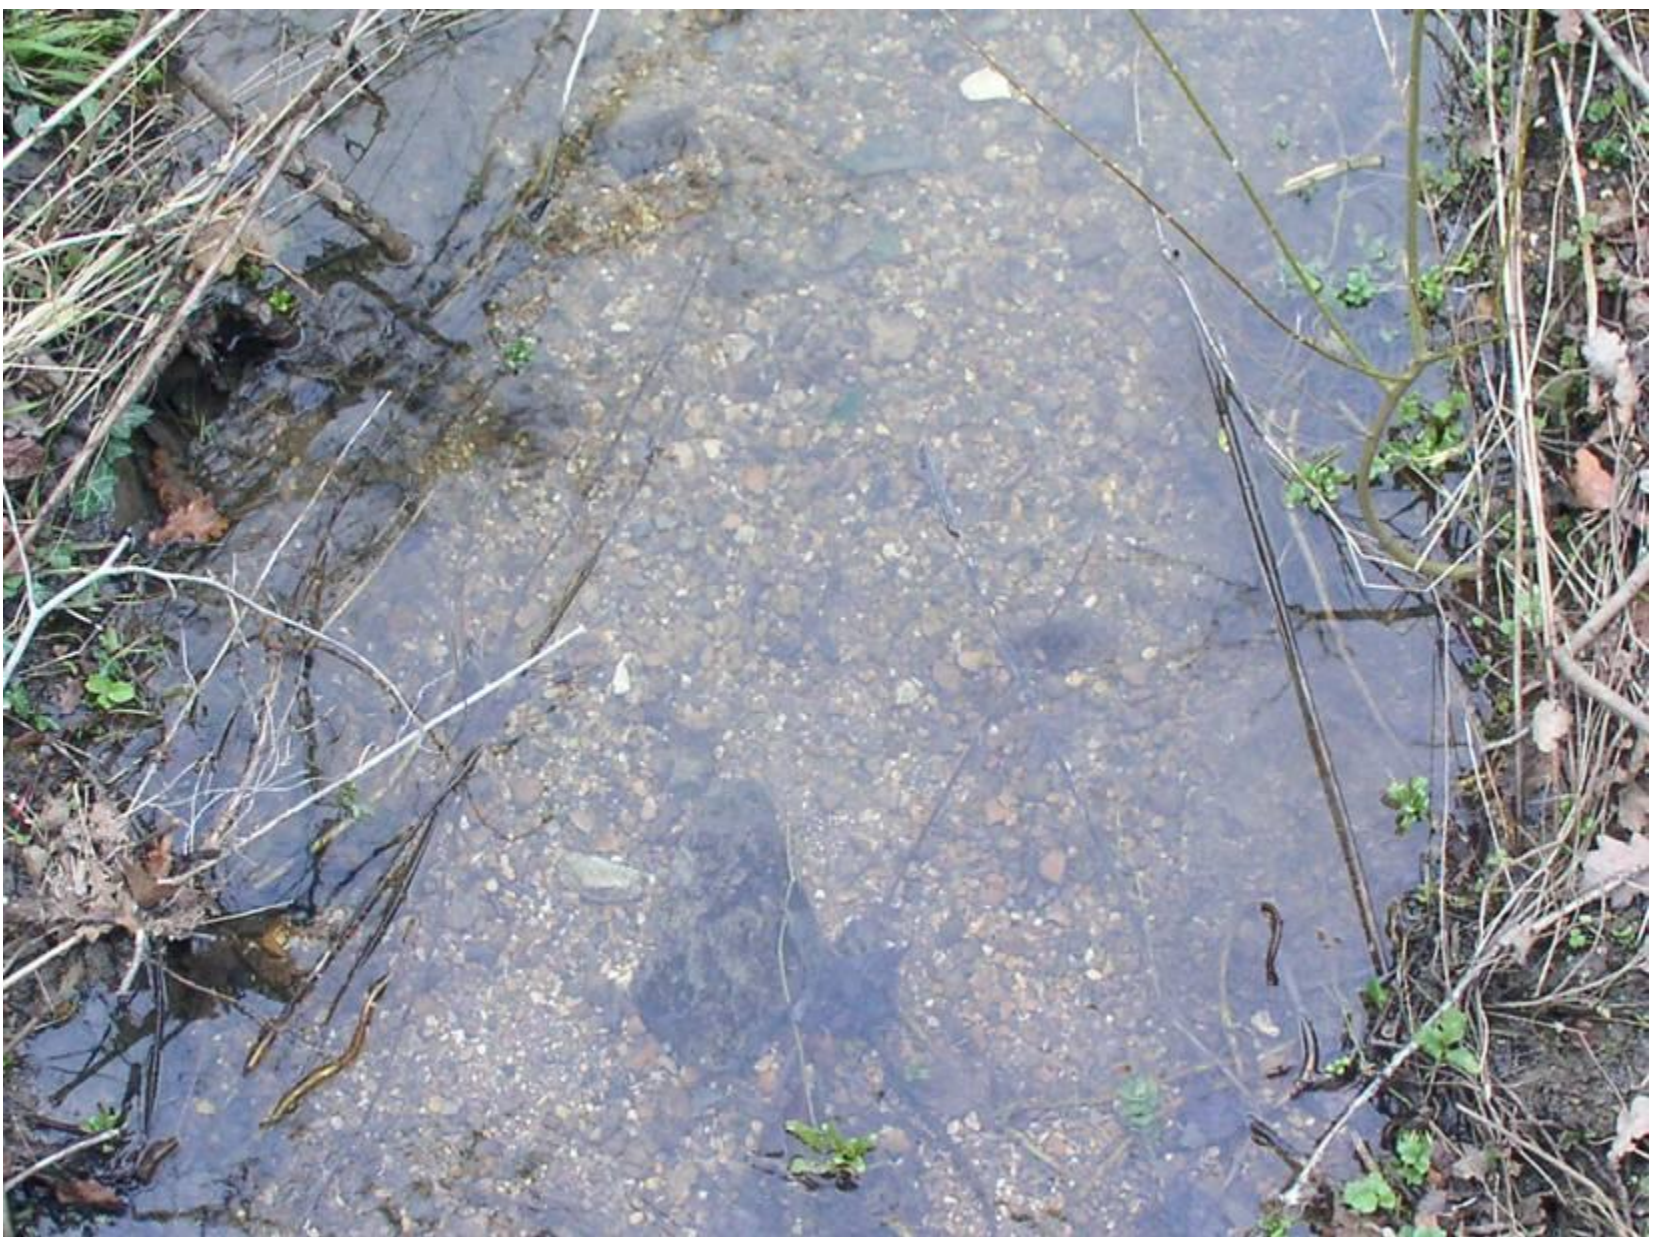
Shot taken from the bridge next to the Lych Gate showing the gravel base which encourages a healthy environment.
