the **play inspection** company

Annual Inspection

Hilton Parish Council

Jubilee Playground

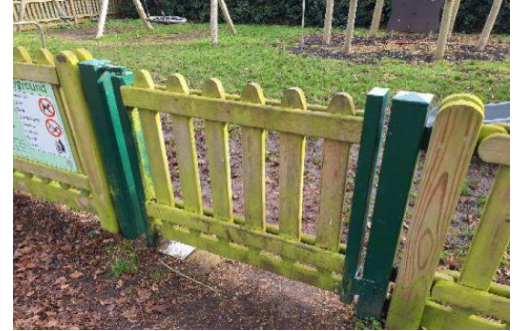
The area under the gate has eroded leaving uneven areas, or the concrete foundations exposed, resulting in trip hazards at the entrance/exit to the playground - Reinstate to level with surrounding surfaces

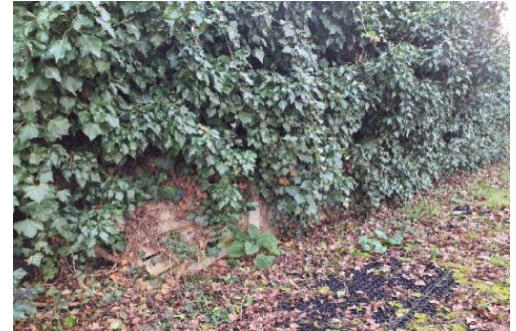
The fence is severely damaged in places - Repair or replace all affected sections

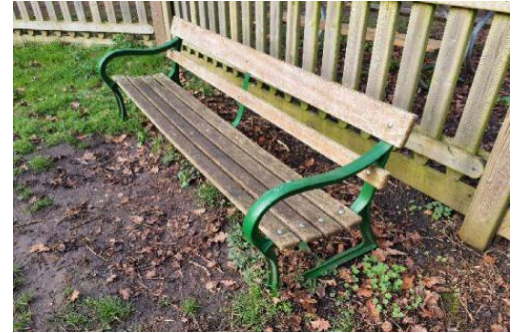
The surface has eroded in some areas and may be slippery in wet conditions - Reinststate the surface

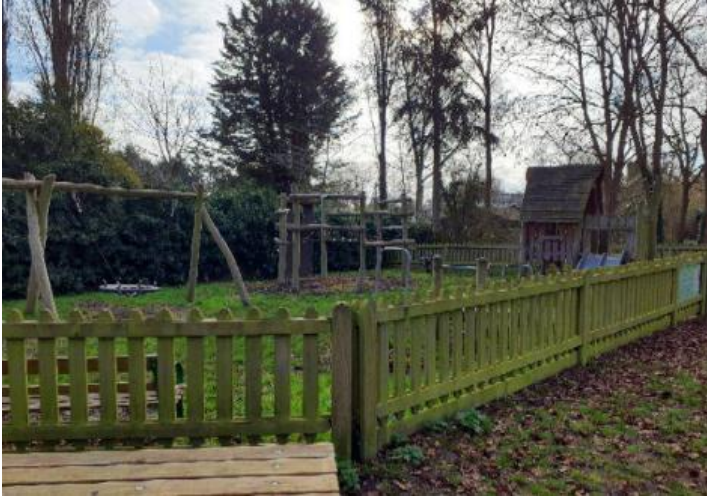
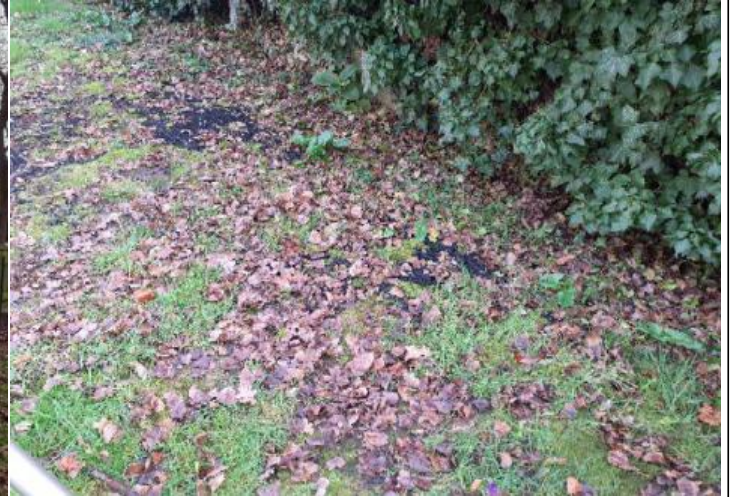
Finding: There is some tree debris on the surfacing

Action: Remove and maintain

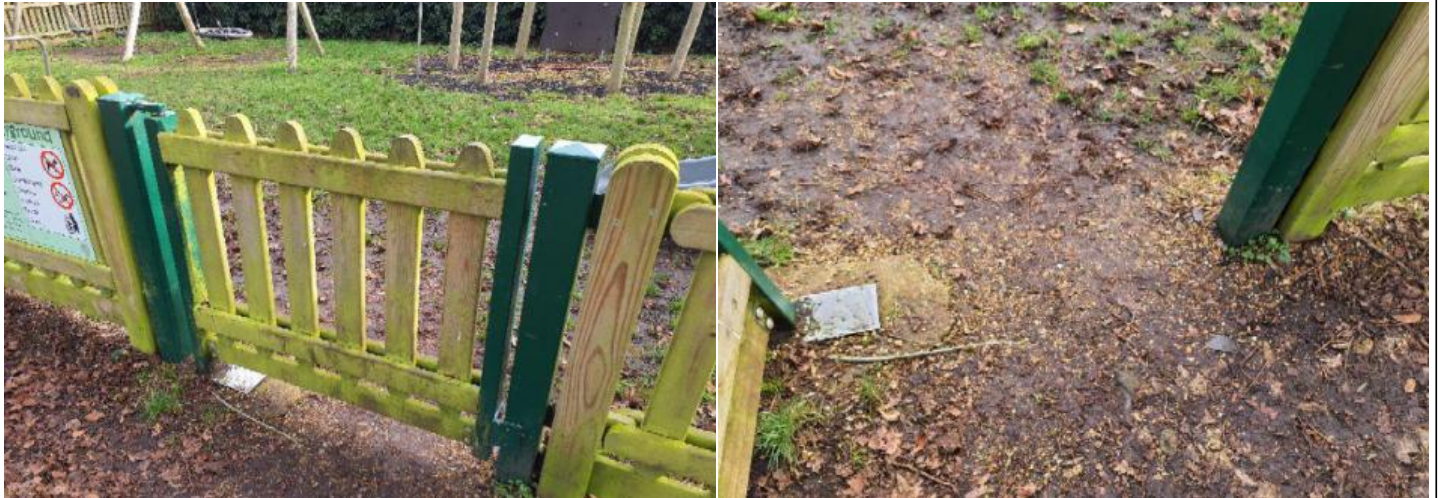
Finding: The area under the gate has eroded leaving uneven areas, or the concrete foundations exposed, resulting in trip hazards at the entrance/exit to the playground

Action: Reinststate to level with surrounding surfaces

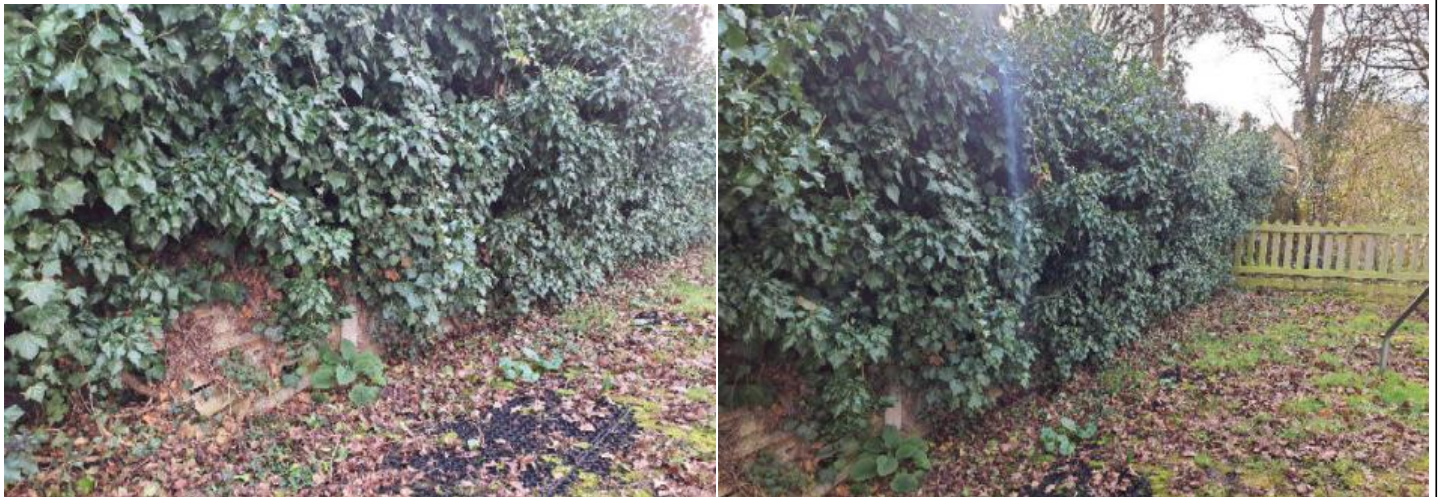
Finding: The adjacent foliage is overhanging

Action: Cut back and maintain

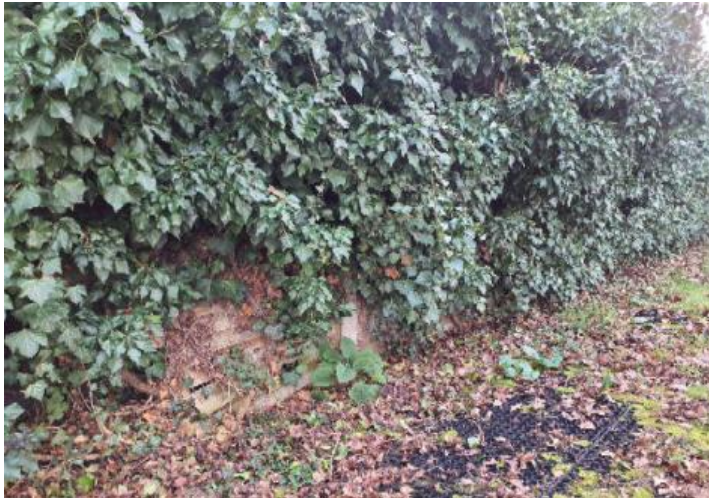
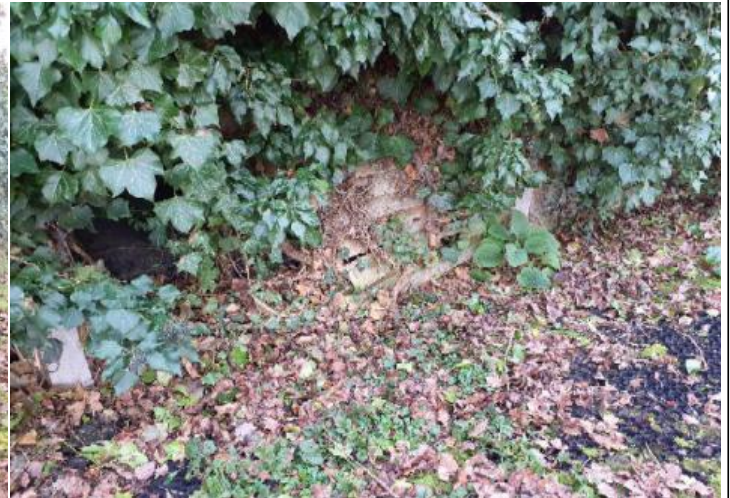
Finding: The fence is severely damaged in places

Action: Repair or replace all affected sections

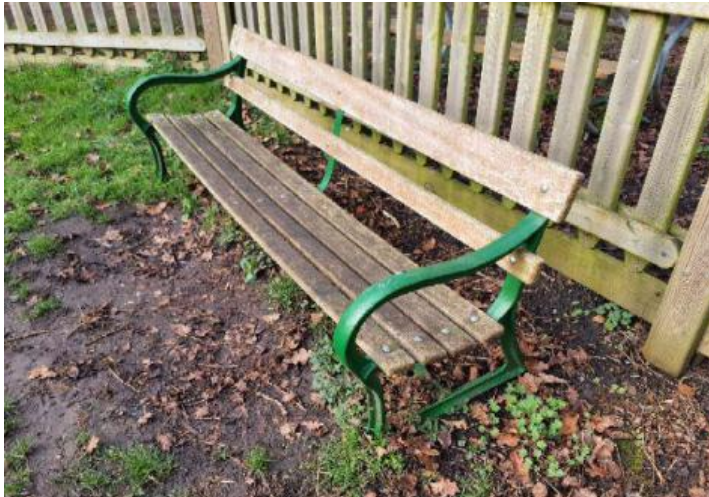
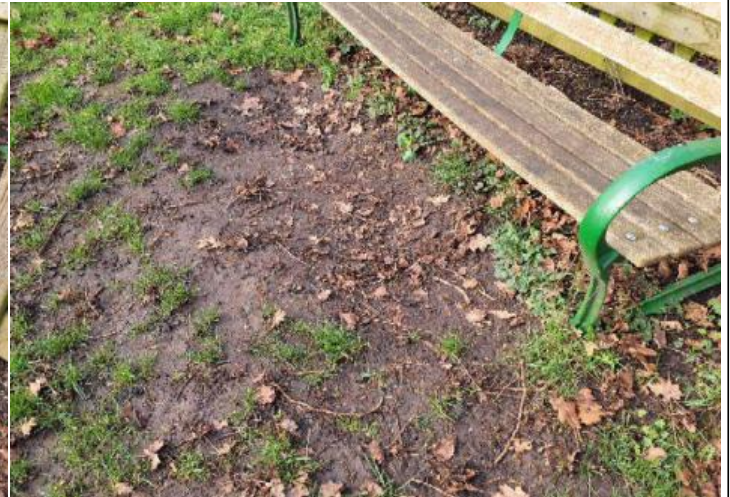
Finding: The surface has eroded in some areas and may be slippery in wet conditions

Action: Reinstate the surface

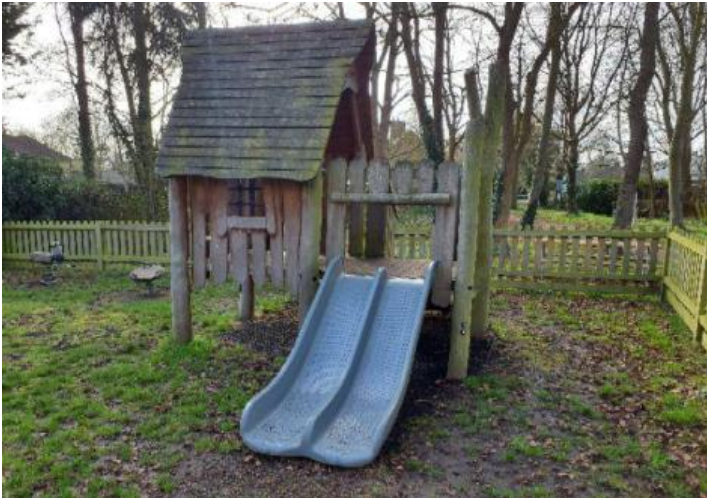
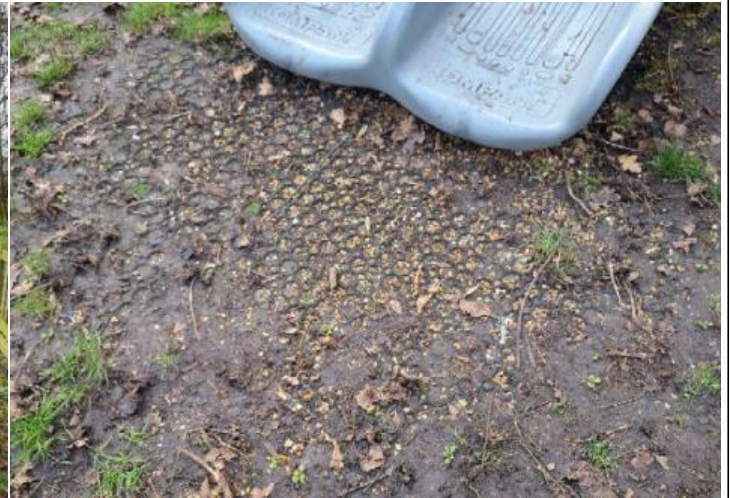
Finding: The grass mats are silted up, the soil is compacted and the area will become very slippery when the soil is wet. **Action:** Reinstate as required

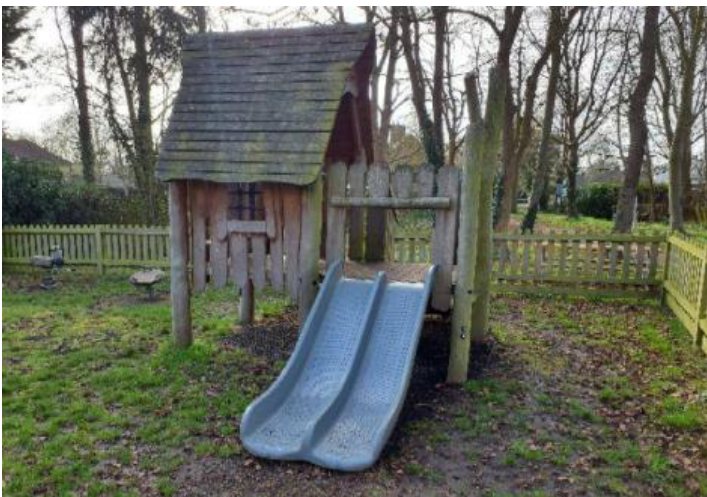
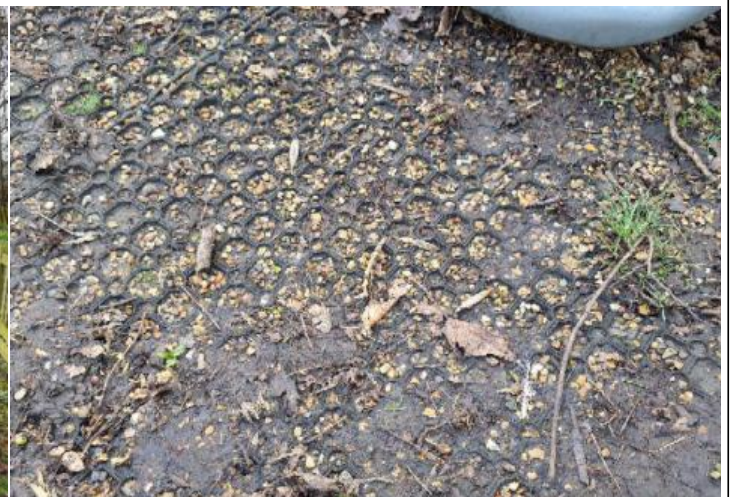
Finding: The grass mat surfacing has numerous stones present within the surface and will not perform as intended in relation to Head Injury Criterion testing **Action:** Lift mats and ensure stones are removed and ground is suitable prior to re-laying

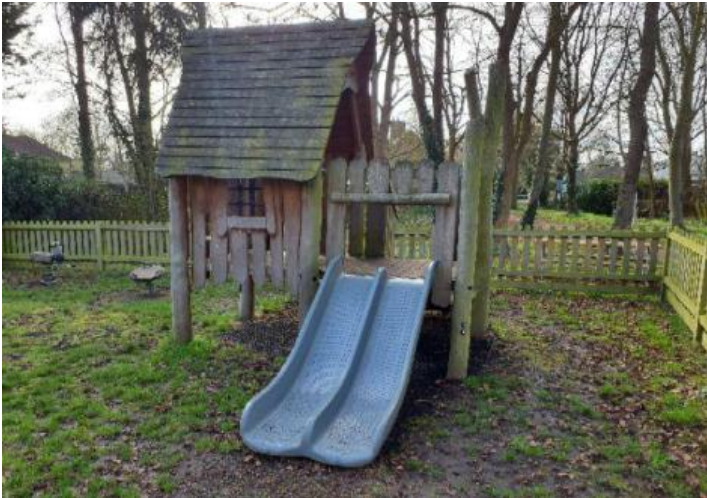
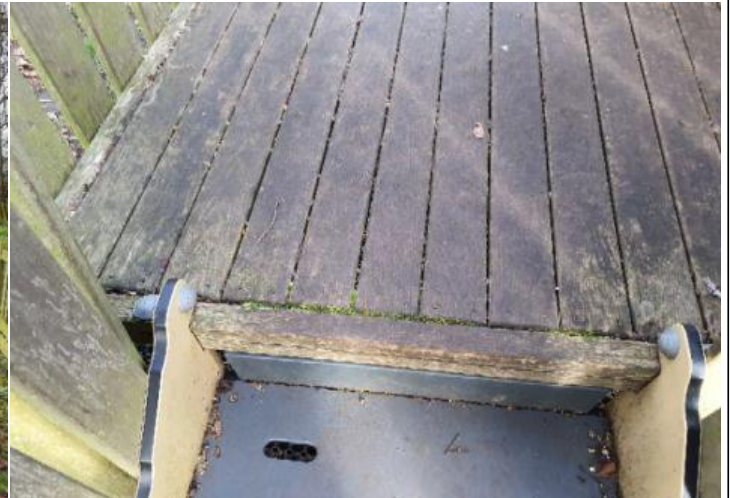
Finding: There is algae or moss on the surface of the equipment

Action: Clean and treat appropriately

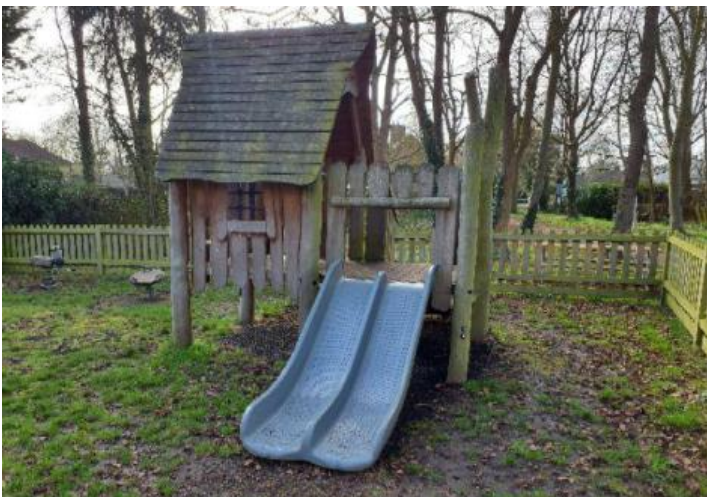
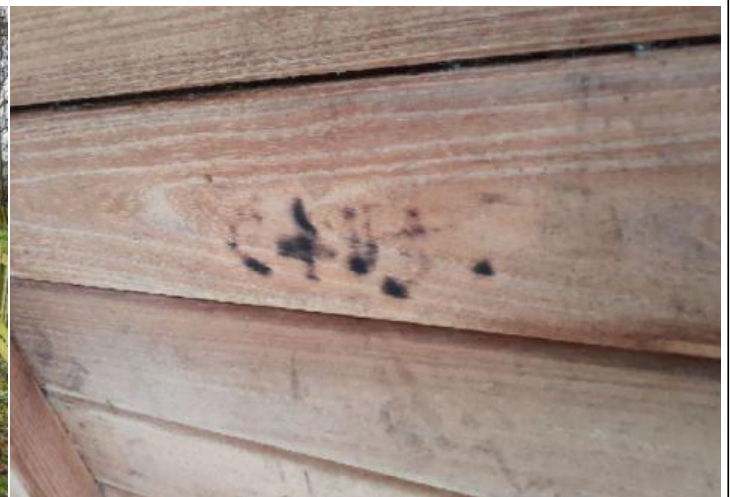
There is some evidence of fire damage to the item - Monitor for any further deterioration and repair as required

Finding: There is some evidence of fire damage to the item

Action: Monitor for any further deterioration and repair as required

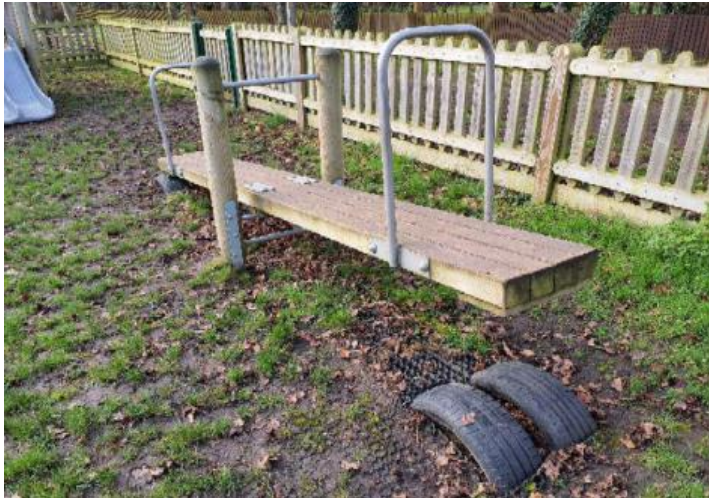
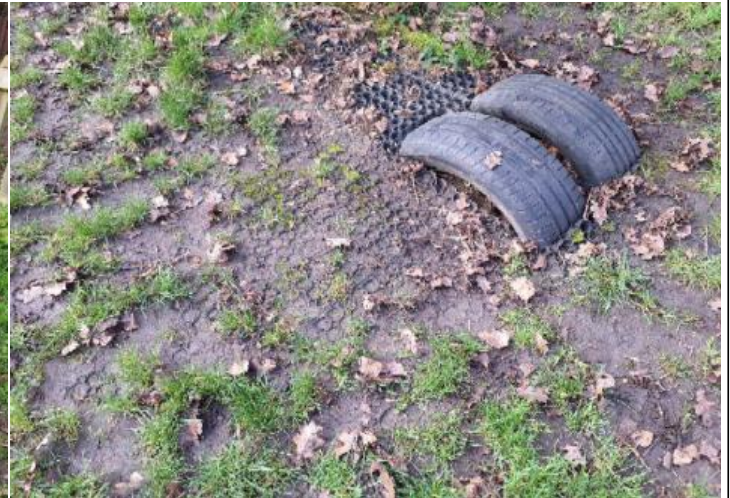
The grass mats are silted up, the soil is compacted and the area will become very slippery when the soil is wet. - Reinstate as required

Finding: The grass mats are silted up, the soil is compacted and the area will become very slippery when the soil is wet. **Action:** Reinstate as required

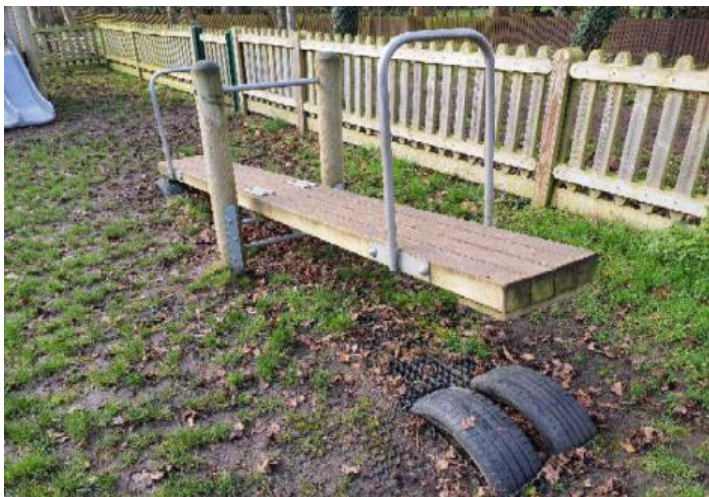
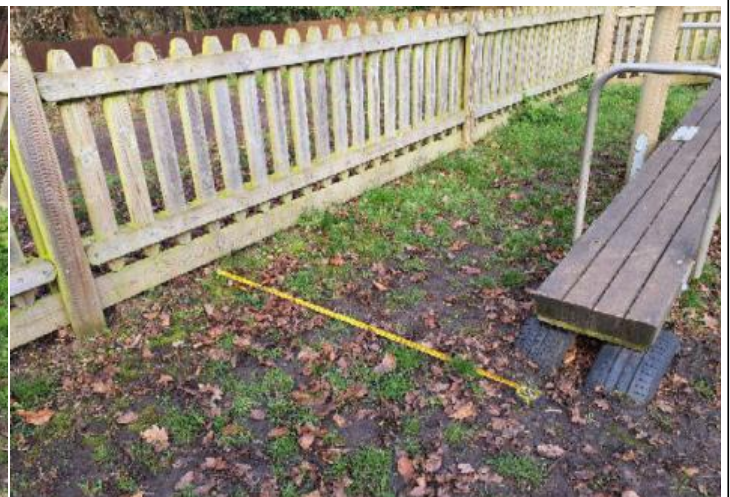
Finding: The fence forms a projecting obstacle / hard object within the falling space of the equipment, in contravention of the requirements of BS EN 1176 Part 1 **Action:** Monitor - No action given the risk assessment

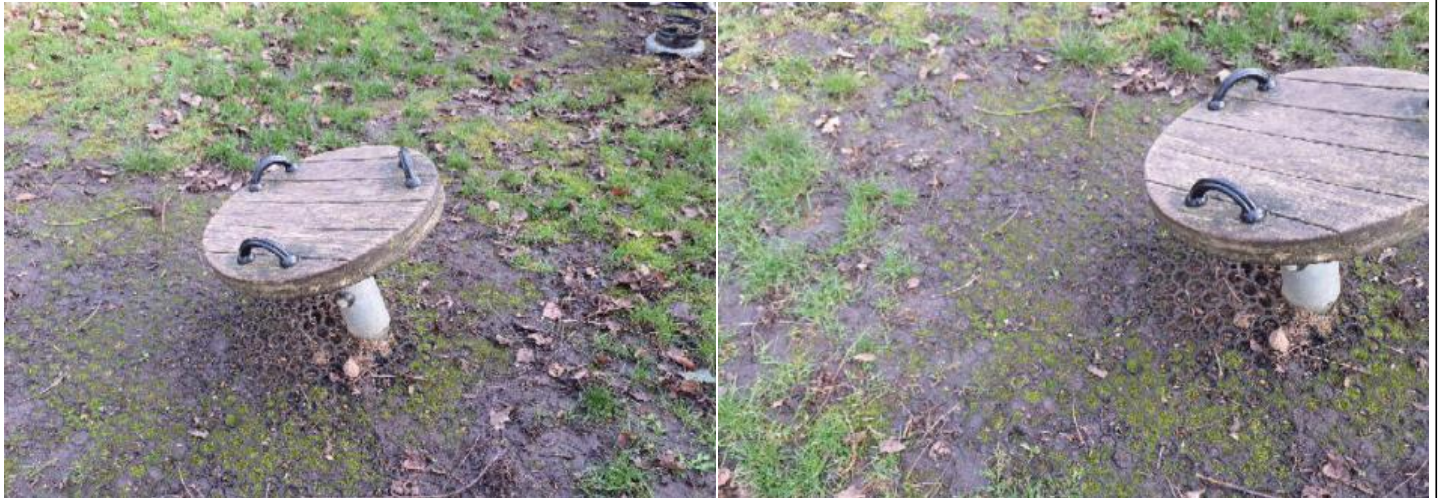
Finding: The grass mats are silted up, the soil is compacted and the area will become very slippery when the soil is wet. **Action:** Reinstate as required

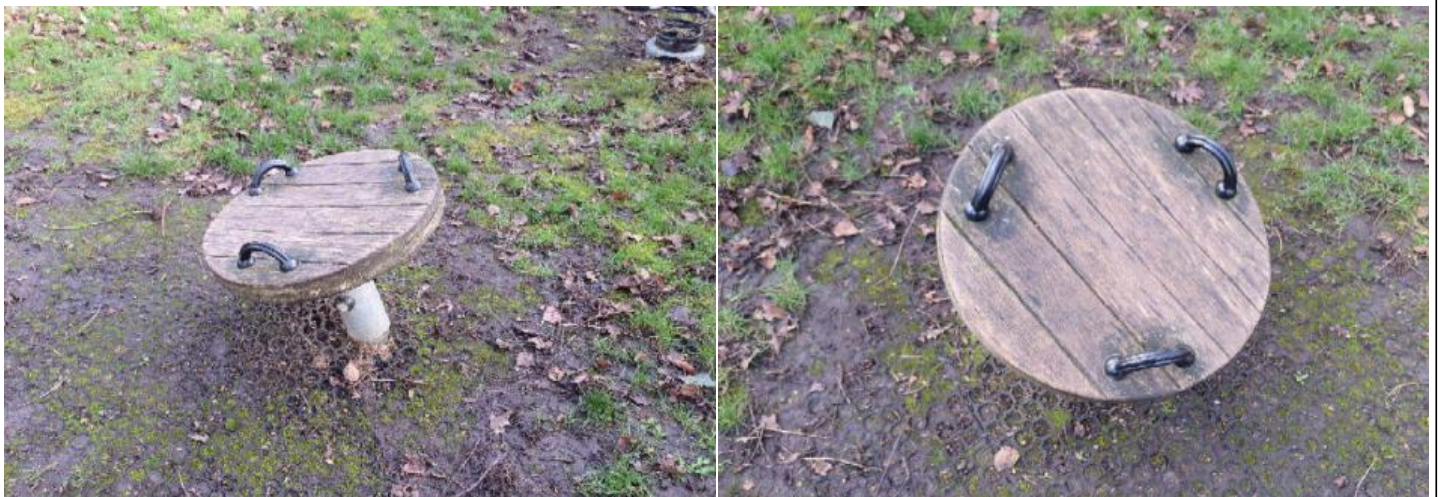
The bearing is showing signs of wear - Monitor for any further deterioration and replace as required

Finding: The bearing is showing signs of wear **Action:** Monitor for any further deterioration and replace as required

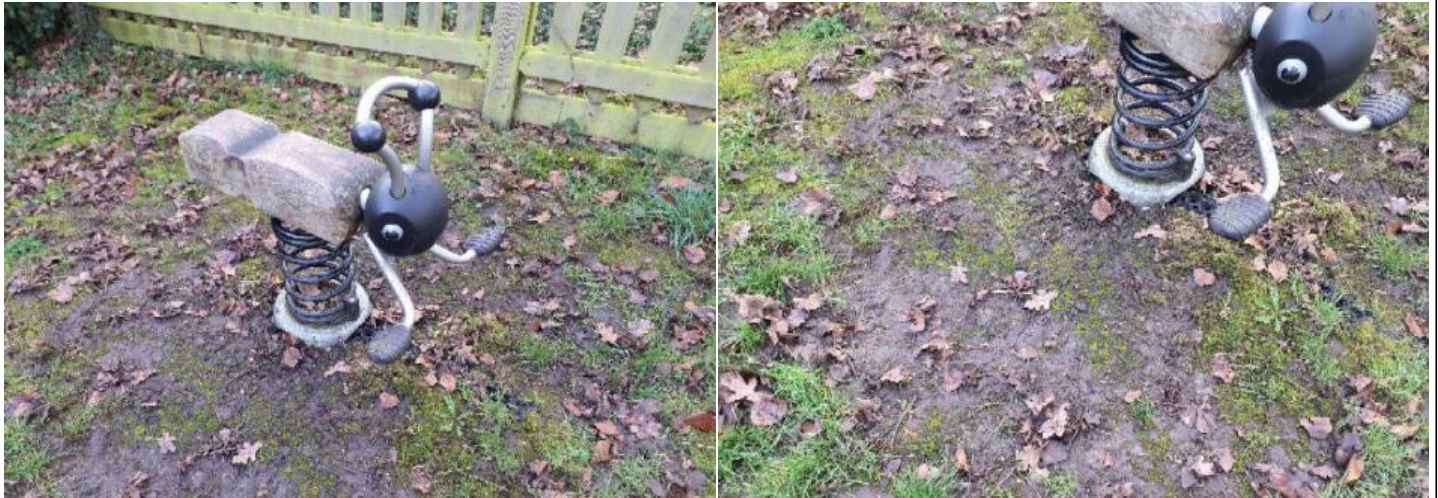
Finding: The grass mats are silted up, the soil is compacted and the area will become very slippery when the soil is wet. **Action:** Reinstate as required

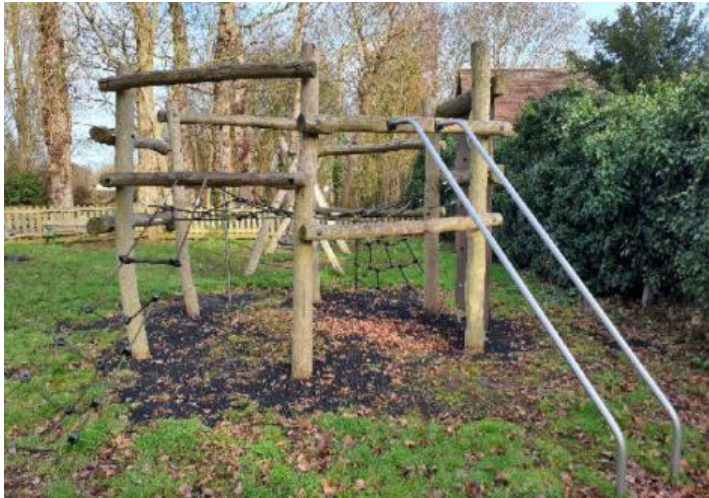
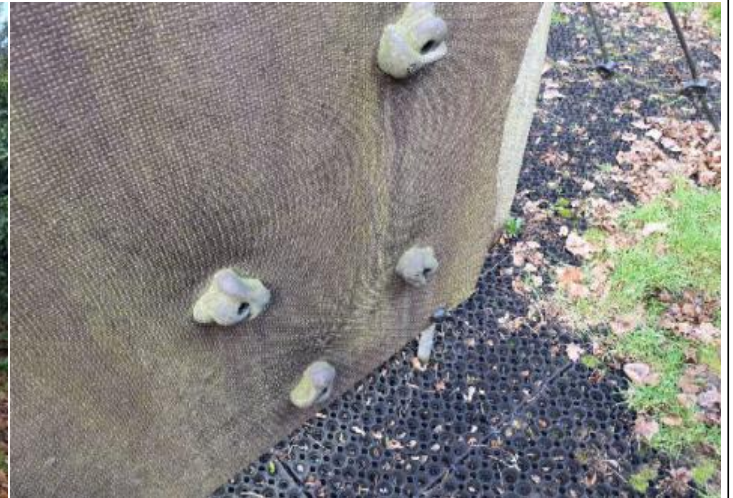
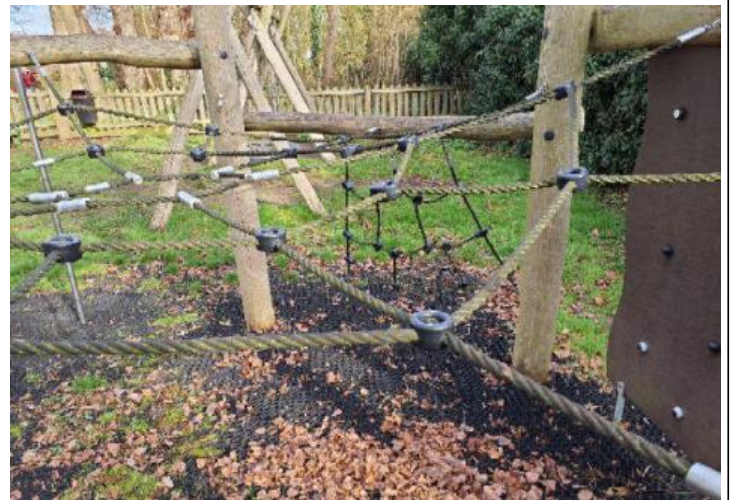
There is algae or moss on the surface of the equipment -
 Clean and treat appropriately

Finding: There is algae or moss on the surface of the equipment

Action: Clean and treat appropriately

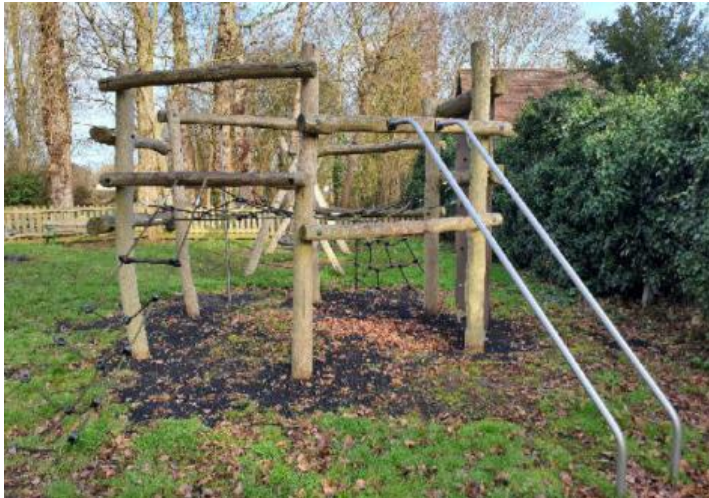
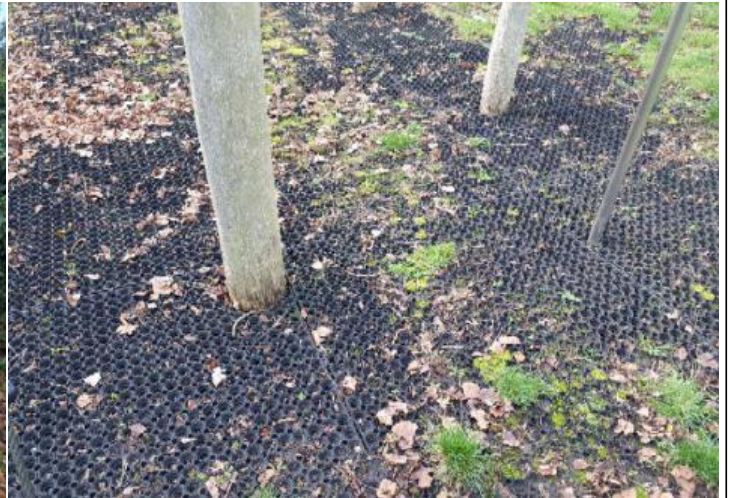
Finding: There is a lack of grass growth within the grassmats

Action: Encourage grass growth

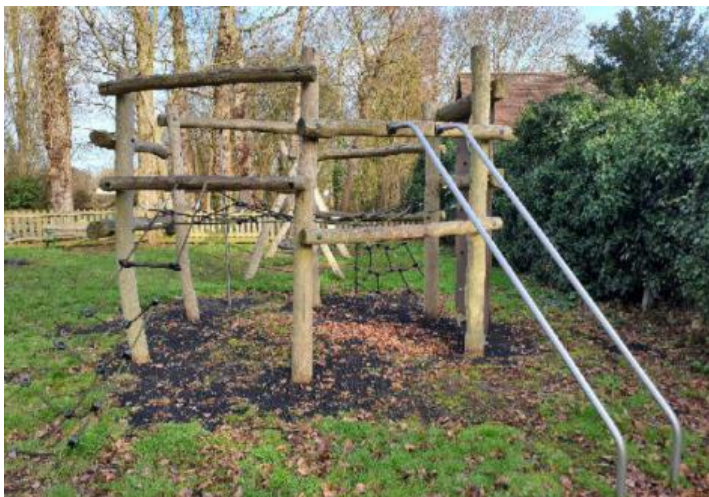
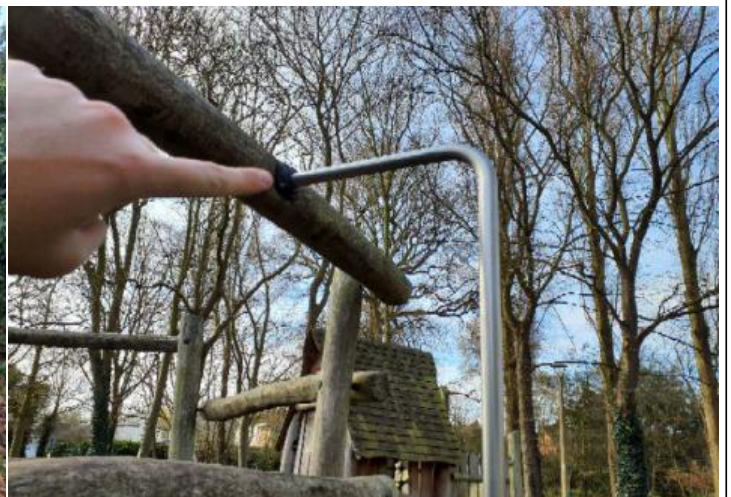
A number of fixing(s) have worked loose - Secure all loose
 fixings

Finding: A number of fixing(s) have worked loose

Action: Secure all loose fixings

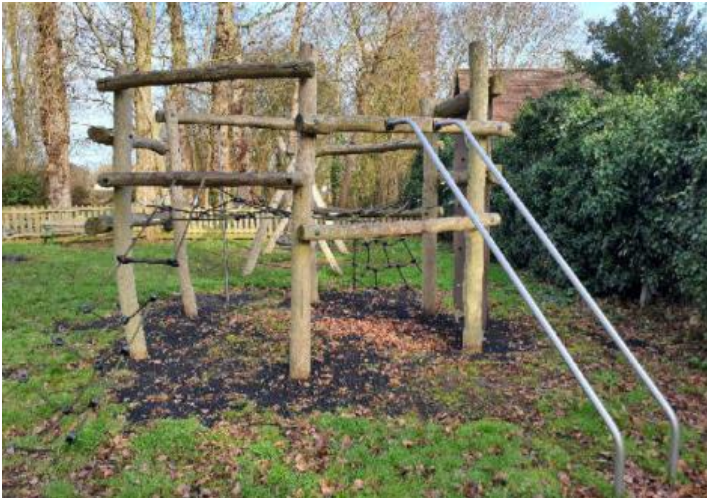
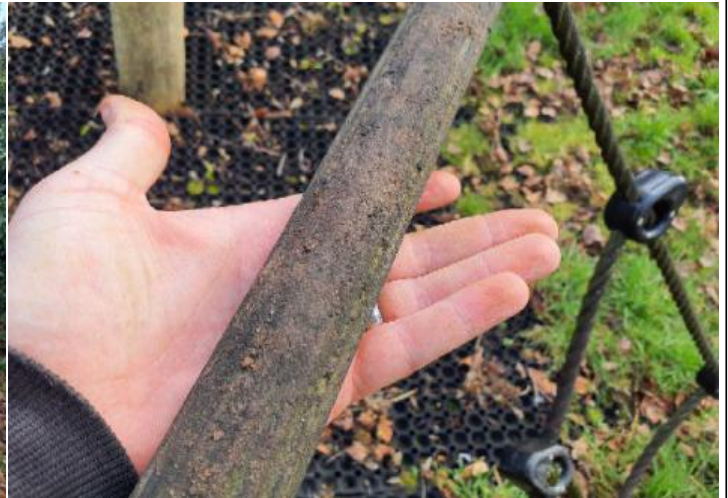
The item has been damaged - Monitor for any further
 deterioration and replace as required

Finding: The item has been damaged

Action: Monitor for any further deterioration and replace as required

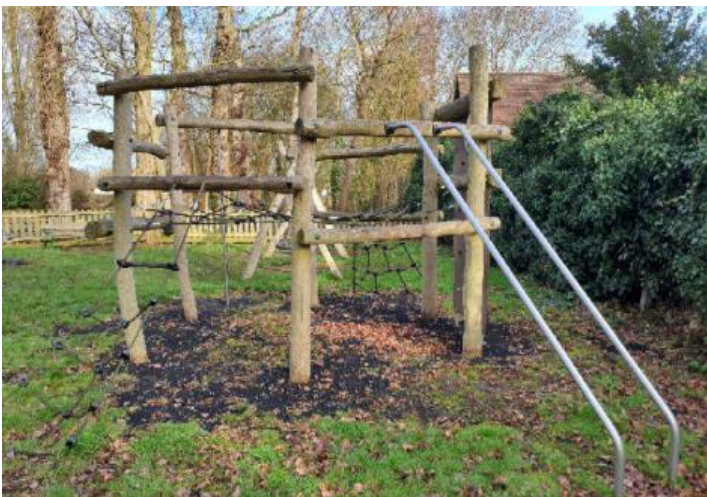
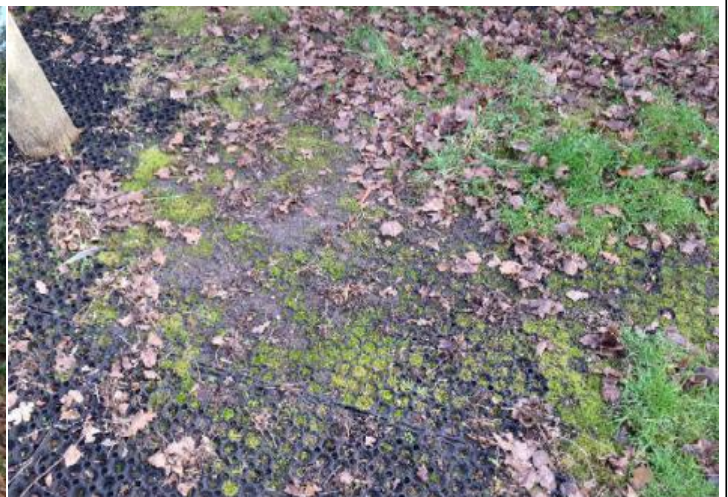
Finding: The grass mats are silted up, the soil is compacted and the area will become very slippery when the soil is wet.

Action: Reinstate as required

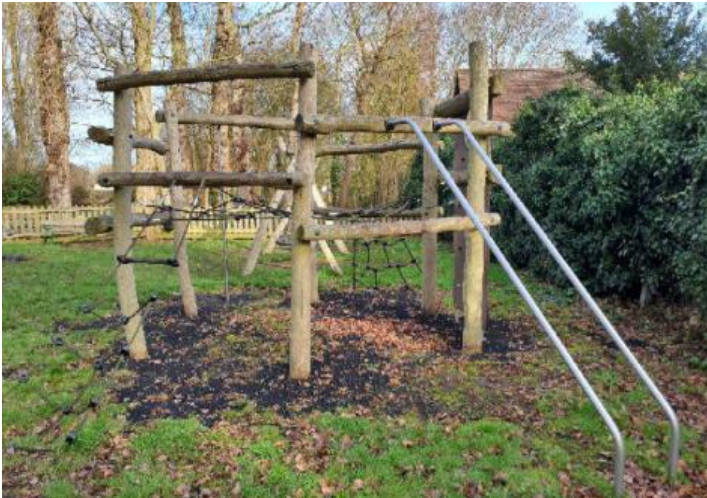
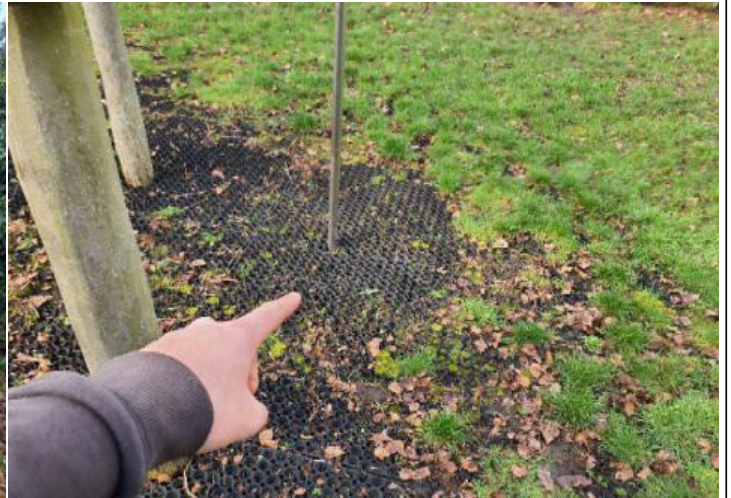
The surface has subsided in some areas - Monitor for any
 further deterioration and repair as required

Finding: The surface has subsided in some areas

Action: Monitor for any further deterioration and repair as required

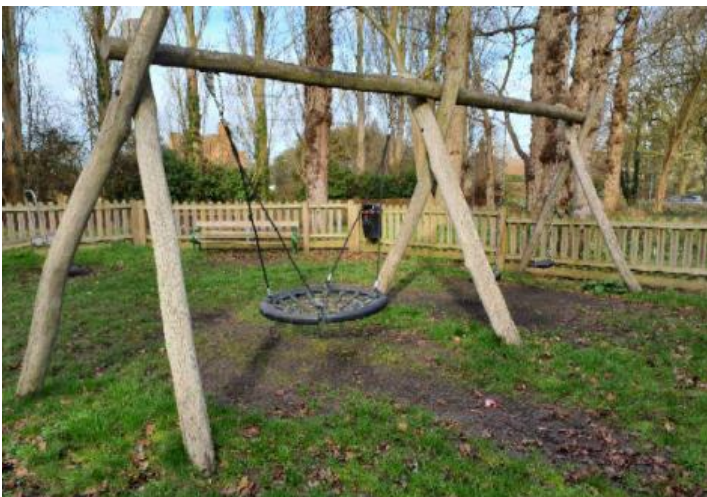
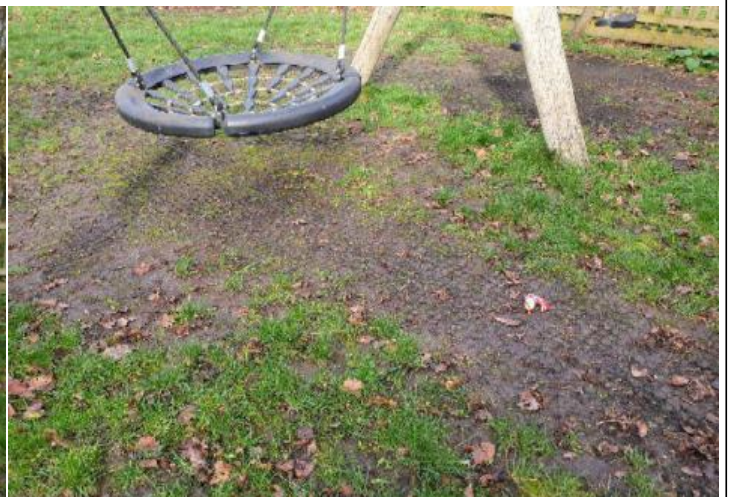
The grass mats are silted up and the soil is compacted; this may have an effect on the impact absorbing properties of the surface. Consideration should be given to HIC testing the surface to verify impact attenuating properties (<https://playinspections.co.uk/inspection-services/safety-surface-testing/>) - Contact our office for a quotation for this service

Finding: The grass mats are silted up and the soil is compacted; this may have an effect on the impact absorbing properties of the surface. Consideration should be given to HIC testing the surface to verify impact attenuating properties (<https://playinspections.co.uk/inspection-services/safety-surface-testing/>)

Action: Contact our office for a quotation for this service

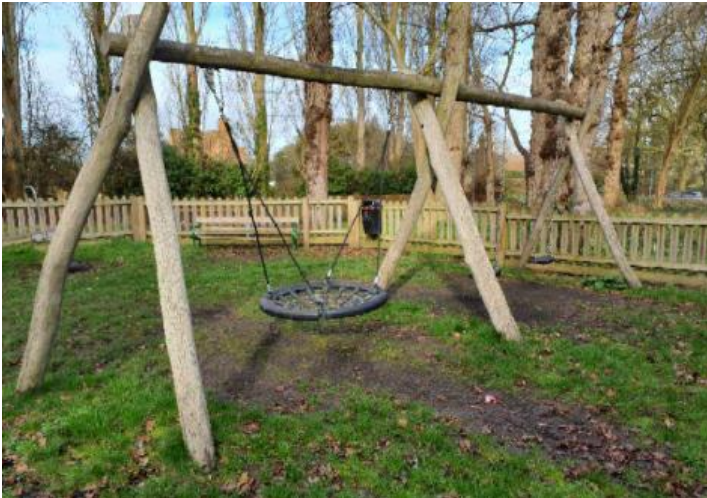
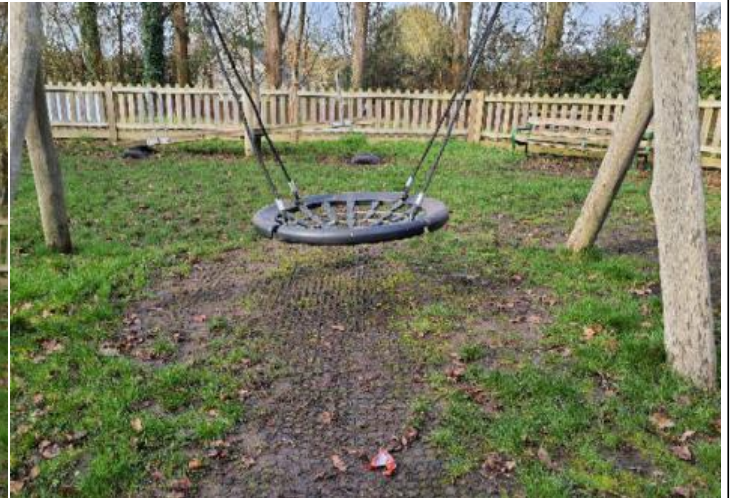
Finding: The seat is not level at rest

Action: Adjust seat

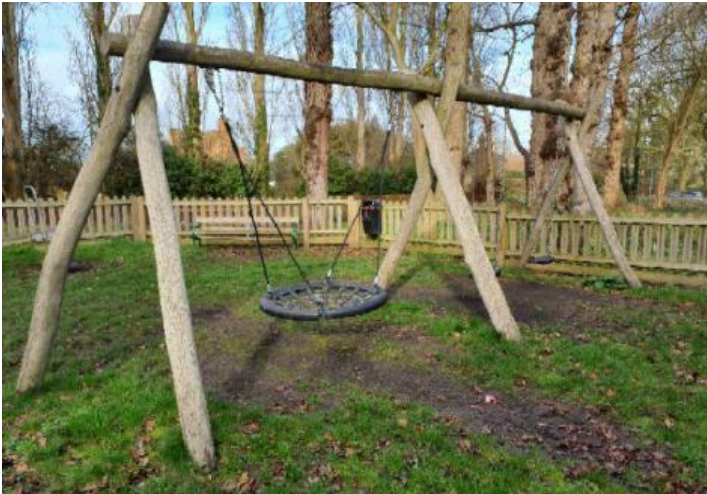
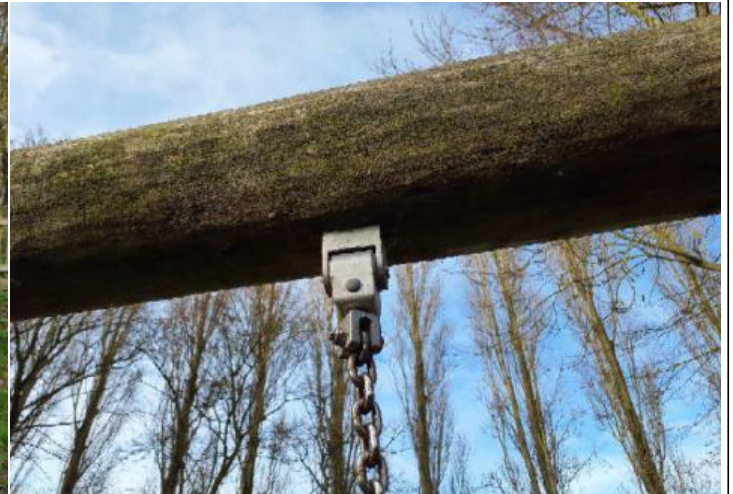
This design of swing joint has been known to fail on the weld connecting the joint to the threaded stud - We would recommend that the joint be dismantled and checked on a regular basis or consulting with manufacturer on whether a Secondary Safety Device can be fitted

Finding: This design of swing joint has been known to fail on the weld connecting the joint to the threaded stud

Action: We would recommend that the joint be dismantled and checked on a regular basis or consulting with manufacturer on whether a Secondary Safety Device can be fitted

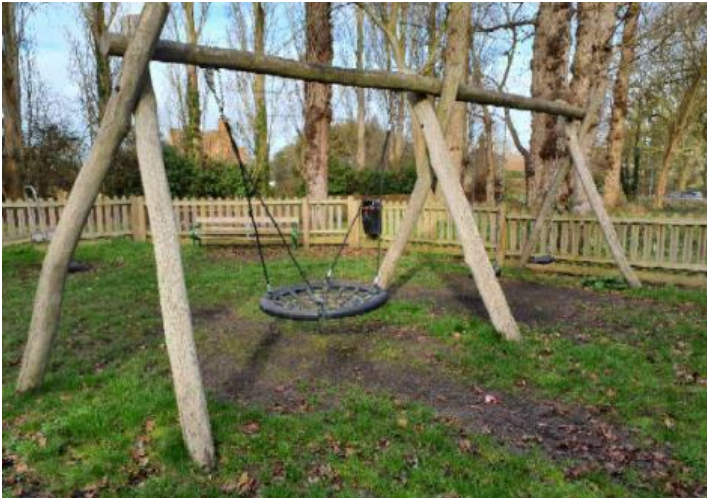
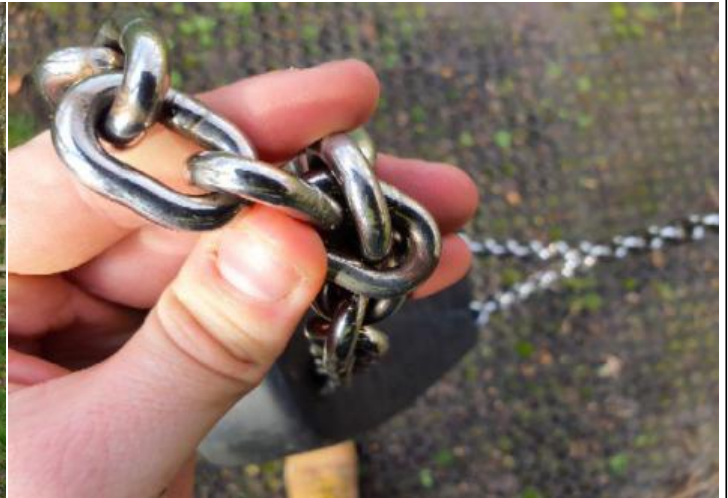
There is some notable evidence of chain wear - Monitor for any further deterioration and replace when 40% worn

Finding: There is some notable evidence of chain wear

Action: Monitor for any further deterioration and replace when 40% worn

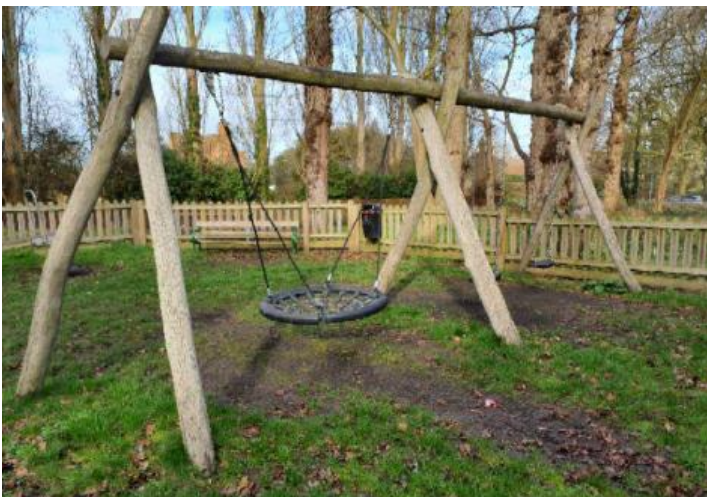
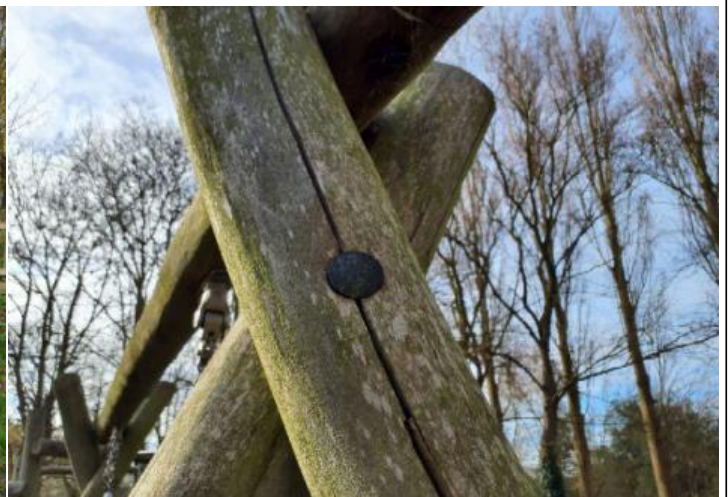
There are splits in the timber running through fixing points that may create instability in the future - Monitor for any further deterioration and replace as required

Finding: There are splits in the timber running through fixing points that may create instability in the future

Action: Monitor for any further deterioration and replace as required

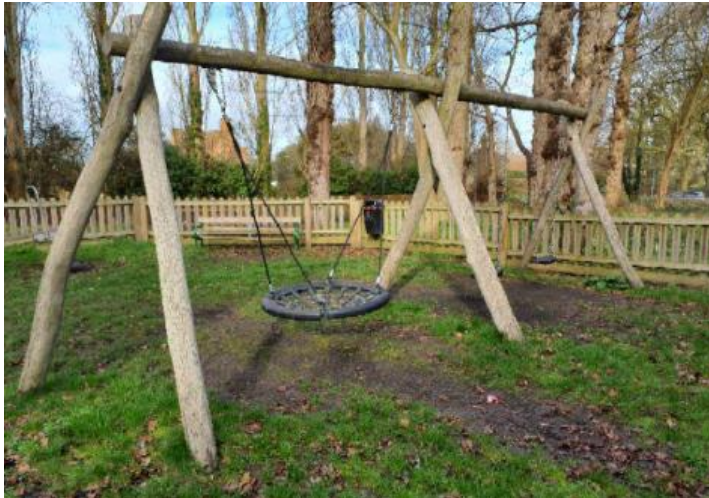
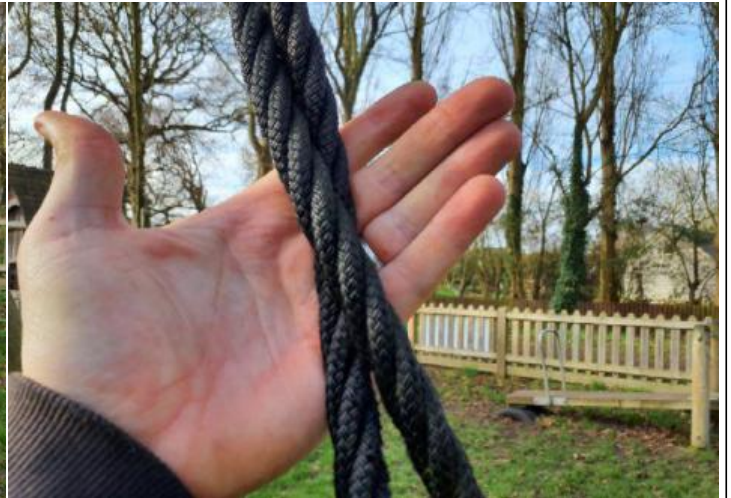
The suspension are twisted creating accelerated wear - Adjust suspension

Finding: The suspension are twisted creating accelerated wear

Action: Adjust suspension

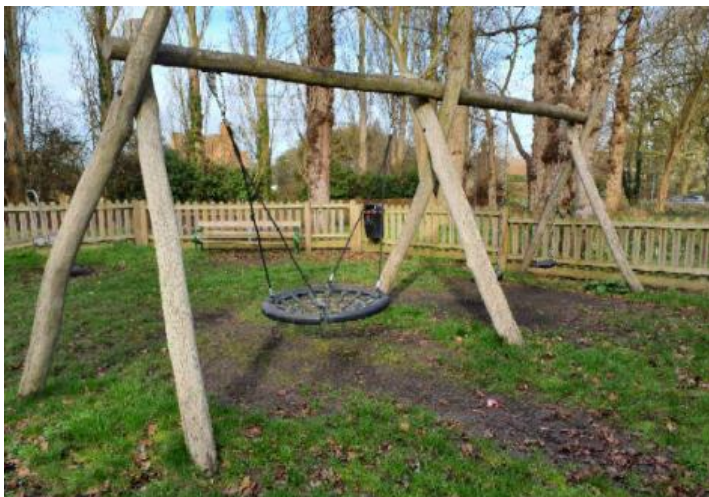
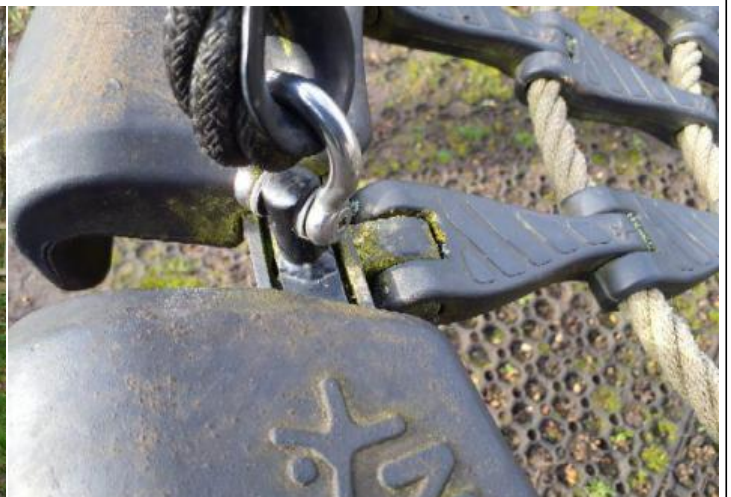
The bushes are showing signs of wear - Monitor for any further deterioration and replace as required

Finding: The bushes are showing signs of wear

Action: Monitor for any further deterioration and replace as required

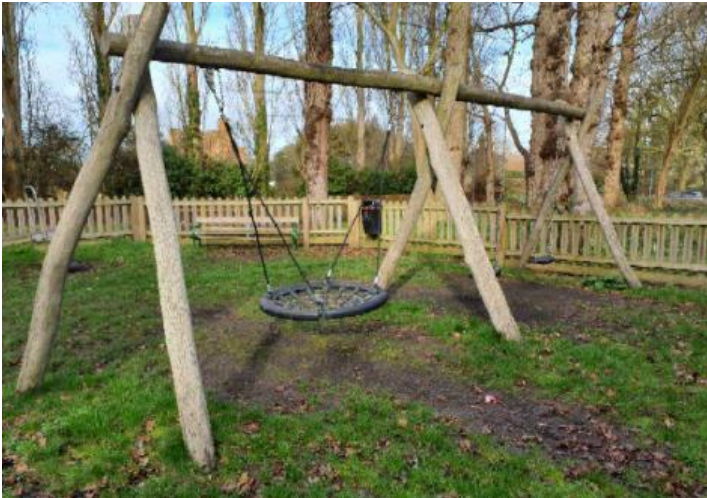
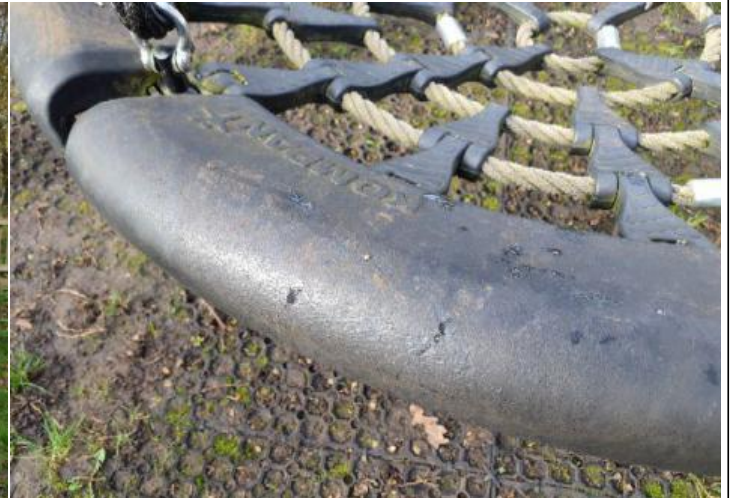
The seat has minor damage or wear - Monitor for any further deterioration and replace as required

Finding: The seat has minor damage or wear

Action: Monitor for any further deterioration and replace as required
