11th August 2025
Ref: 11846

Re: Picus Sonic Tomograph and IML PD 500 Micro Drill testing of 1x English oak at The Green, Hilton.

T001 – English oak (*Quercus robur*)

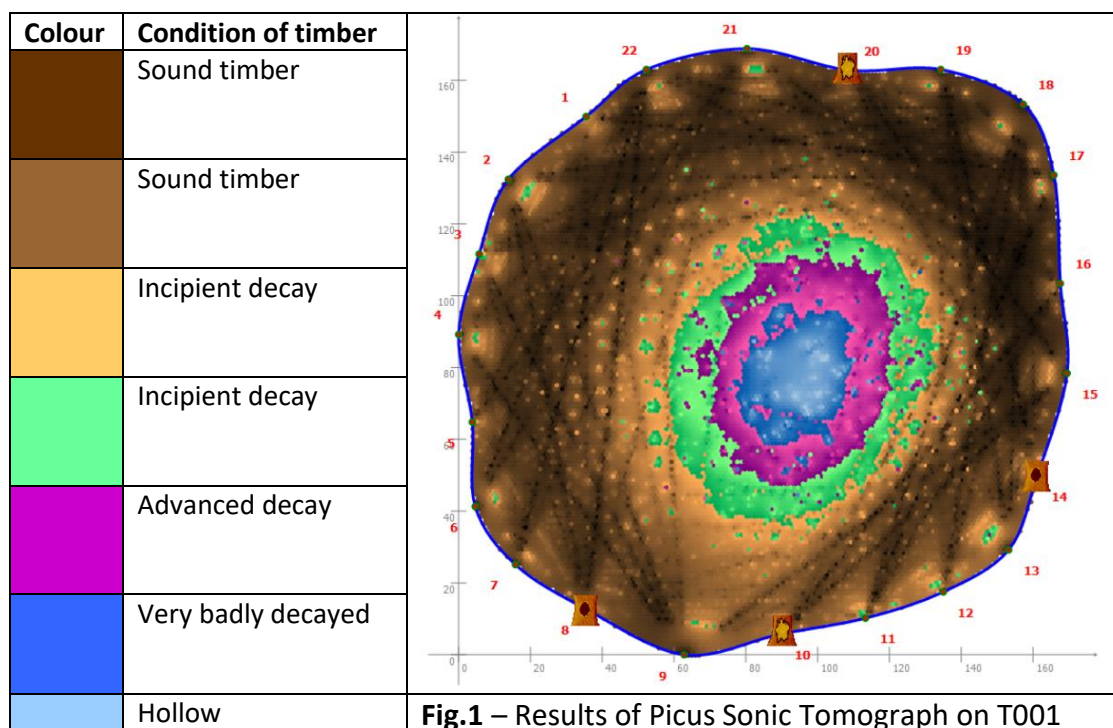
Referring to Figure 1 above, the image is a cross section of the stem at approximately 1m above ground level. Each red number is the position of a sensor that was attached to the tree during testing. The sensor located at “1” points north. There were bark defects found at sensors 10 and 20. There were narrow basal cavities at sensors 8 and 14. The grey axis lines measure in centimetres.

There is a clear central decay in the middle of the stem. This decay is considered to be advanced, worsening towards the centre of stem (the purple and blue zones). There is also a solid ring of wood between the defect and the bark. There is between 320mm and more than 500mm of solid wood at any point across the cross section. This indicates that there is a thick wall of wood still present.

The wood decay between sensors 9-11 suggest a correlation of less solid wood in proximity with the defects found in the bark surface. This matches the hollowing that was found with a sounding mallet when the tree was being inspected immediately prior to the Picus test.

It is recommended that the Picus and drill tests are repeated in July 2026 to measure any advance in the level of decay. Annual reinspection is recommended to establish a better understanding of the fungal activity in this tree.

The fence that has been erected around the tree should be retained to prevent access beneath the crown. The vegetation within the enclosure should not be managed in order to further dissuade access. Consideration could be given to erect a more permanent fence.

It is likely that the fungal pathogen will continue to subsist in the tree and advance the decay. With the continuation of the decay, the condition of the tree will deteriorate. As a result, it is recommended that tree surgery is undertaken to remove branches accounting for approximately 5% of the crown volume. These branches should be no larger than 100mm at the point of pruning and all cuts must be taken at an appropriate pruning point or union, in accordance with BS3998. This surgery will seek to mimic natural retrenching in order to a) reduce the potential for falling branches, b) stimulate reaction growth in response, and c) reduce weight in the crown.

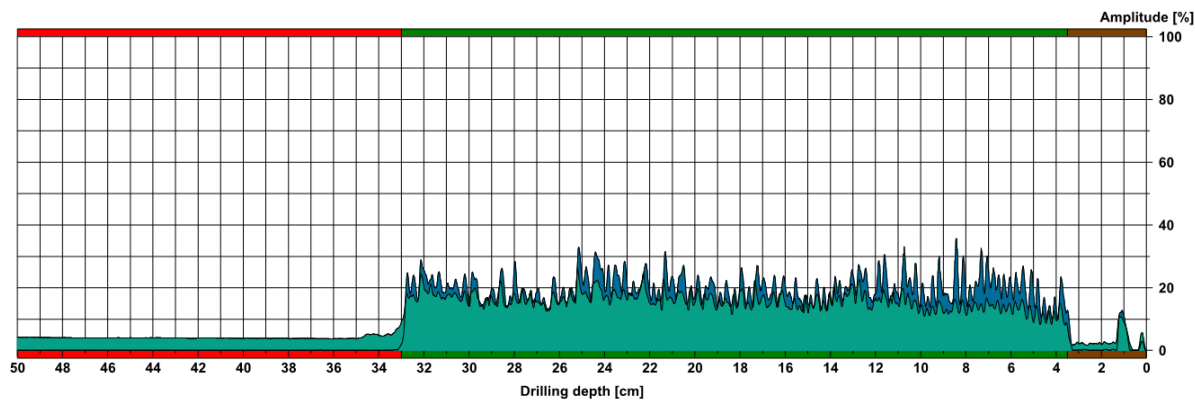
Drill 4

From	0.00 cm	to	3.50 cm	:	Bark
From	3.50 cm	to	33.00 cm	:	Solid wood
From	33.00 cm	to	50.00 cm	:	Decay

MP16

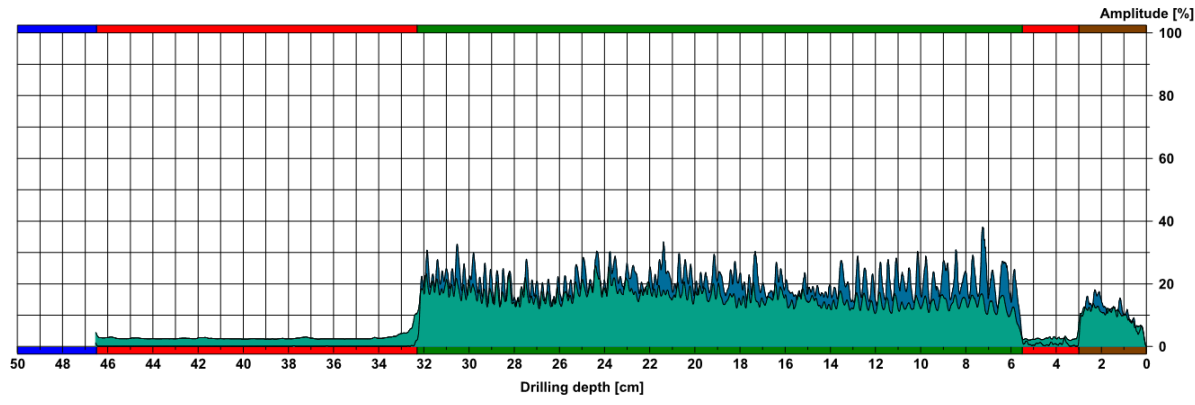
Drill 5

From	0.00 cm	to	3.00 cm	:	Bark
From	3.00 cm	to	5.50 cm	:	Decay
From	5.50 cm	to	32.30 cm	:	Solid wood
From	32.30 cm	to	46.50 cm	:	Decay
From	46.50 cm	to	50.00 cm	:	End of test

MP14

Broadly, the results from the drill testing aligns with the tomograph. The tests at MP2 and MP14 are a particularly good comparison to the Picus data as one shows a long extent of solid wood (drill 10 at MP2) and the other shows an extent of solid wood that falls away in terms of resistance in the wood where decay is evident (drill 5 at MP14). The drill tests have been taken on all aspects of the stem and concentrate on the areas of dysfunction on the stem.
