the **play inspection** company

Annual Inspection

Hilton Parish Council

Jubilee Playground

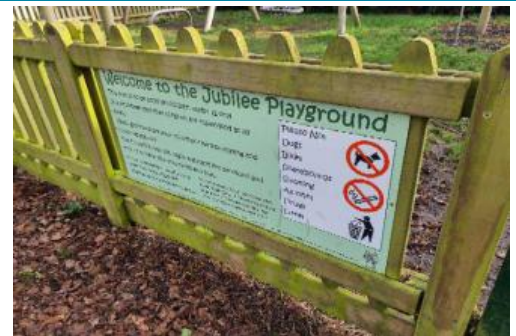
Item: Sign
Manufacturer: Not Identified
Surface Type: N/A
Item Part Number: Fence Mounted
Item Quantity: 1
Equipment Compliance: N/A
Surface Area Compliance: N/A
Total Findings: 1

This item is satisfactory - no work required -

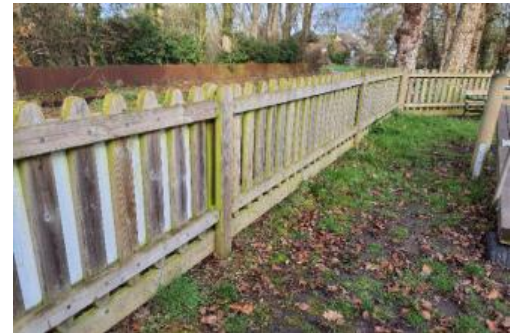
Item: Fencing - Timber
Manufacturer: Jacksons Fencing
Surface Type: Grass
Item Quantity: 1
Equipment Compliance: N/A
Surface Area Compliance: N/A

This item is satisfactory - no work required -

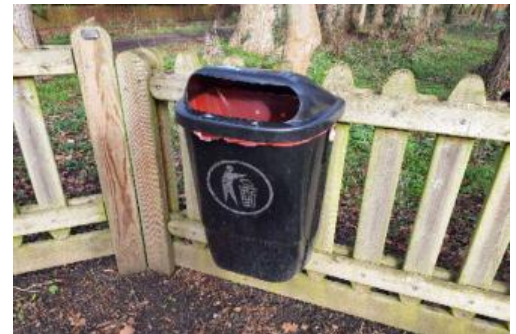
Item: Litter Bin
Manufacturer: Not Identified
Surface Type: Grass
Item Part Number: Fence Mounted
Item Quantity: 1
Equipment Compliance: N/A
Surface Area Compliance: N/A
Total Findings: 1

This item is satisfactory - no work required -

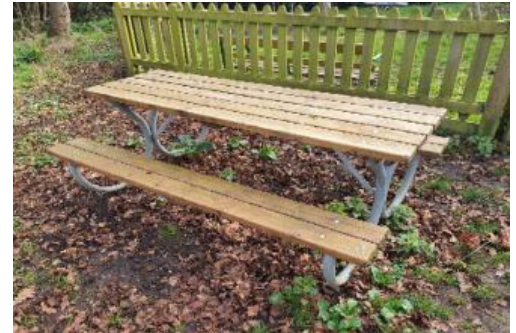
Item: Picnic Table
Manufacturer: Kompan Ltd
Surface Type: Grass
Item Quantity: 2
Equipment Compliance: N/A
Surface Area Compliance: N/A

This item is satisfactory - no work required -

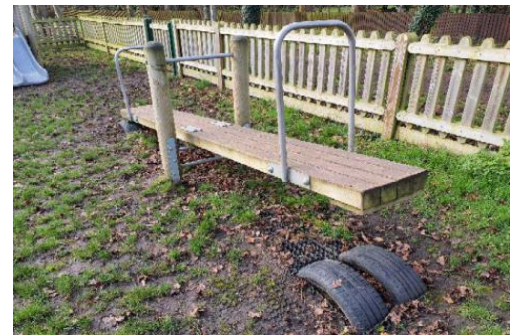
Item: Stand up SeeSaw
Manufacturer: Eibe Play Ltd
Surface Type: Grass Matrix Tiles
Item Part Number: Stand on seesaw
Item Quantity: 1
Equipment Compliance: No
Surface Area Compliance: Yes
Total Findings: 2

The grass mats are silted up, the soil is compacted and the area will become very slippery when the soil is wet. - Reinstate as required

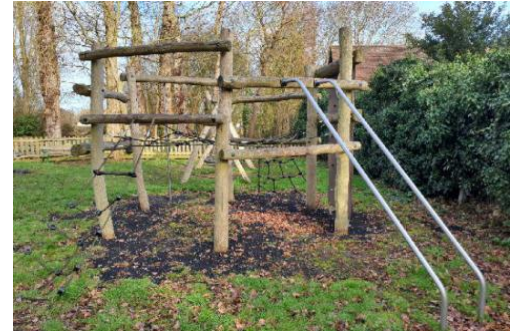
Item: Climbing Frame
Manufacturer: Kompan Ltd
Surface Type: Grass Matrix Tiles
Item Quantity: 1
Equipment Compliance: Yes
Surface Area Compliance: Yes

There is algae or moss on the surface of the equipment -
 Clean and treat appropriately

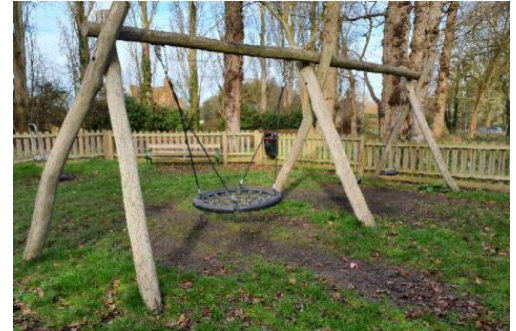
Item: 2 Bay 2 Flat 1 Basket Seat
Manufacturer: Kompan Ltd
Surface Type: Grass Matrix Tiles
Item Quantity: 1
Equipment Compliance: Yes
Surface Area Compliance: Yes

The grass mats are silted up and the soil is compacted; this may have an effect on the impact absorbing properties of the surface. Consideration should be given to HIC testing the surface to verify impact attenuating properties (<https://playinspections.co.uk/inspection-services/safety-surface-testing/>) - Contact our office for a quotation for this service
